ARBORICULTURAL ASSESSMENT

MIDGLEY STREET PUMP STATION

Water Corporation
629 Newcastle Street
Leederville
6007 WA

Re: Tree Plotter survey at the above address

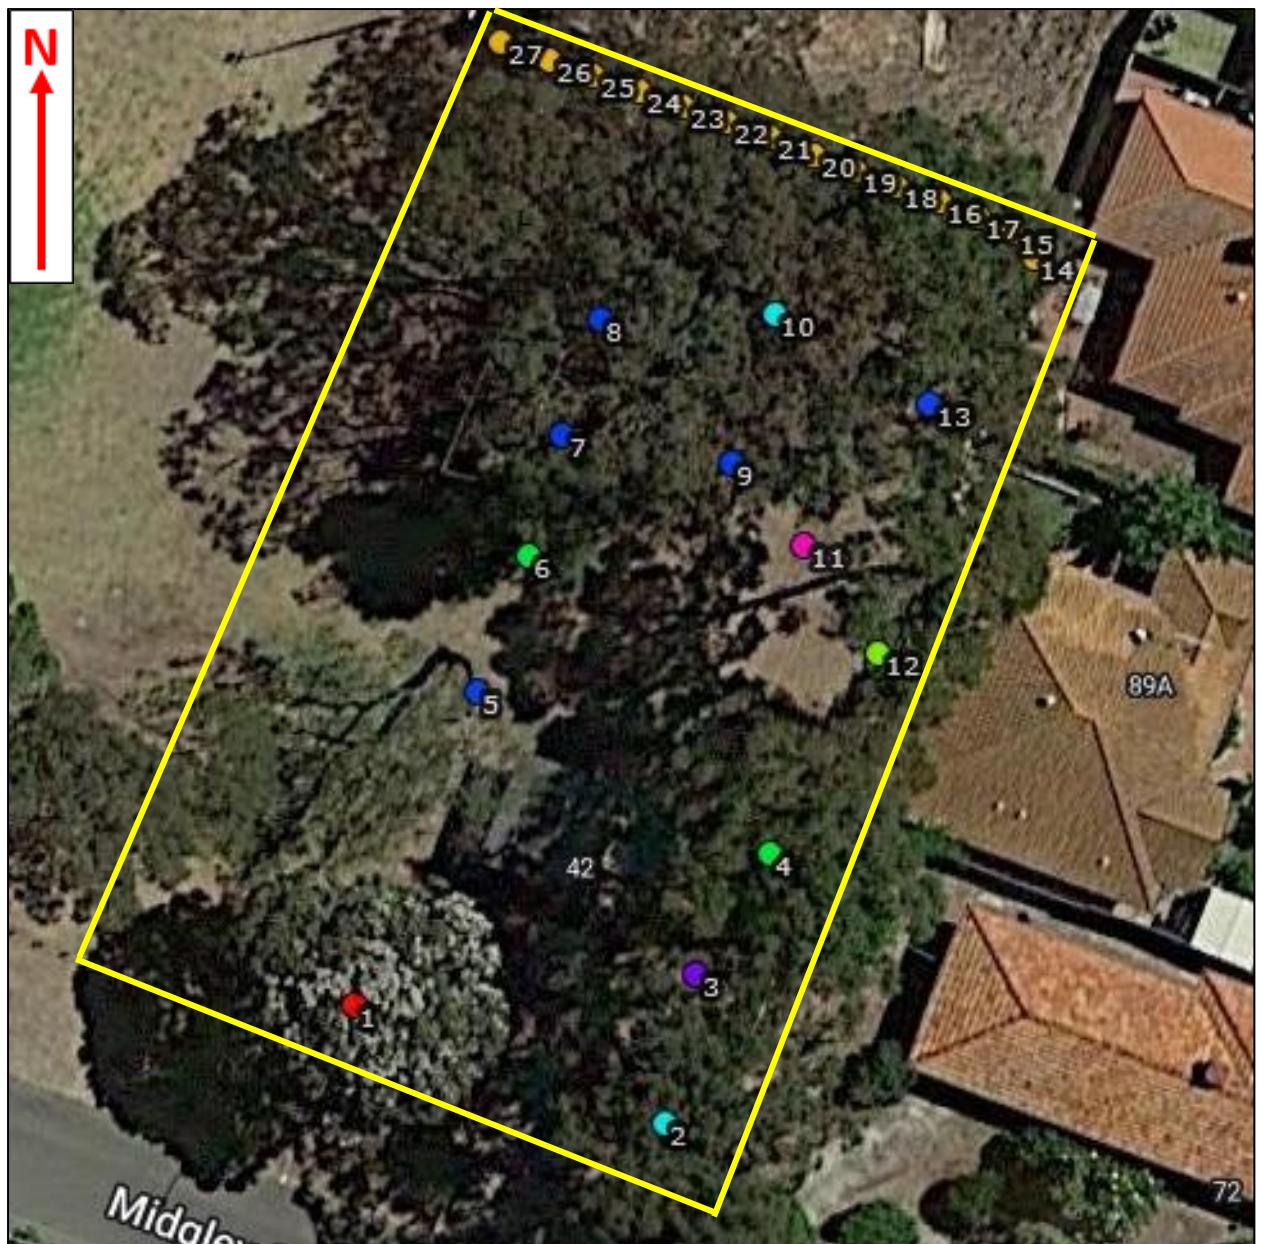
IMG.2 Shows boundaries of the site and location of trees within.

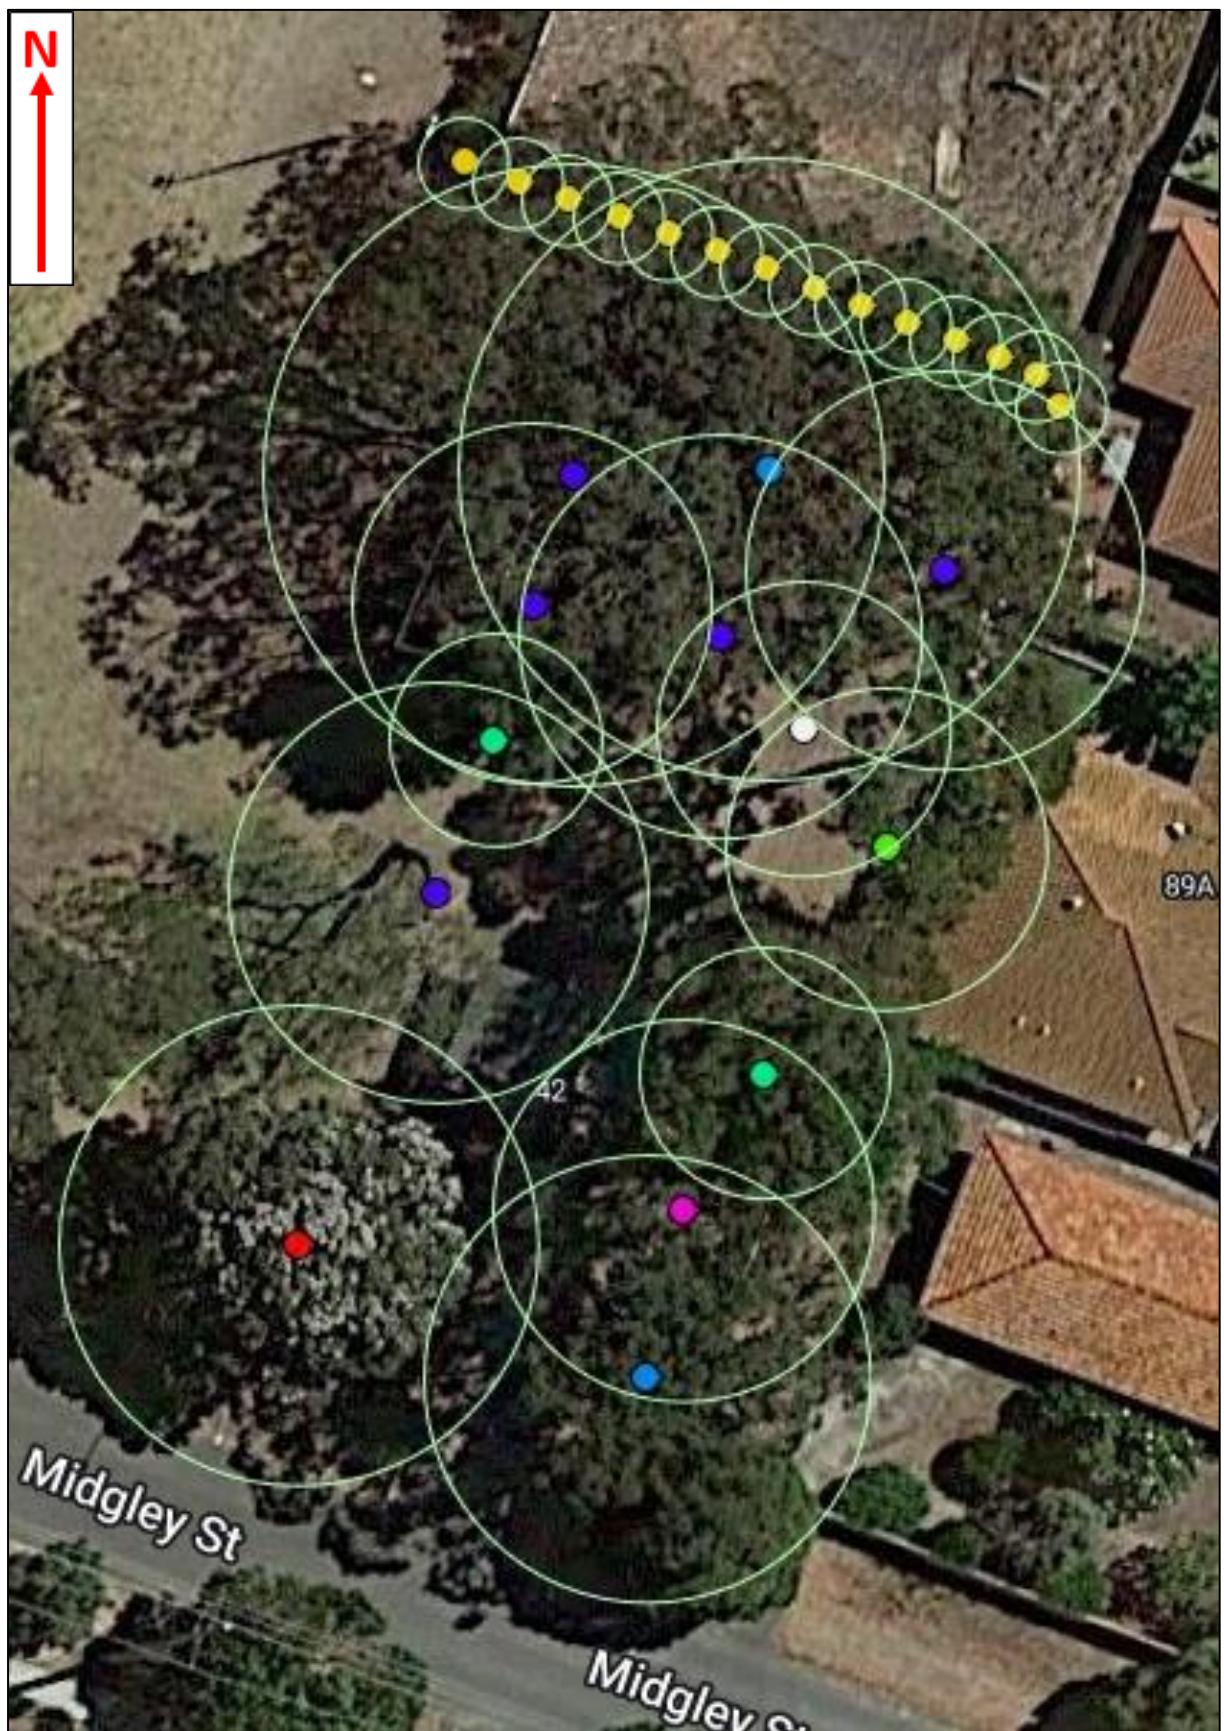
IMG.3 Shows Tree Protection Zones of all trees on site.

- 4.2 Due to the position of the Tree Protection Zones, any form of excavation within the site may negatively impact the vitality of trees to some extent depending on final designs and the footprint of the excavation.

- 5.1 Minimise the footprint of any excavations.
- 5.2 Undertake excavations in accordance with AS 4970:2009 "*Protection of Trees on Development Sites*".
- 5.2 Engage a consultant arborist to be on-site during any excavations to monitor and undertake any root pruning required.

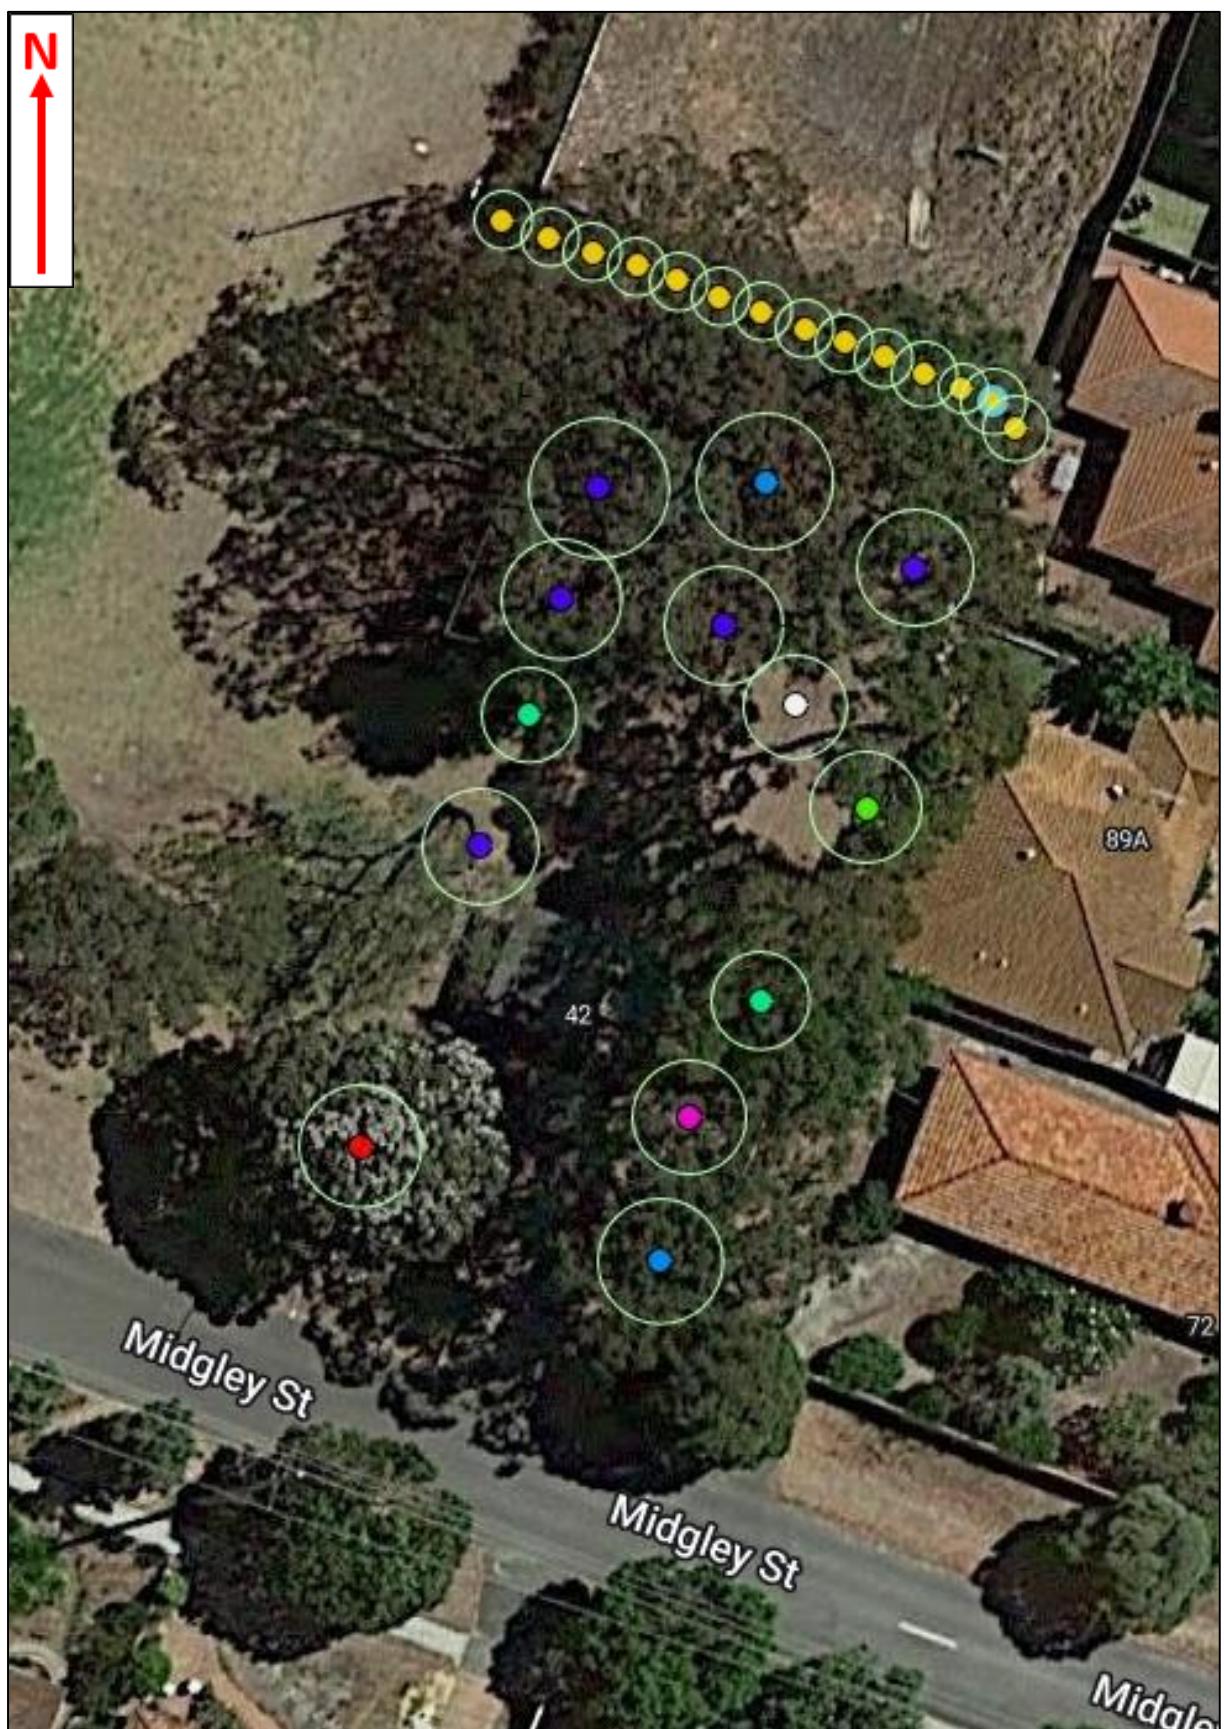
IMG.4 Shows Structural Root Zones of all tree on site.

- 4.3 Excavation within the Structural Root Zones (SRZ) of any trees is likely to have significant negative impact on both structural integrity and vitality. There is space within the site, to the northeast of the existing structure that does not fall within the SRZ of any trees, should significant excavation be required this location appears most suitable from a tree retention perspective.

- 4.4 Should excavation be required within the Structural Root Zones retention of the impacted trees is unlikely to be feasible. As such it is recommended that the footprint of any excavation be kept to a minimum and outside the SRZ of any trees where possible. Any excavation on the site will likely be within the Tree Protection Zone of at least one of the trees and it is likely that roots will be encountered. Excavations should be undertaken under supervision of a consultant arborist to assist in decision making and undertake any root pruning where required.
