STATS Australia
Specialist Testing and Technical Services

RELOCATION OF TIMBER STRUCTURE, SHEPPERTON ROAD AND RUSTHON STREET

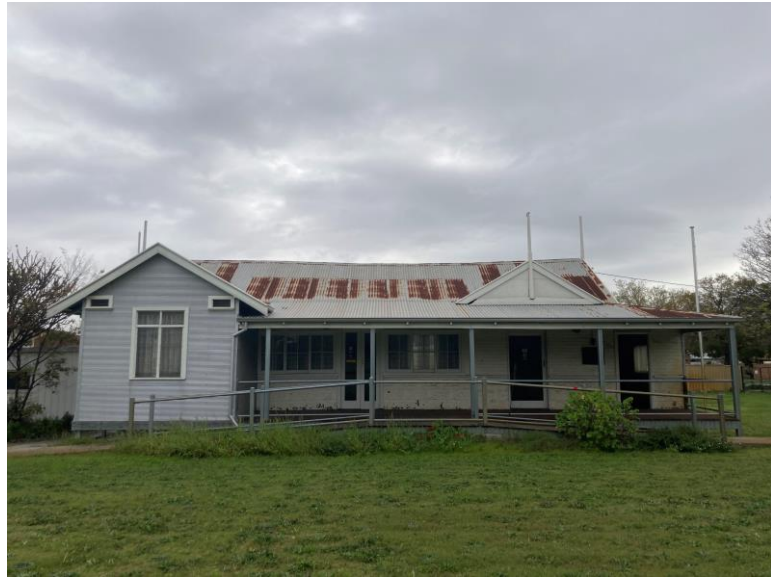
Visual Inspection and Feasibility Study

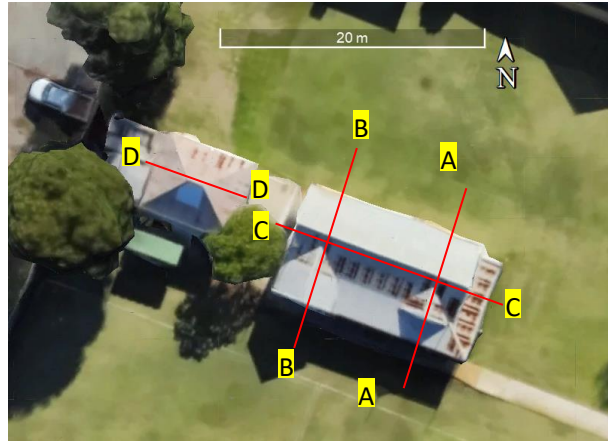
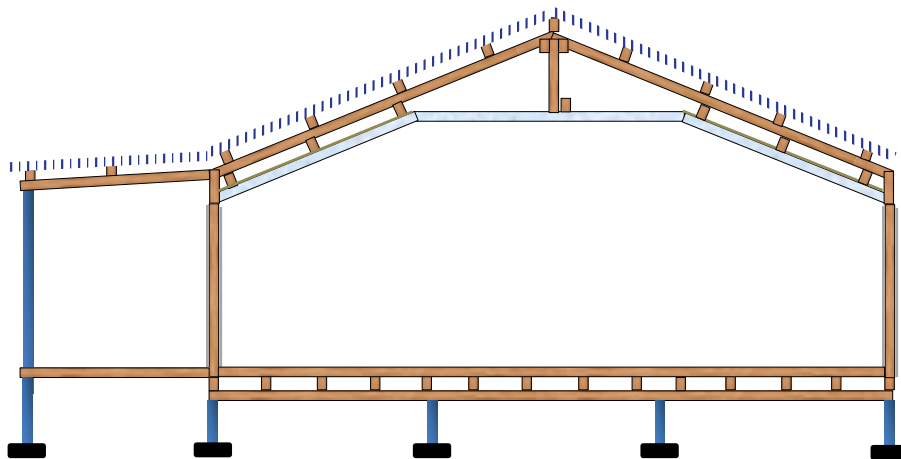
Section A-A of Croquet Clubhouse

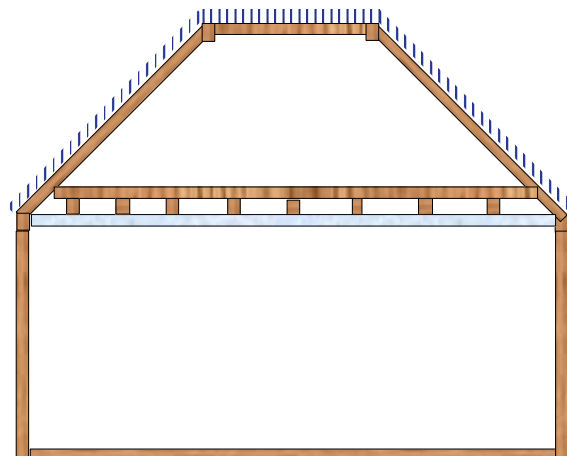
Section D-D of Cottage

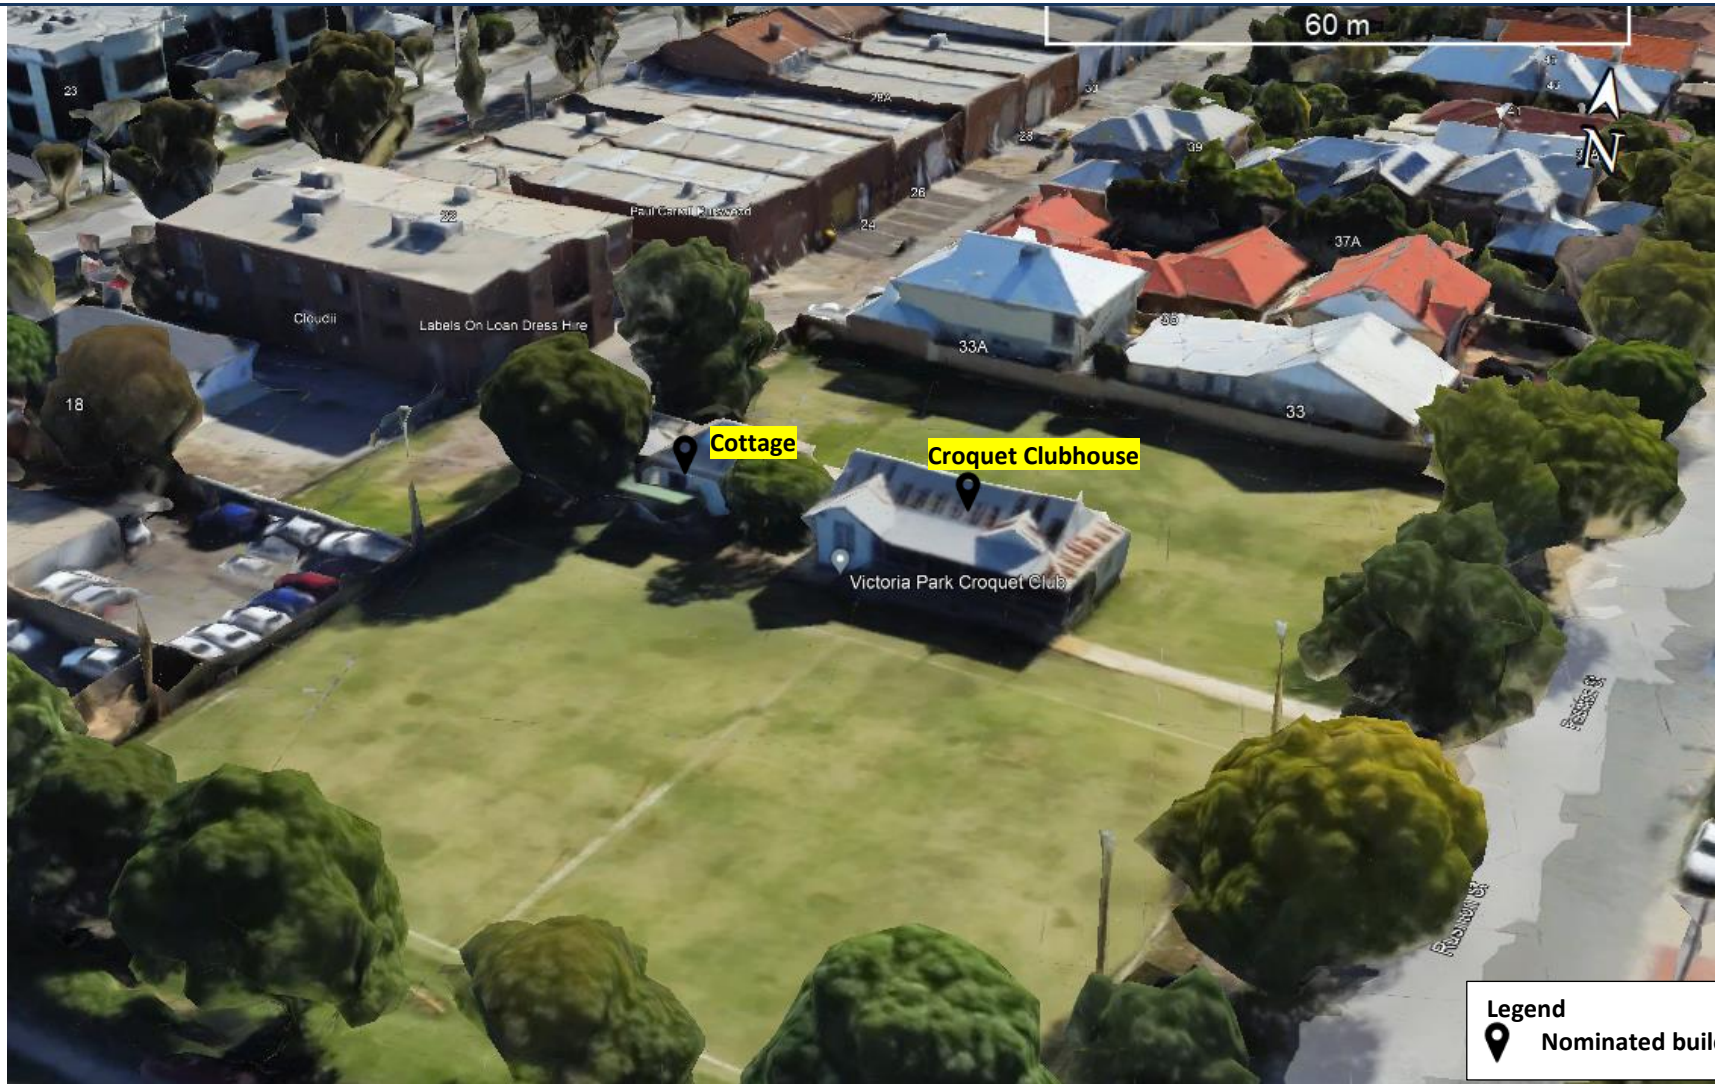
Project Title:
**RELOCATION OF TIMBER STRUCTURE,
 SHEPPERTON ROAD AND RUSTHON
 STREET**
 - Feasibility Study

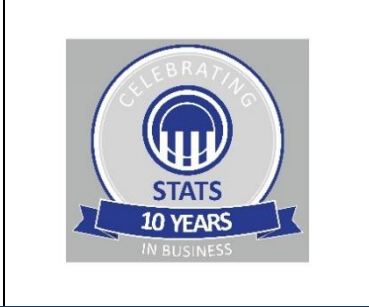
STATS AUSTRALIA
 Unit 1/16 Production Road,
 CANNING VALE WA 6155
 Tel: 08 9455 3654
 Fax: 08 9455 3709
 www.statsaustralia.com.au

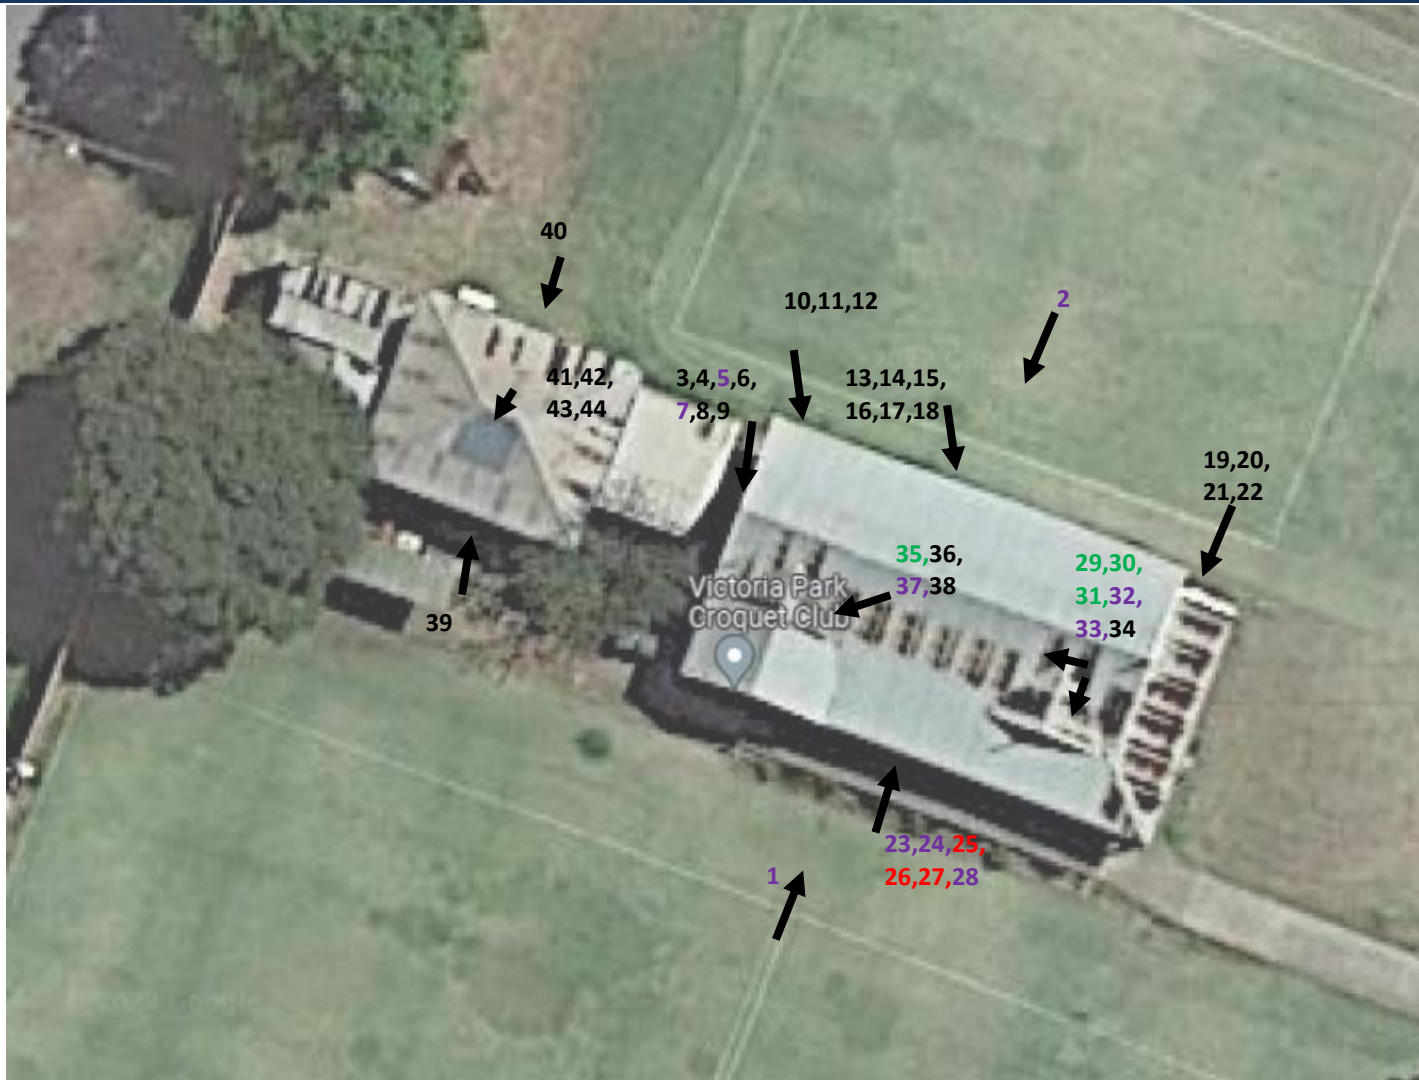
Condition Rating	Defects Description
4	Significant Defects
3	Moderate condition (Defects, Cracks or Loosen Element)
2	Asbestos Product
1	Good Condition

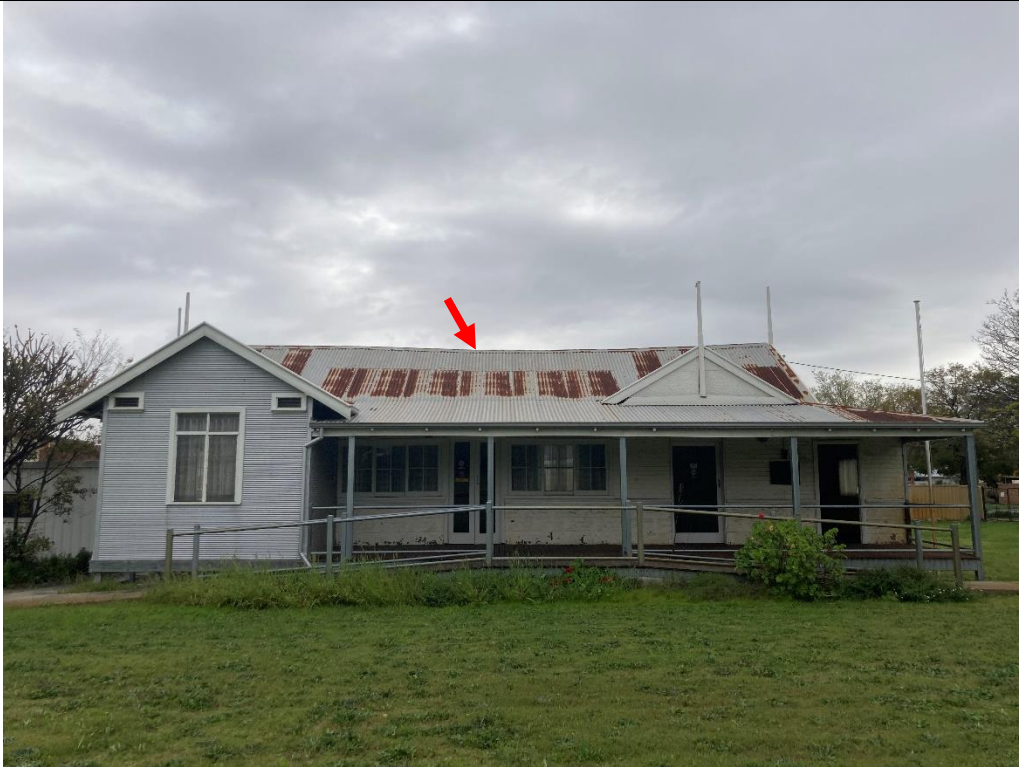
Photo 1: Overall view from the South of the croquet clubhouse looking North. Observed sagging of the roof ridge beam.

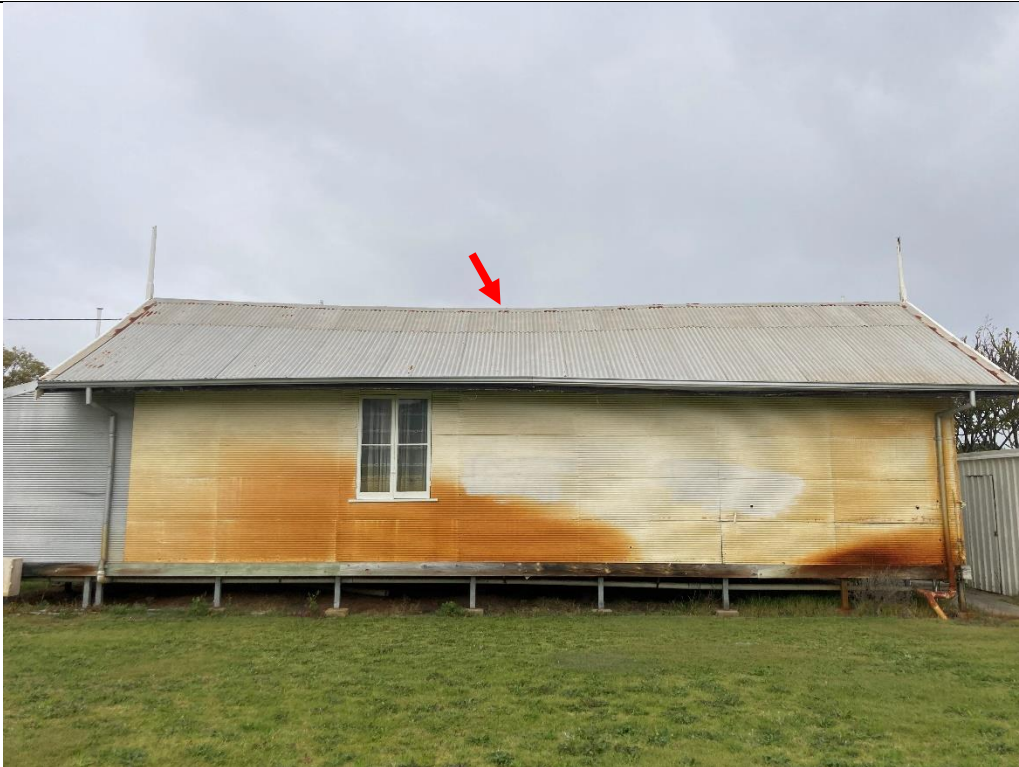
Photo 2: Overall view from the North of the croquet clubhouse looking South. Observed sagging of the roof ridge beam.

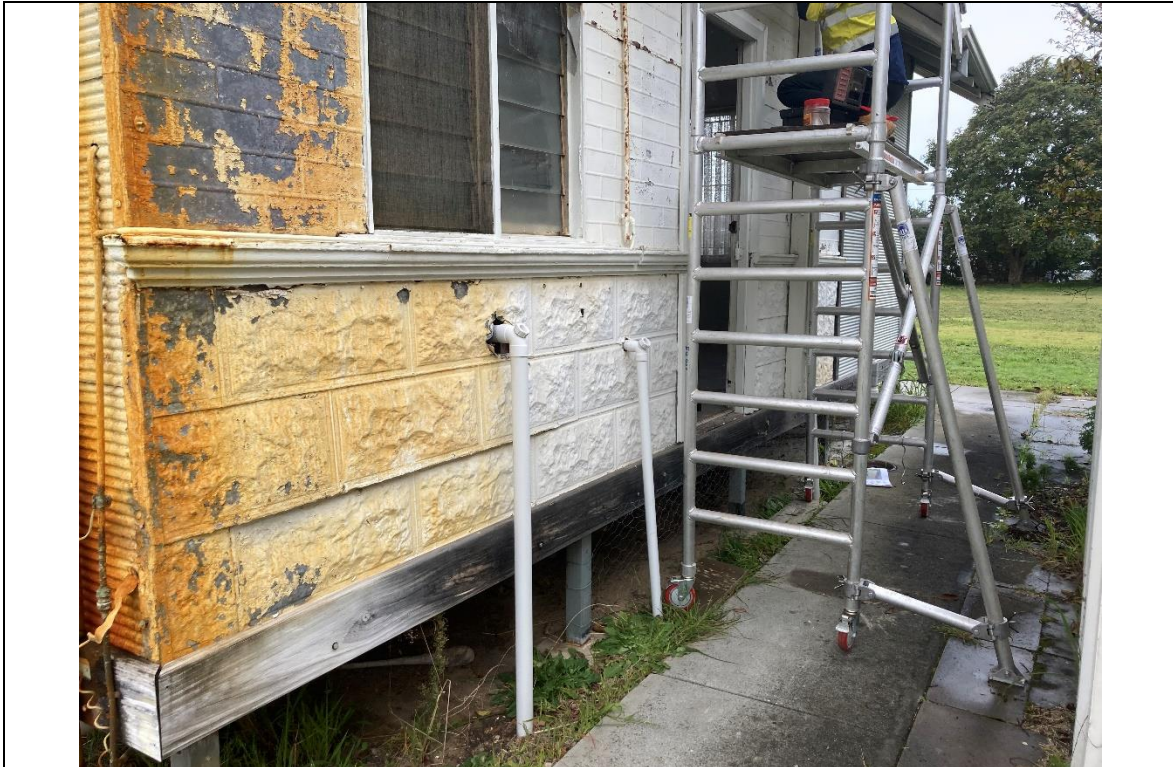
Photo 3: Scaffold set up and inspection access point on the Western end of the croquet clubhouse.

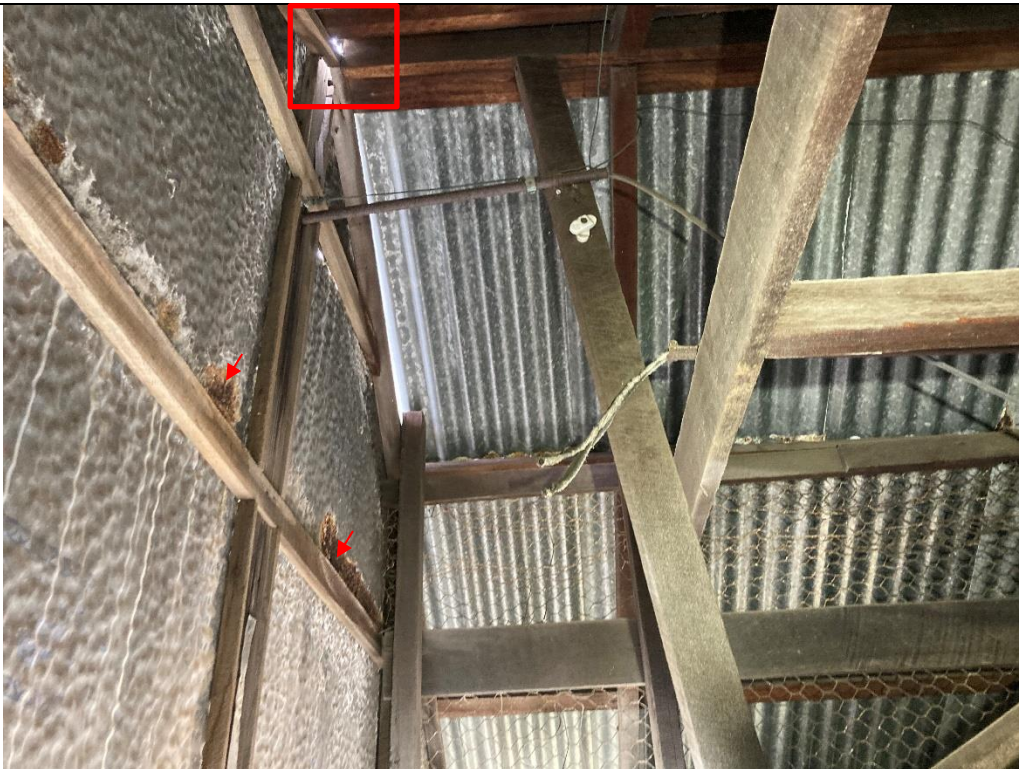
Photo 5: Skylight at purlin prop to beam rafter connection. Widespread corrosion on the internal cladding.

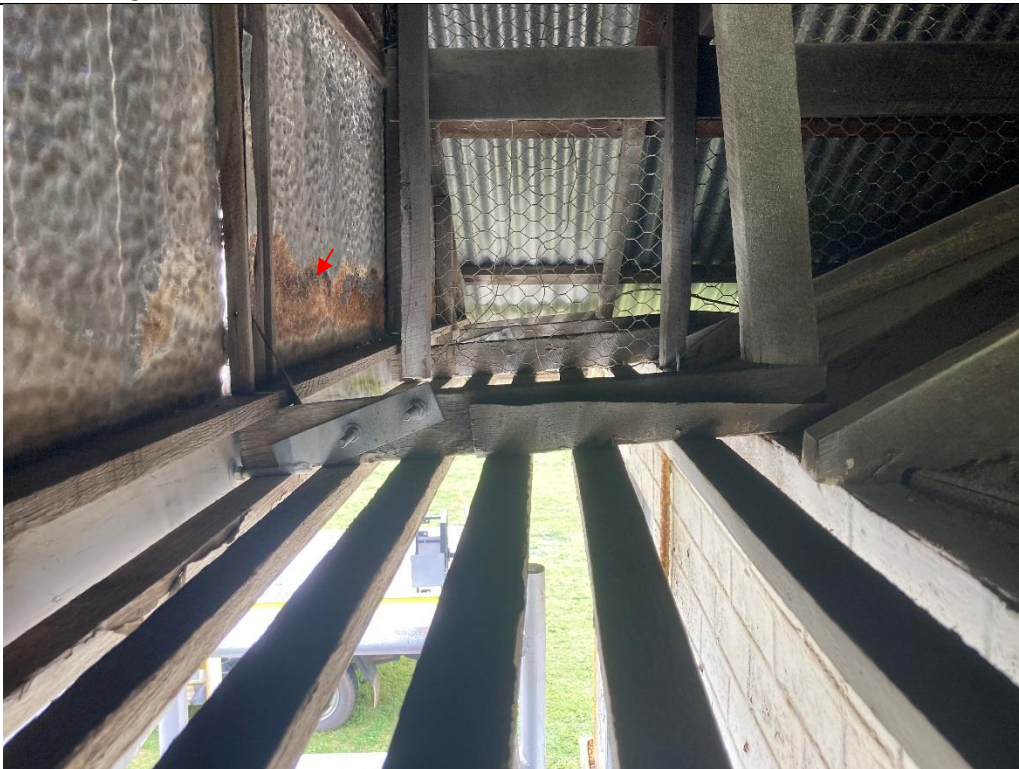
Photo 6: View of the wall plate connection and timber eaves on the West side. Widespread corrosion on the internal cladding.

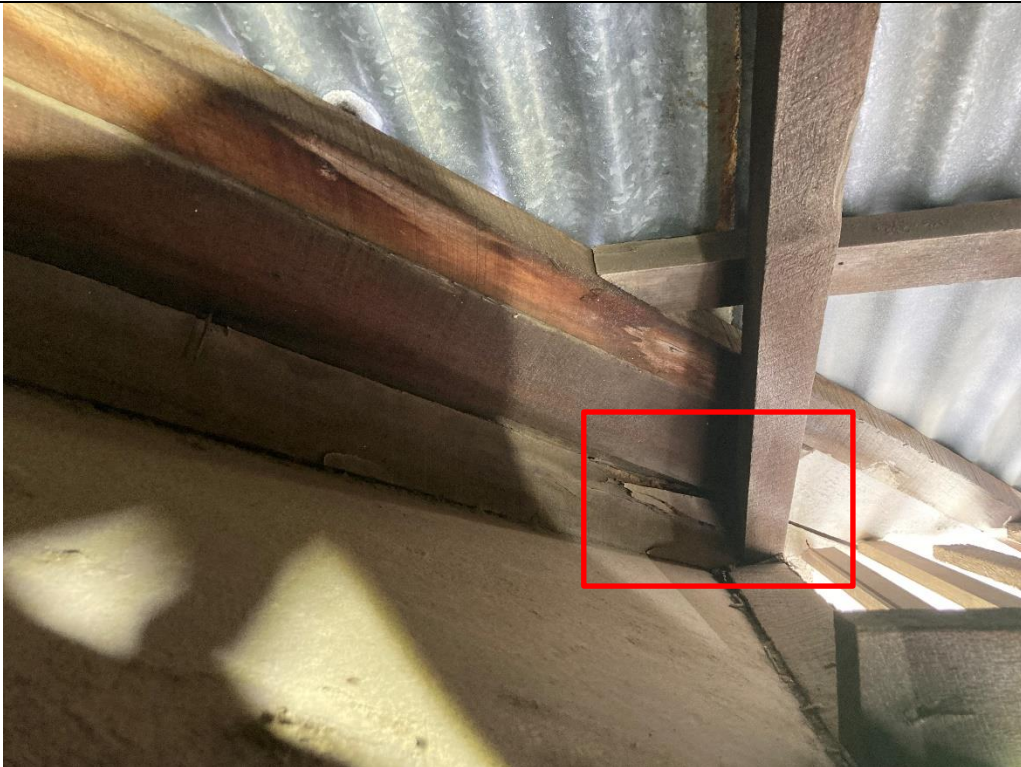
Photo 7: View of the rafter and beam connection – showing localised timber splitting.

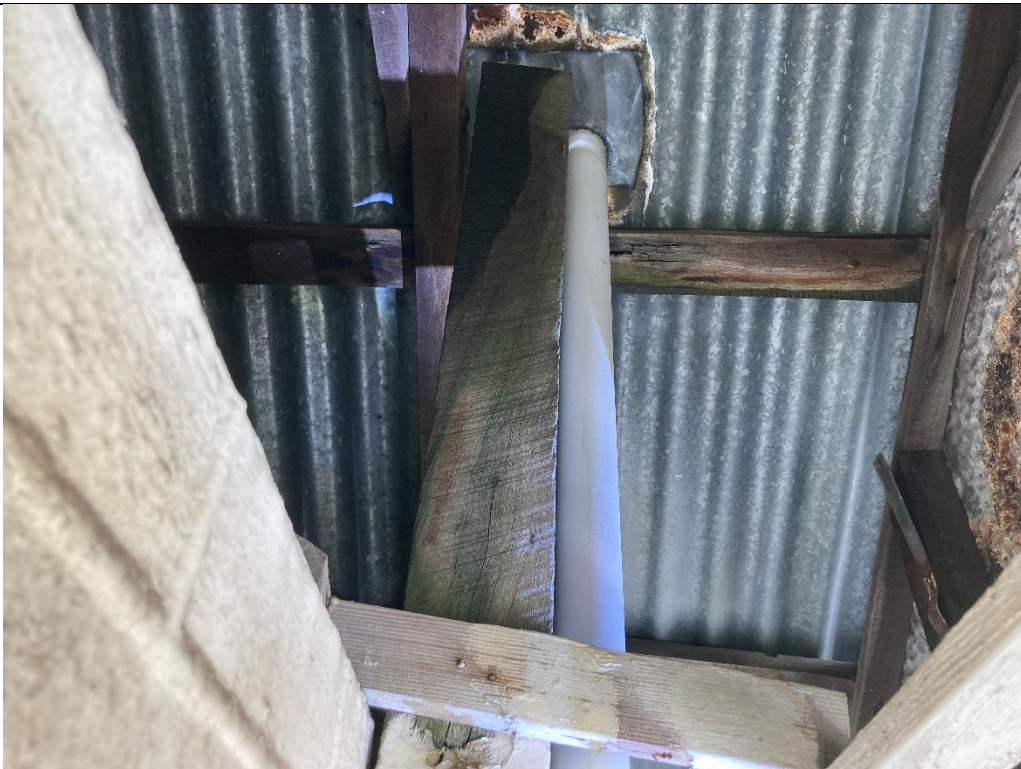
Photo 8: View of purlin prop and localised corrosion on roof sheet.

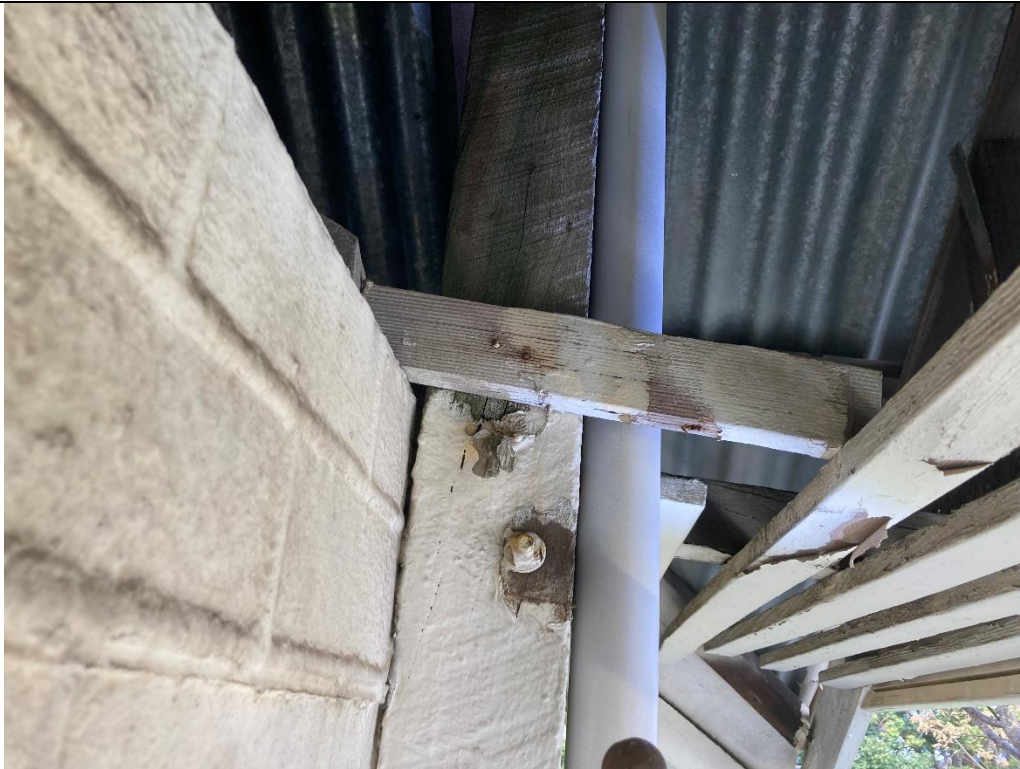
Photo 9: View of the bolt connection to purlin prop.

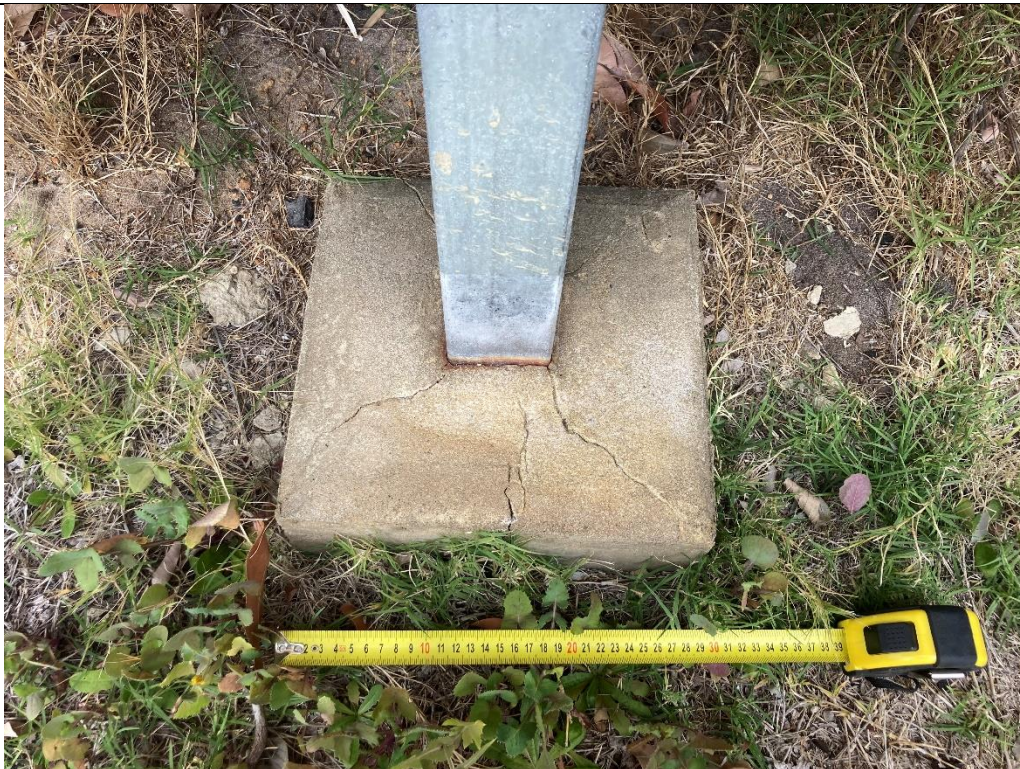
Photo 10: Observed cracks on the pad footing.

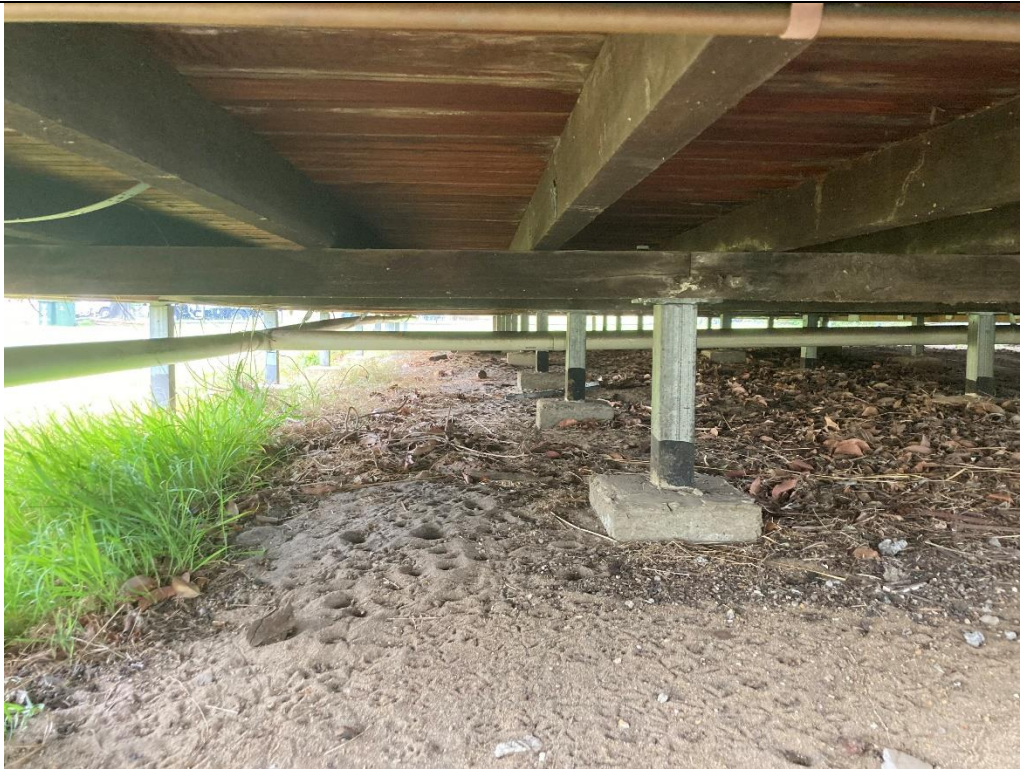
Photo 11: Overall view of pad footings.

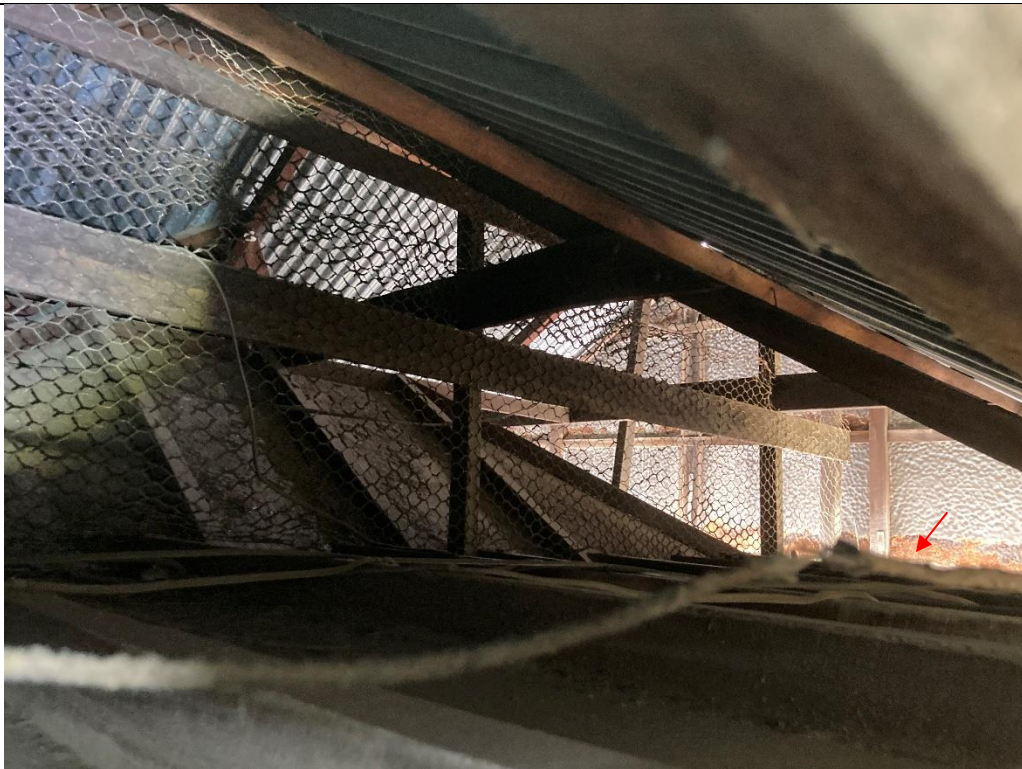
Photo 14: Overall view of the roof condition. Widespread corrosion on the internal cladding.

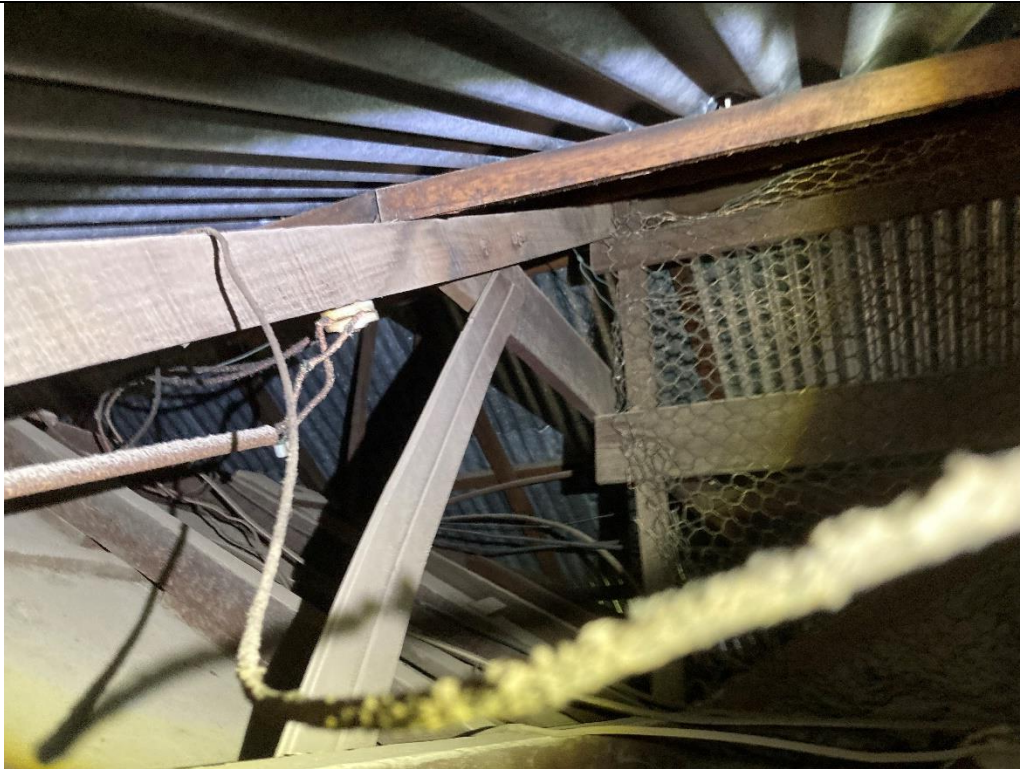
Photo 15: Overall view of roof members.

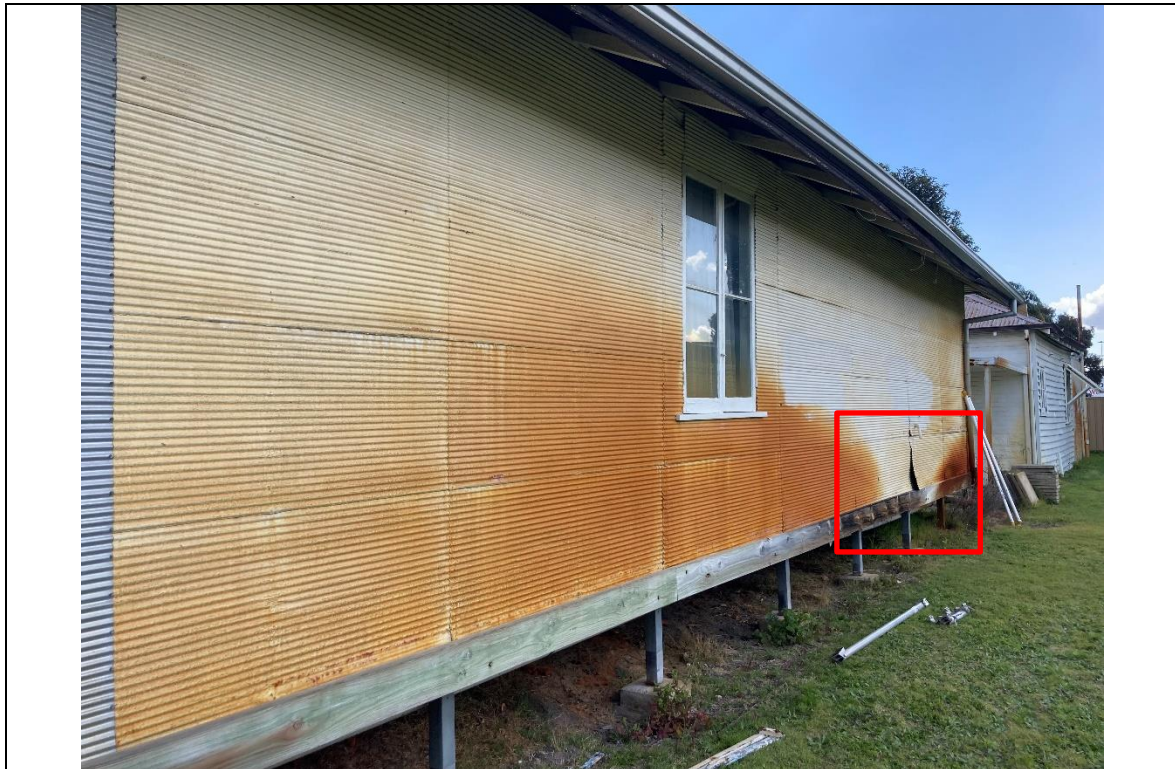
Photo 17: Overall view of cladding on the Northern end of the building – showing significant corrosion stains and localised defect.

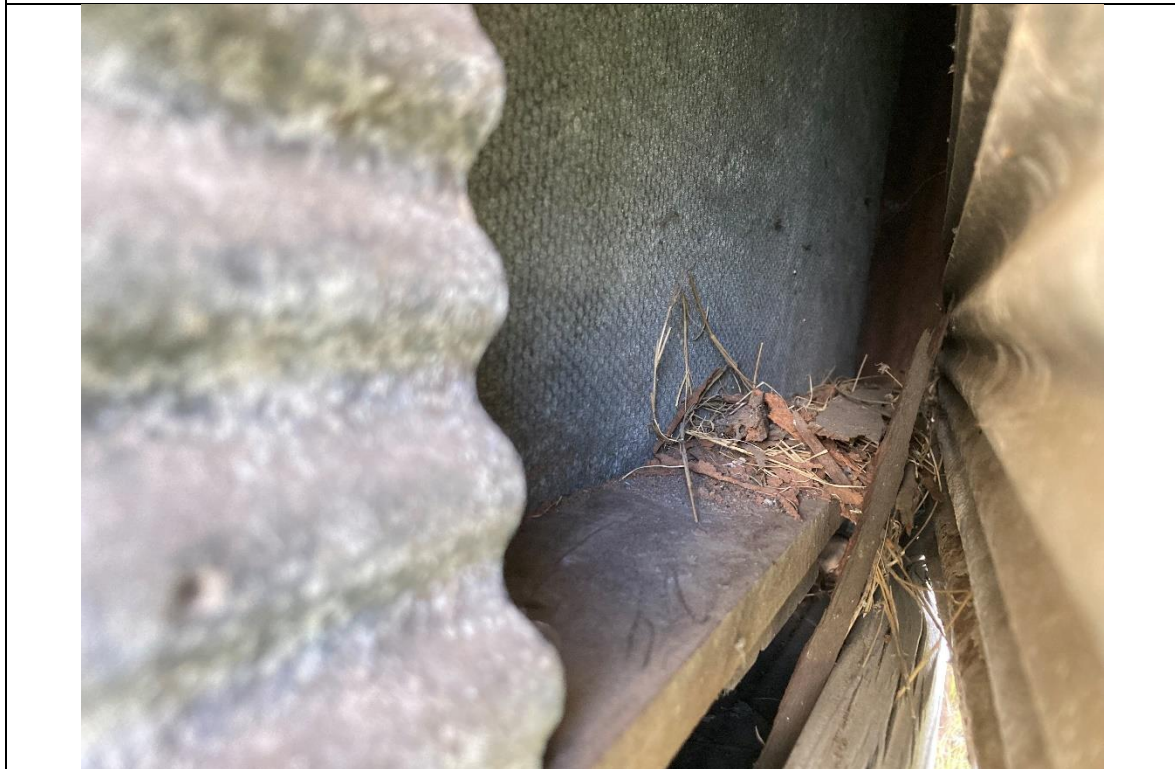
Photo 18: A view behind the cladding showing internal timber frame condition.

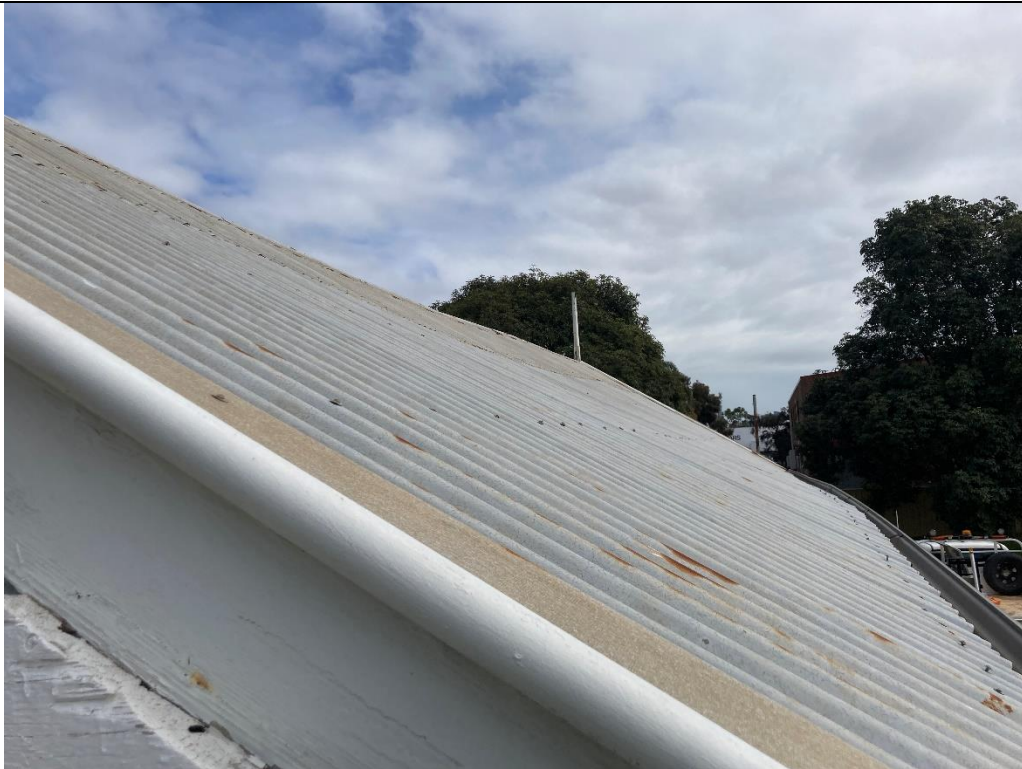
Photo 19: View of the corrugated roof sheet, looking West.

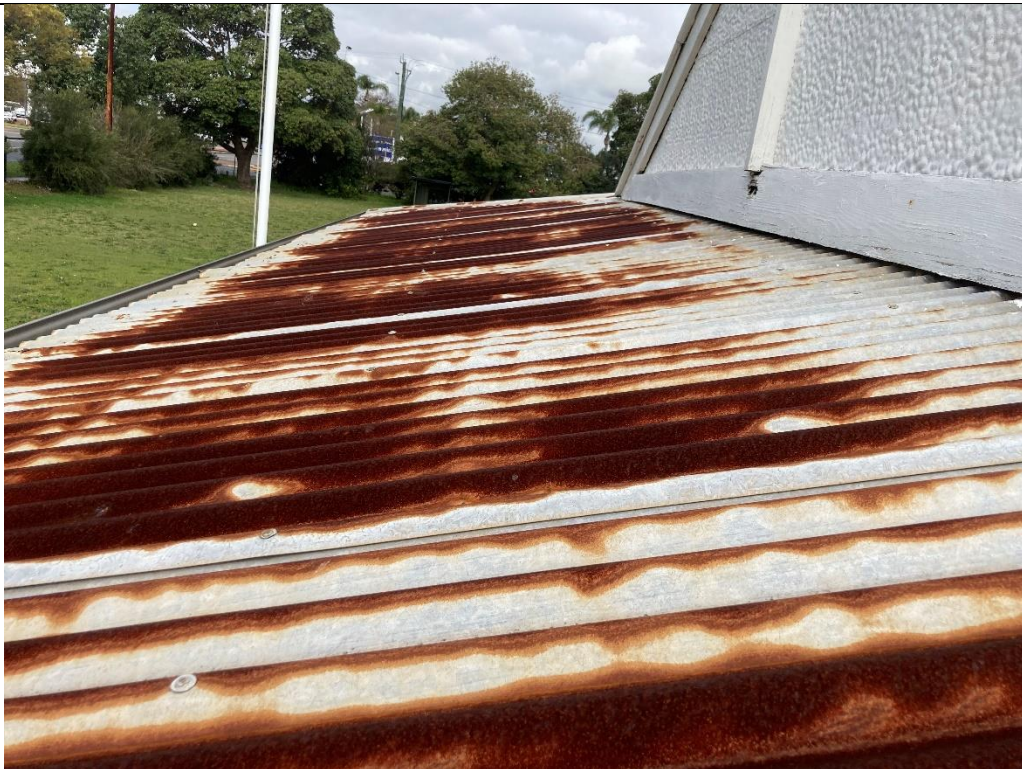
Photo 20: View of the corrugated roof sheet, looking South – showing significant corrosion and rust.

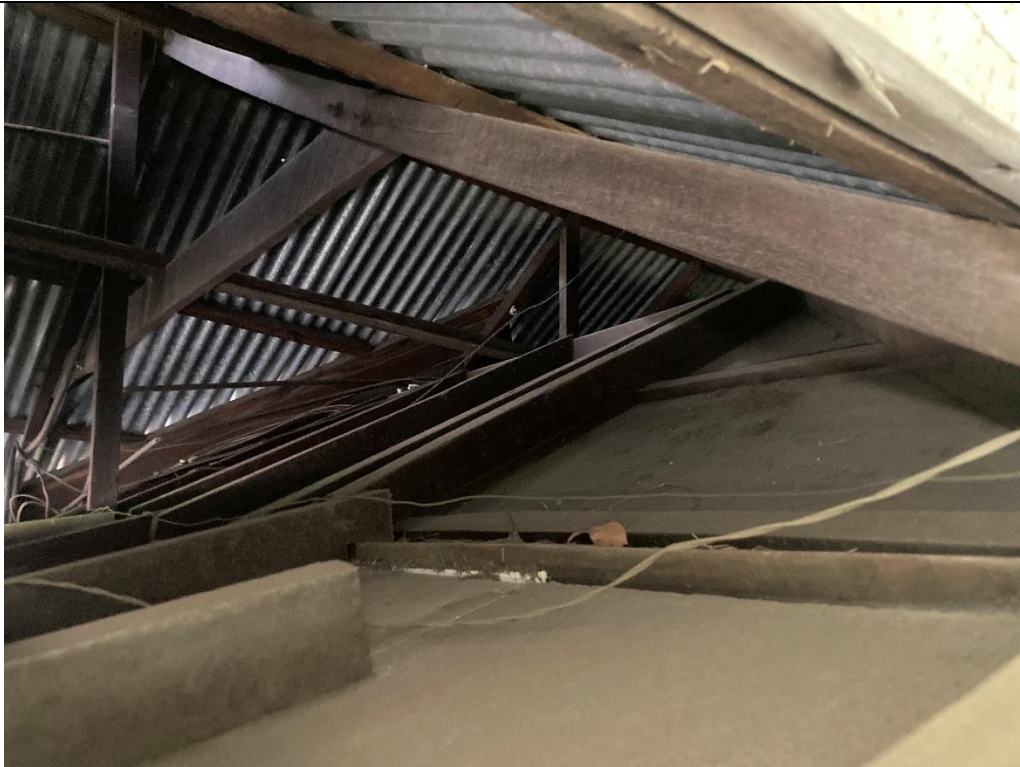
Photo 21: Rafter condition, looking southwest.

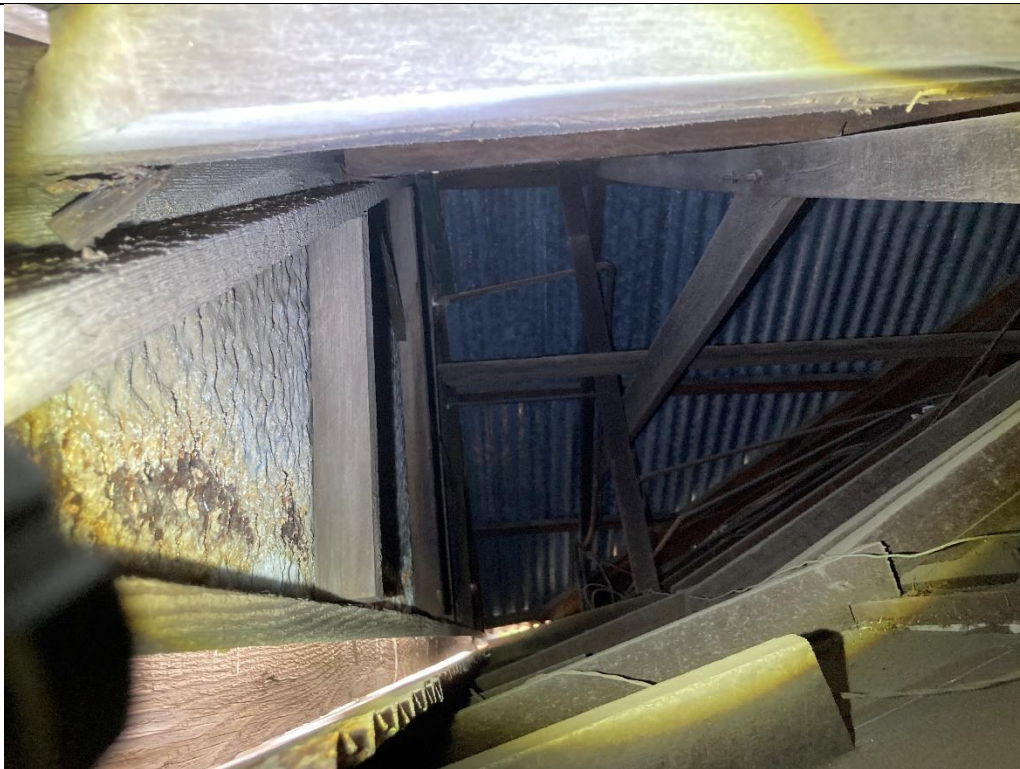
Photo 22: View of rafter beam, vertical posts and rafters, from North to South.

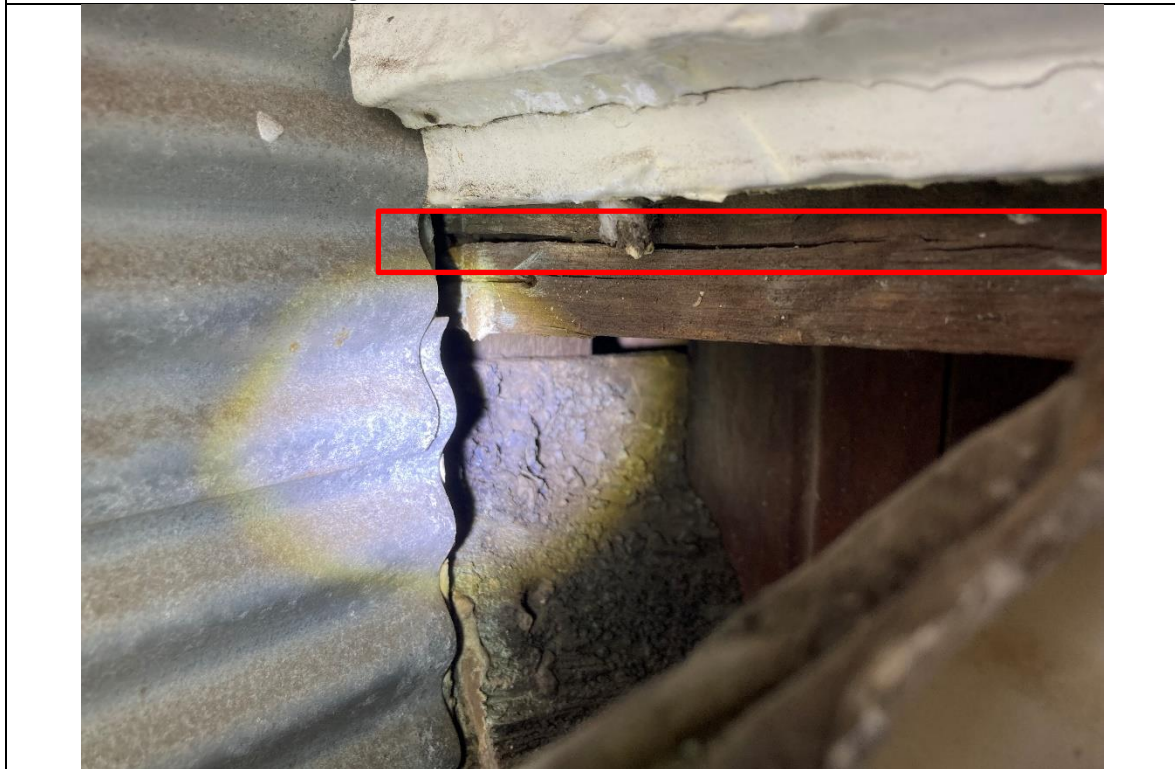
Photo 24: Transverse crack (refer to Photo 23).

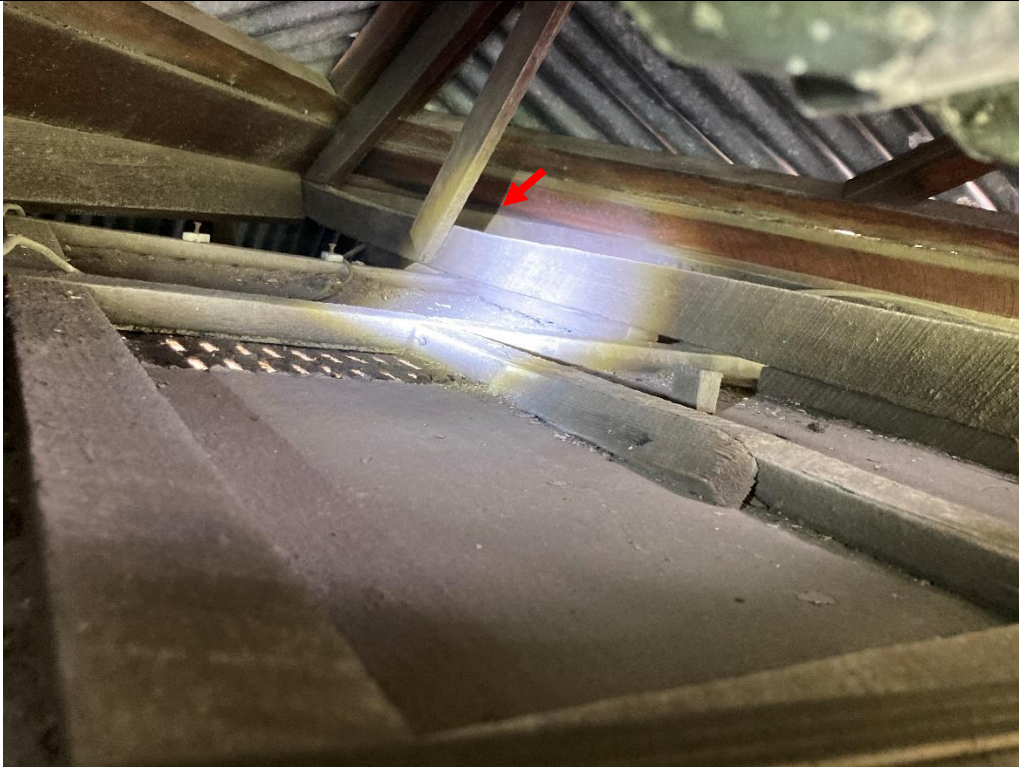
Photo 25: Observed sagged rafter.

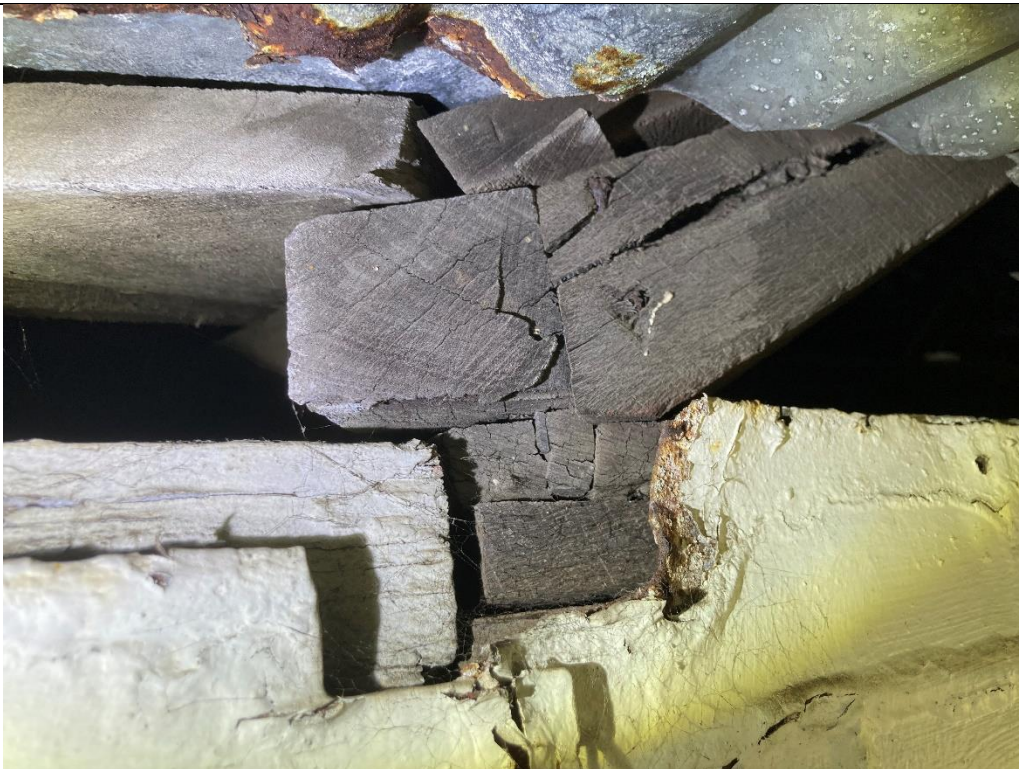
Photo 26: Observed timber splits on the top plate, refer to Photo 23.

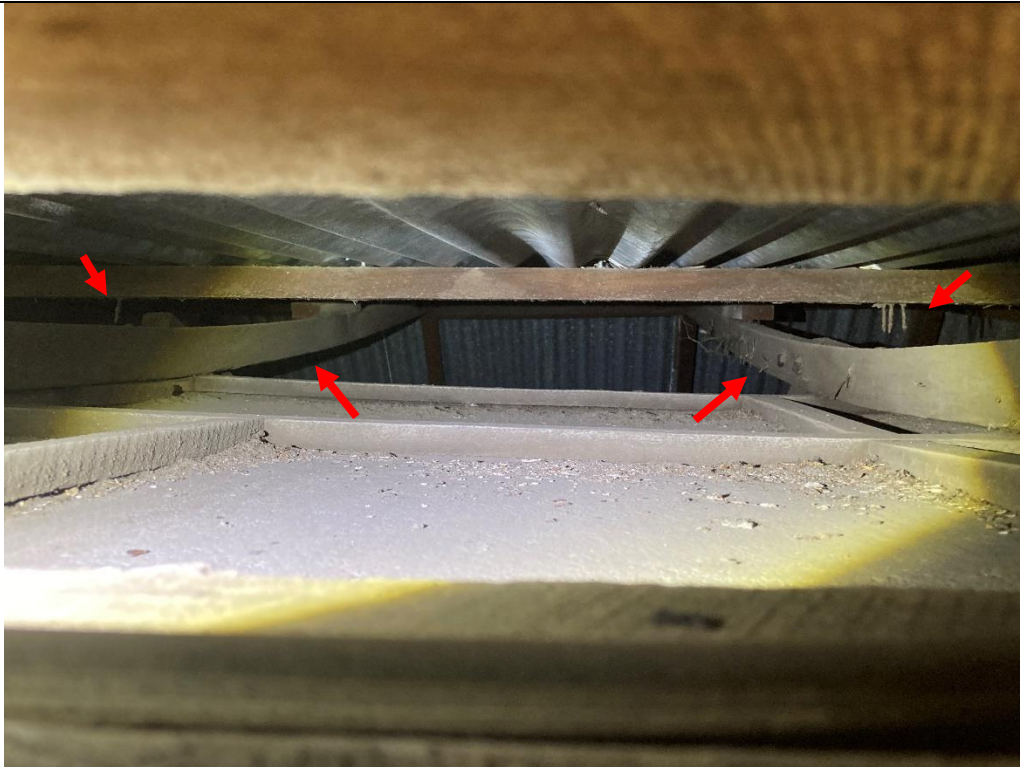
Photo 27: Observed sagging rafter beams and loosened nail connections to purlin.
