STATS Australia
Specialist Testing and Technical Services

RELOCATION OF TIMBER STRUCTURE, SHEPPERTON ROAD AND RUSTHON STREET

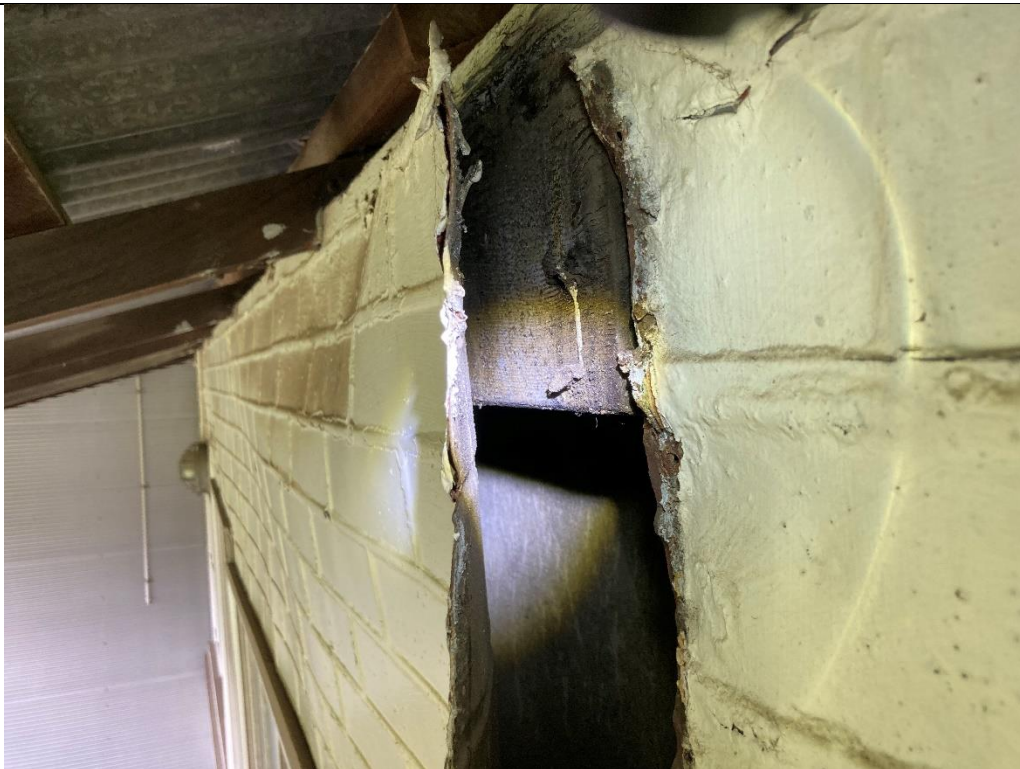
Photo 28: Delaminated cladding to wall frame, refer to Photo 23.

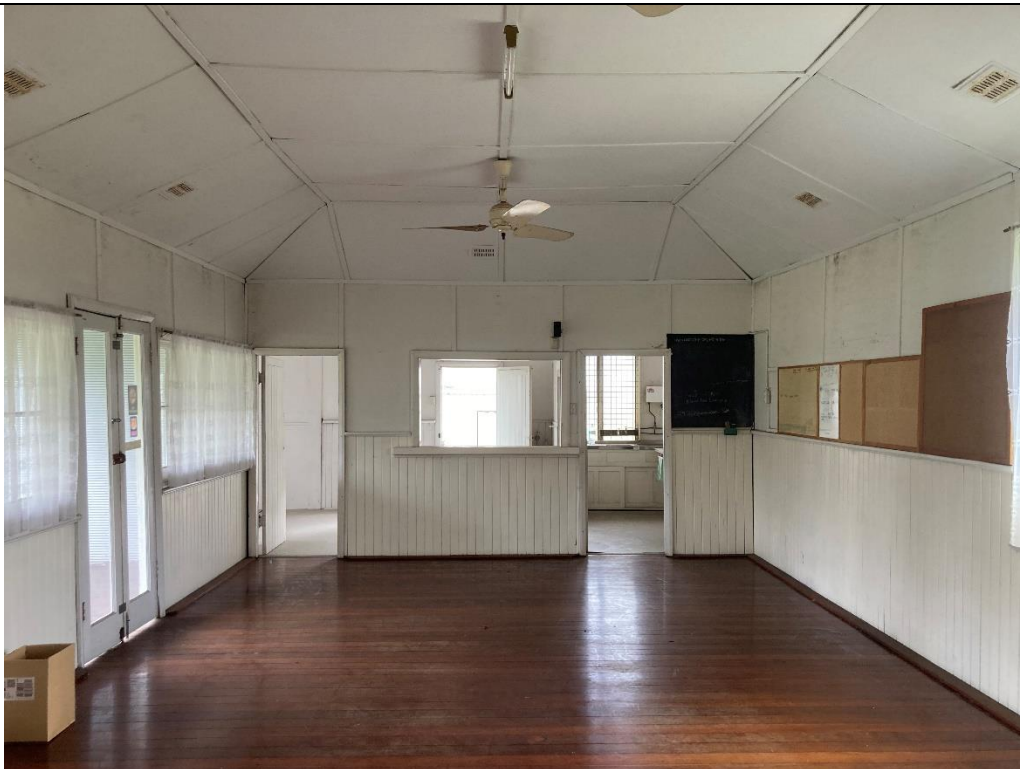
Photo 29: Interior view, looking West. Observed Asbestos fibre cement sheeting product at the internal wall.

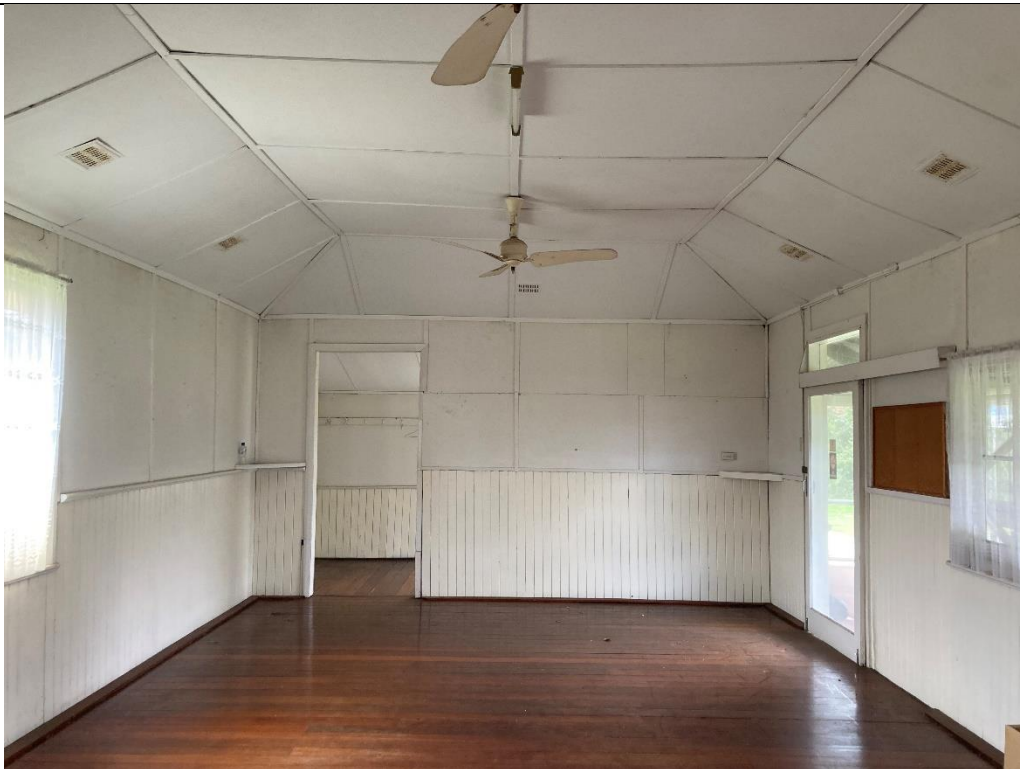
Photo 30: Interior view, looking East. Observed Asbestos fibre cement sheeting product at the internal wall.

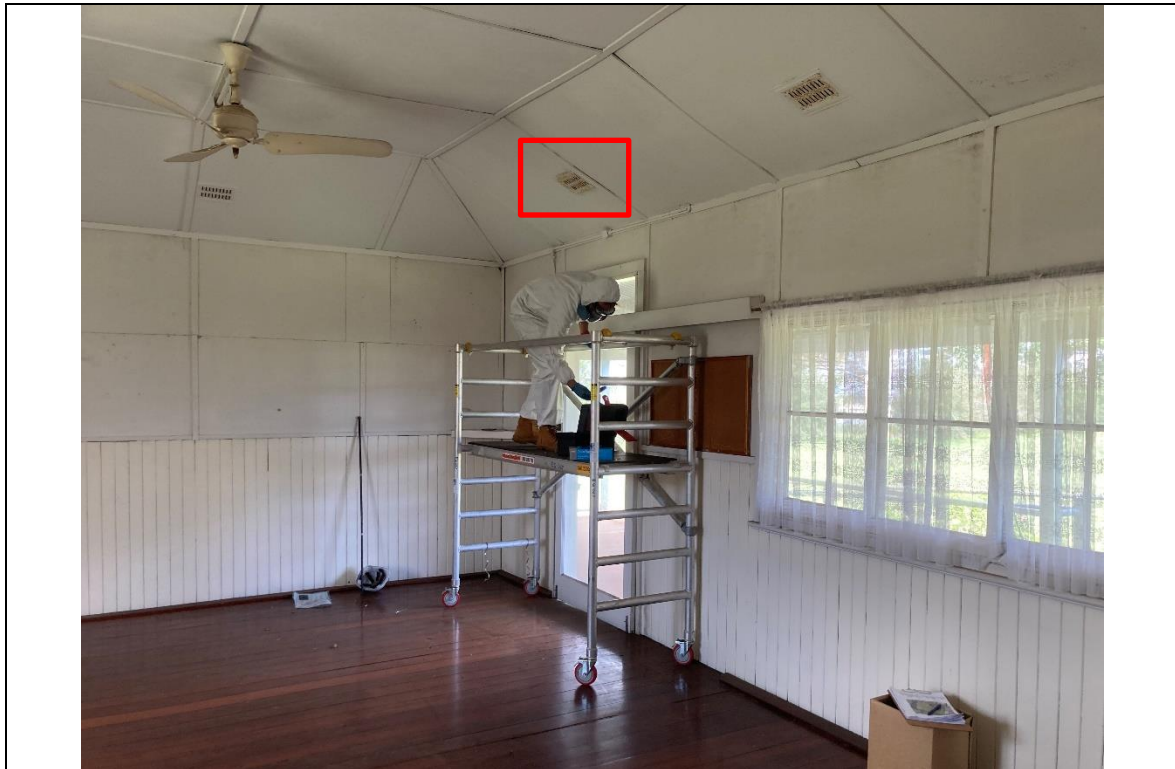
Photo 31: Set up the platform and carried out roof inspection through the air vent. Inspectors were well-protected from asbestos by wearing the proper PPE.

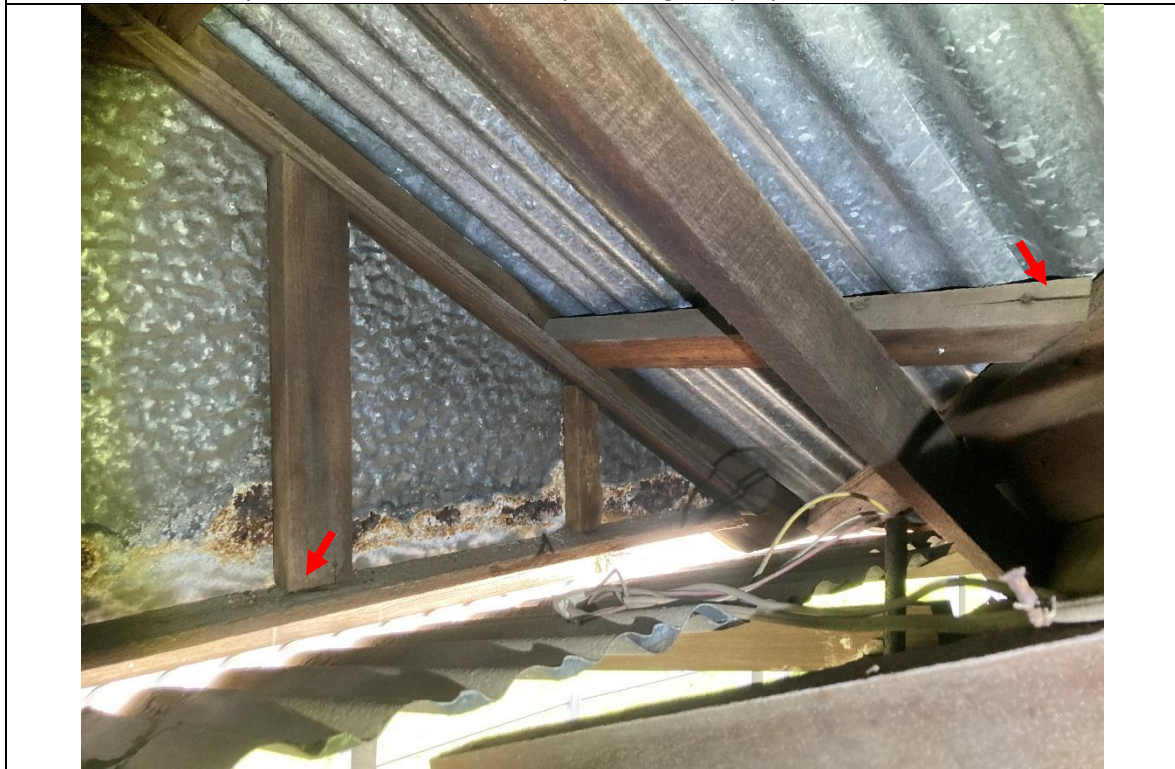
Photo 32: Observed timber splits at nail connections.

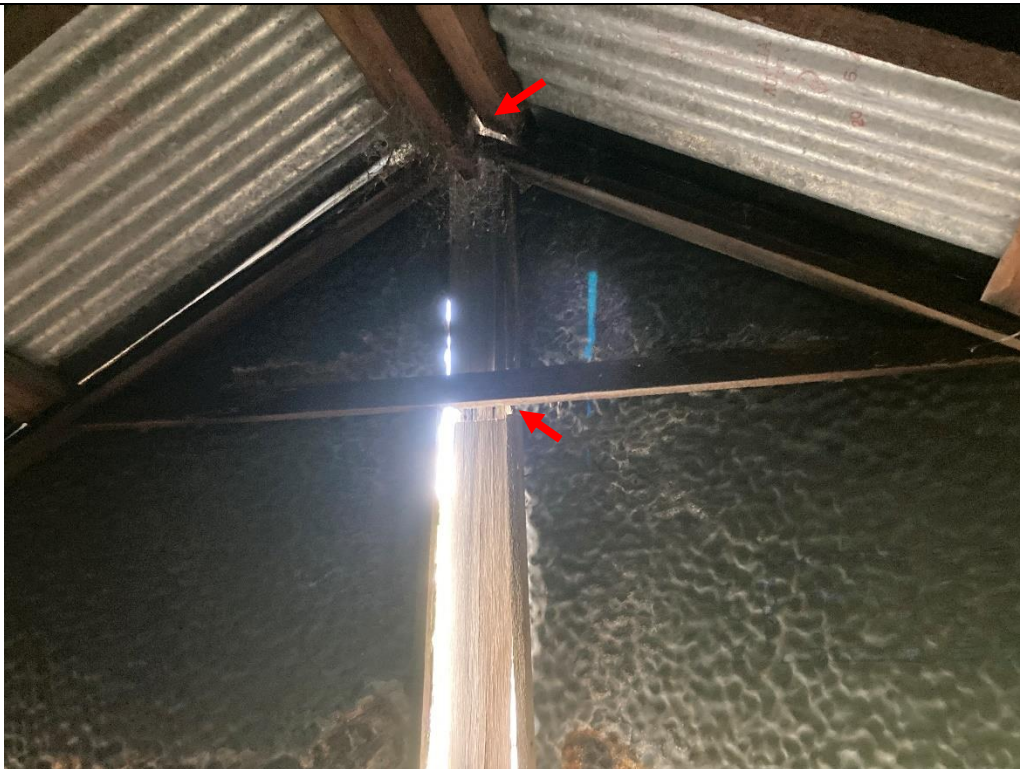
Photo 33: Observed skylight and timber split.

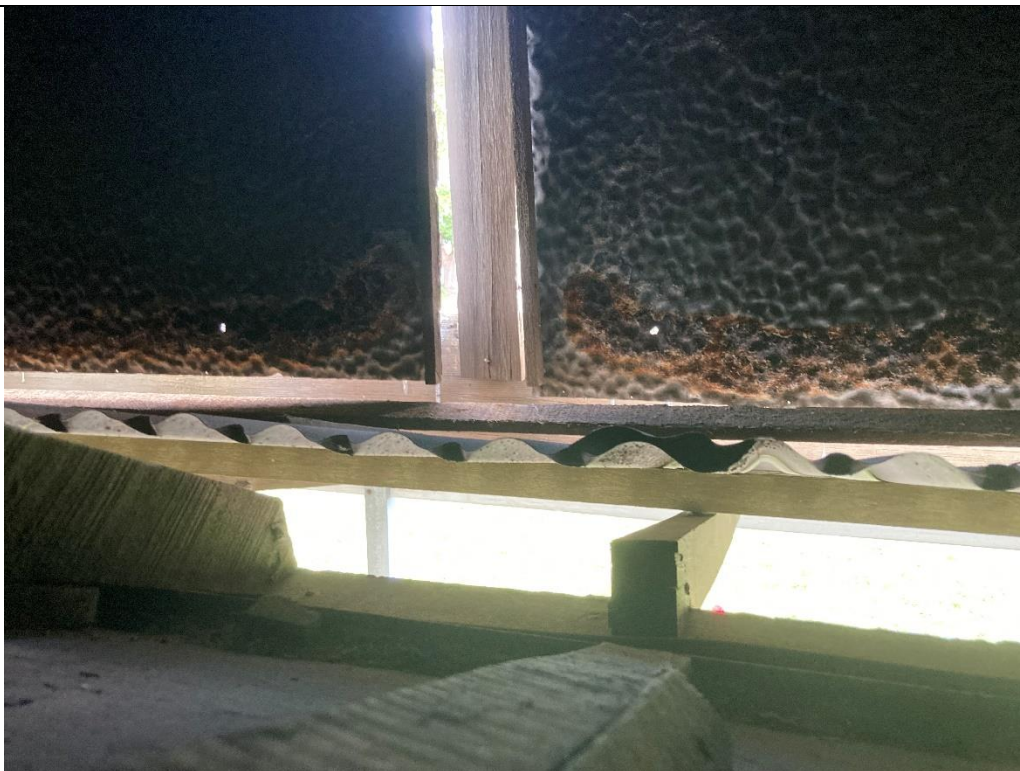
Photo 34: View of the stud and top plate. Localised corrosion on cladding sheet.

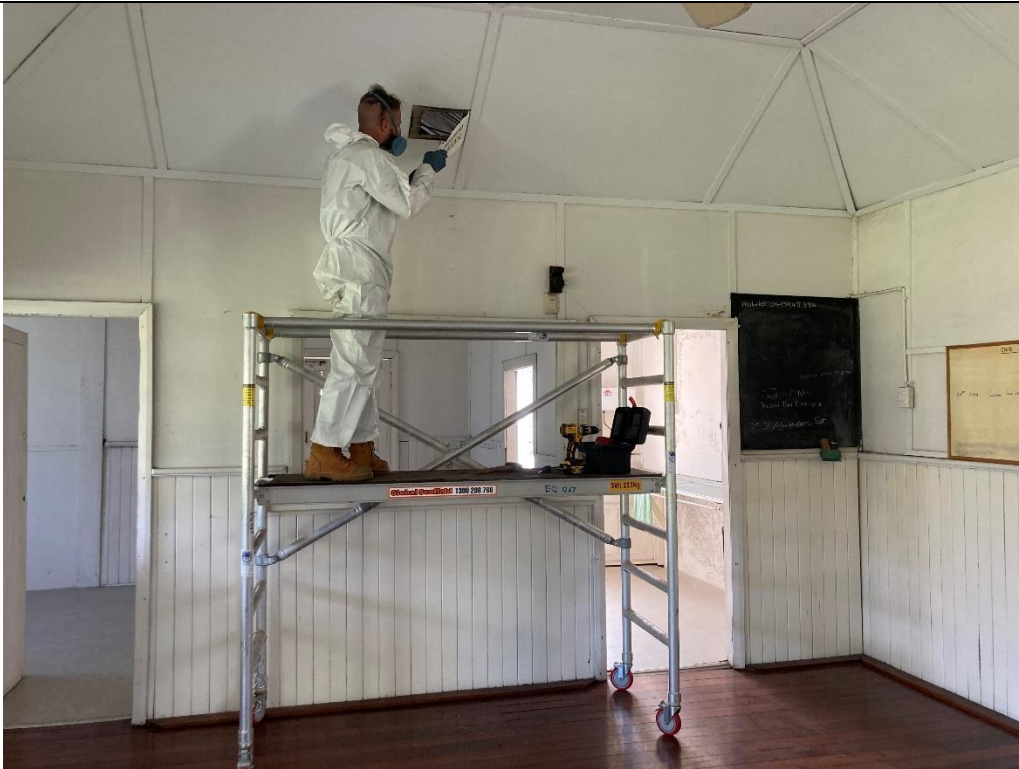
Photo 35: Set up the platform and carried out inspection through the air vent.

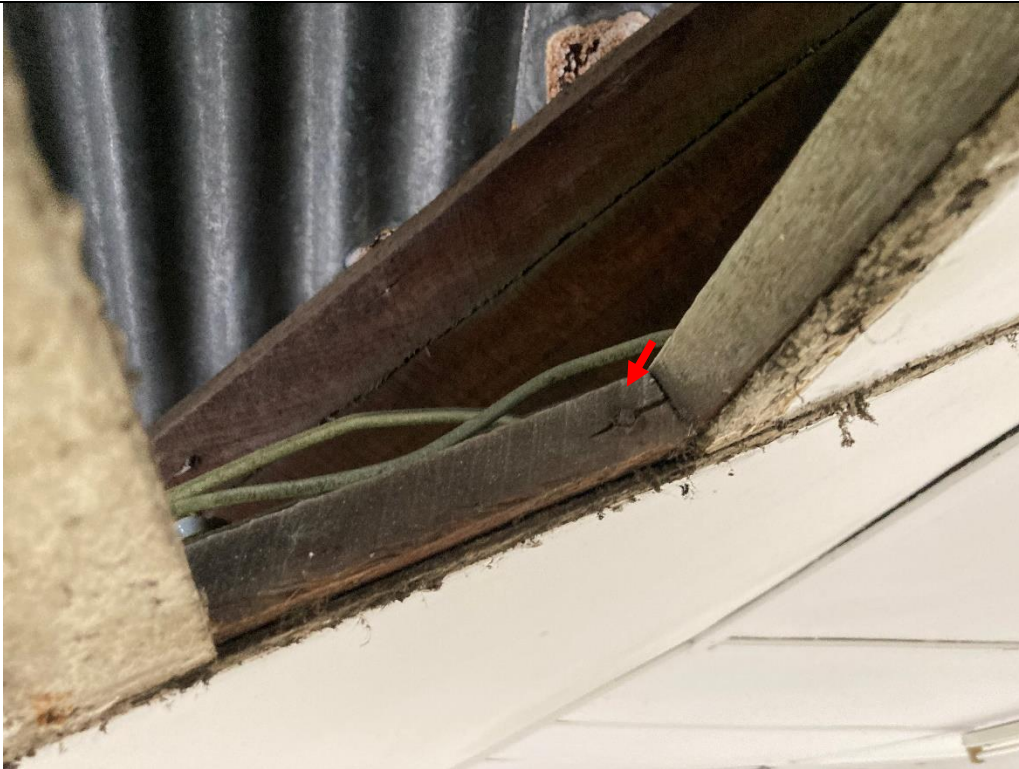
Photo 37: Observed timber split at nail connection of the ceiling joist.

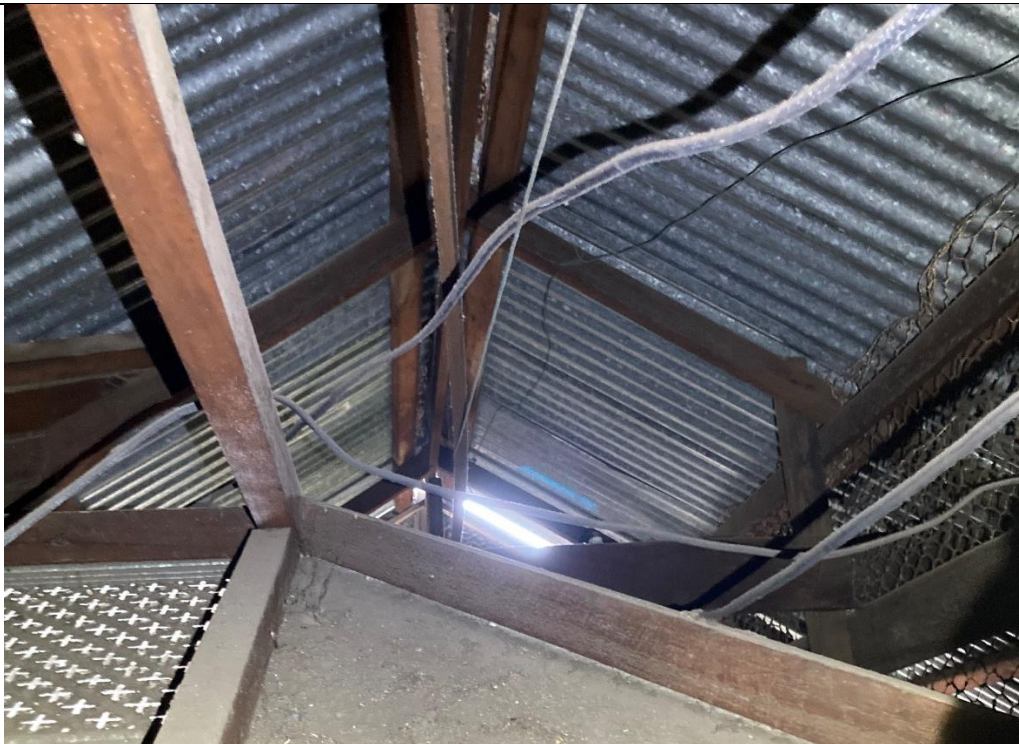
Photo 38: View of rafter elements, looking west.

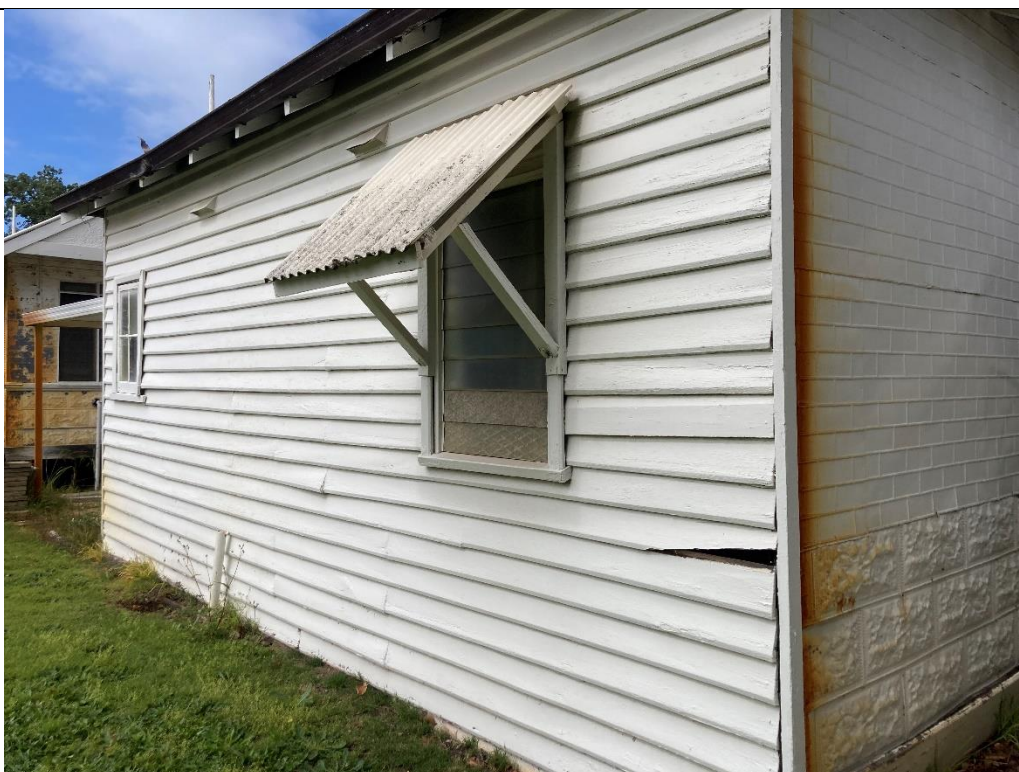
Photo 40: Overall view of the cottage, looking South. Corrosion and rust stains on wall cladding.

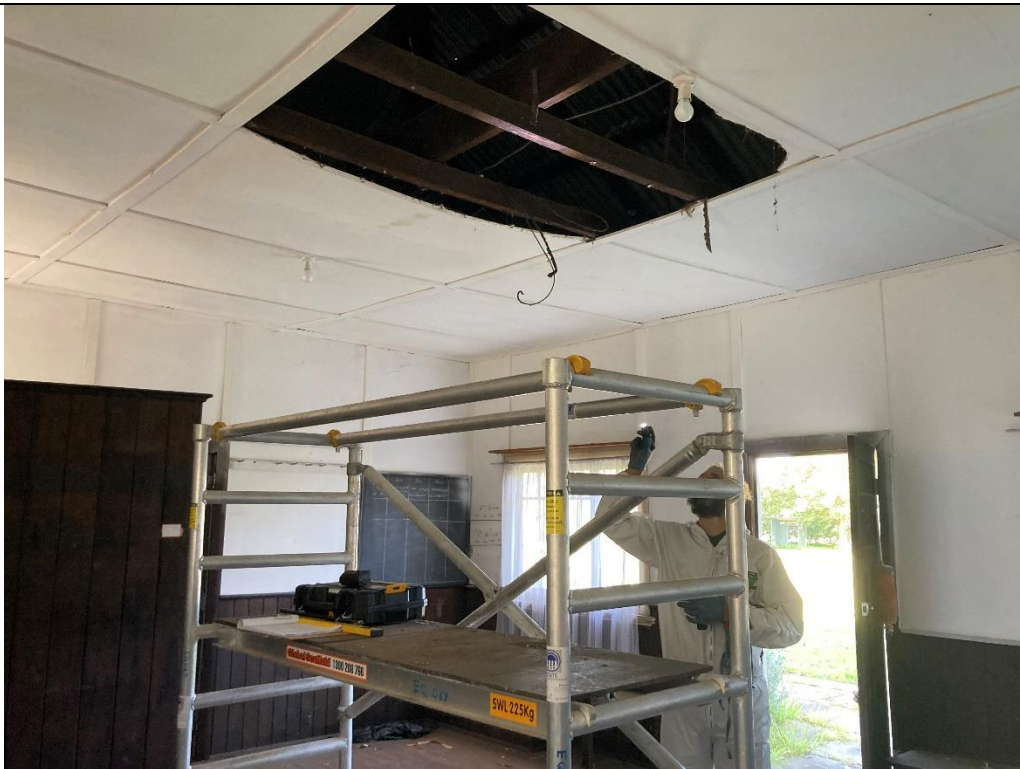
Photo 41: Set up the platform and carried out the inspection.

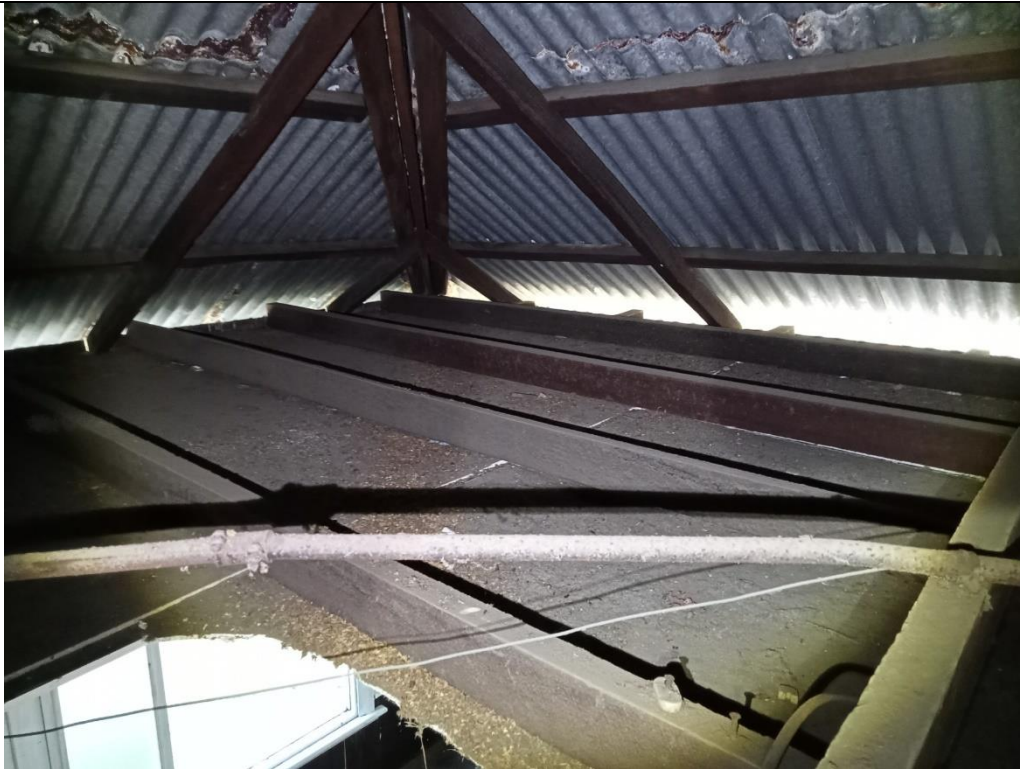
Photo 43: Overall view of the ceiling and rafters. Roofing sheets showing corrosion.

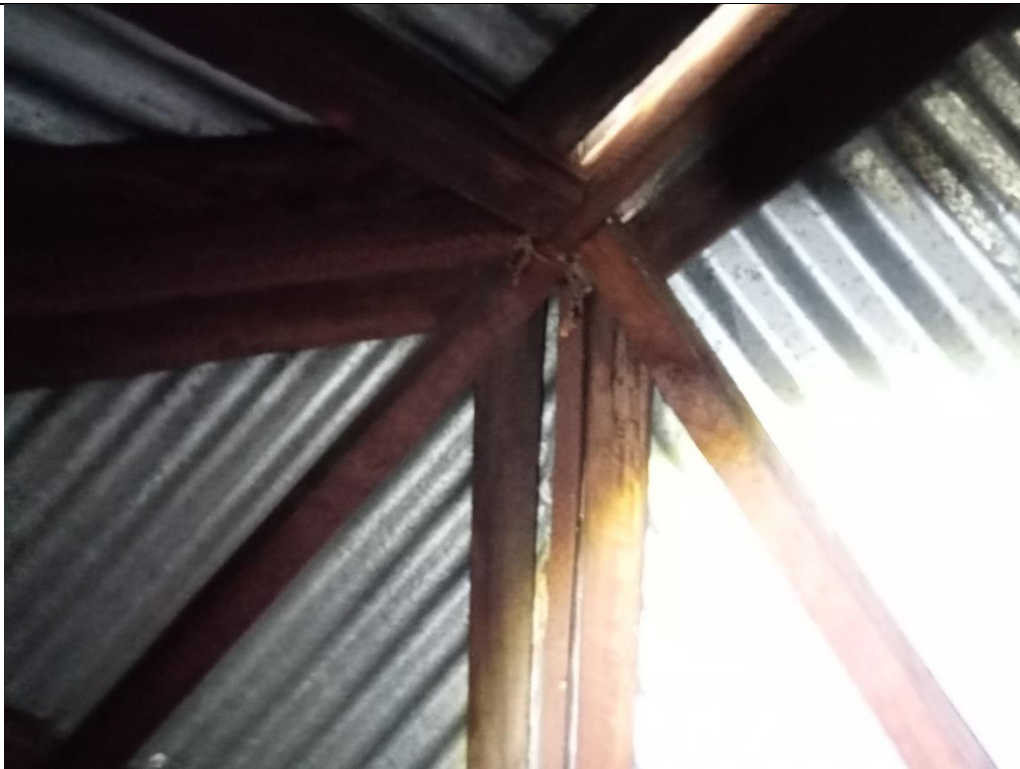
Photo 44: A close-up view of the roof framing work connection details.
