Arboricultural Report

Briggs St and Raleigh St, Carlisle

9th June 2025

Arboricultural assessment of: *Ficus microcarpa* (Hill's Weeping Fig)

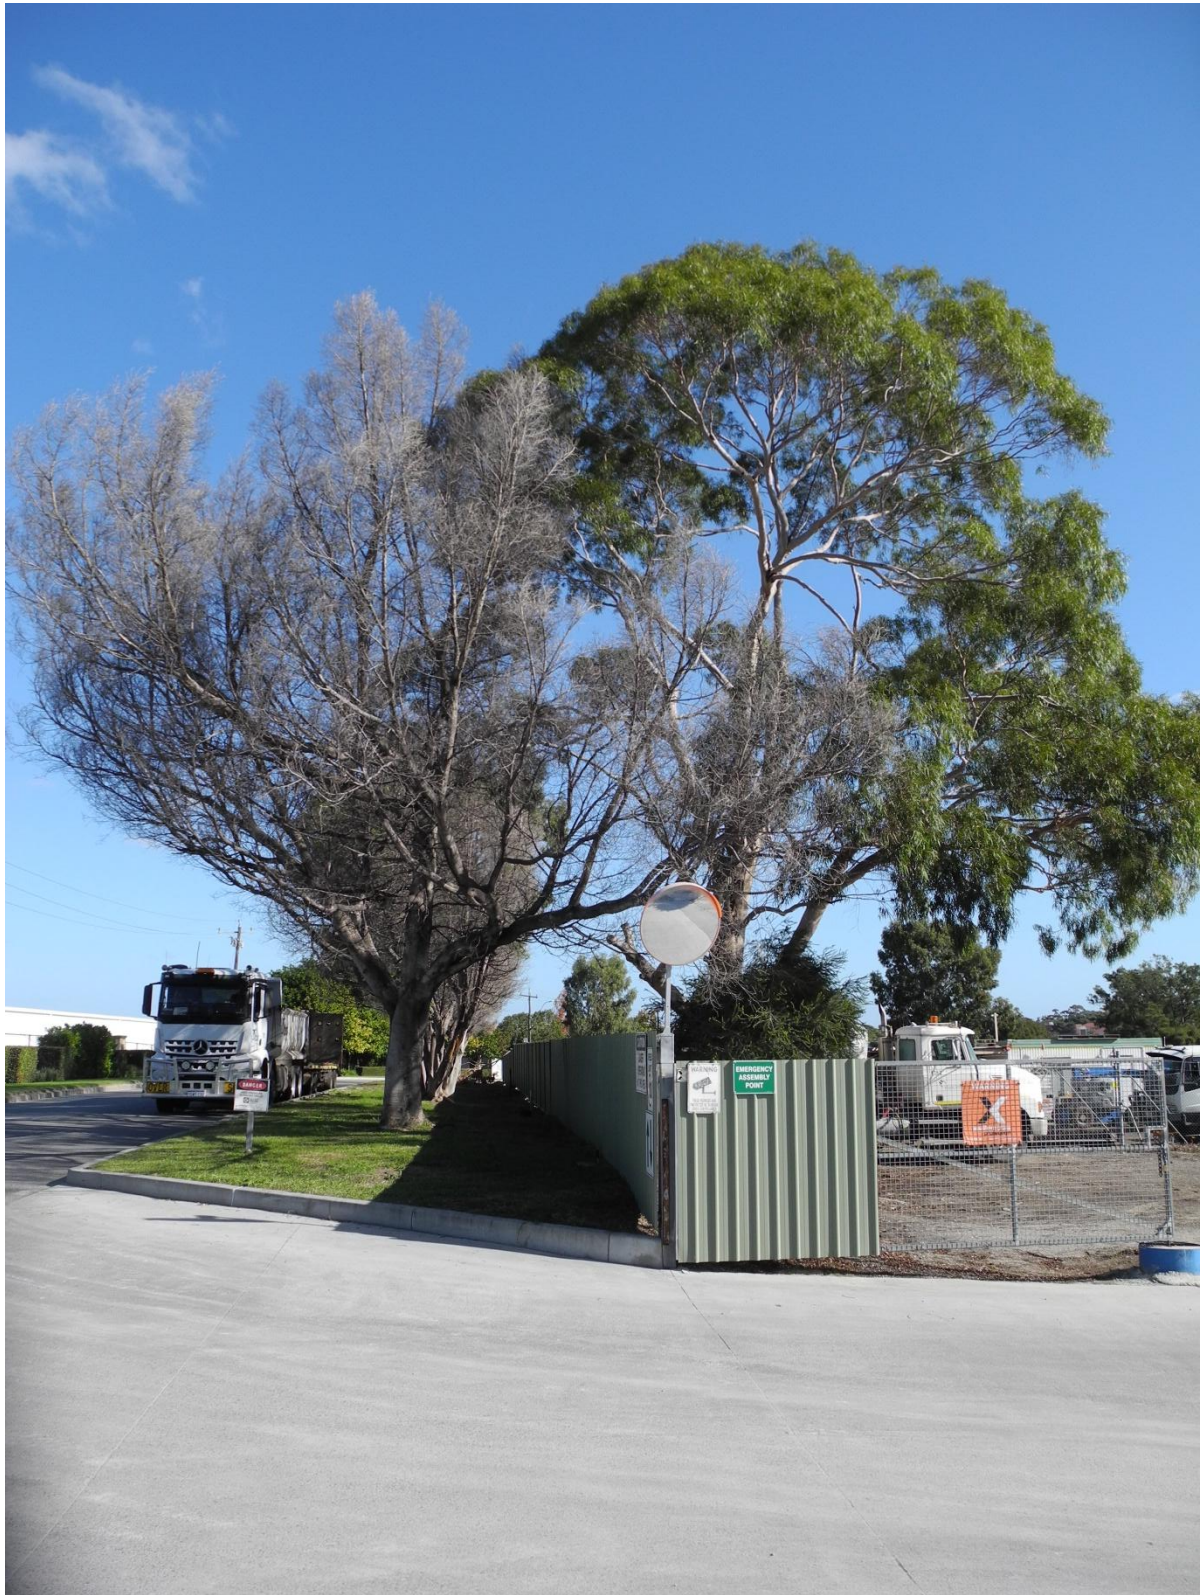
3. Leakage from the gas supply line within the verge was also considered a possible cause of tree decline, however the continued health of two mature *Eucalyptus* spp. nearby suggests this was not the case.

Figure 1 Displaying the *Ficus microcarpa* within the Briggs St verge with high pressure gas service warning and the adjacent mature *Eucalyptus* sp. within the property evident.

- 7.1
1. Removal of the tree and grinding of the stump is recommended.
 2. Replacement planting as soon as is practicable to do so is also recommended.

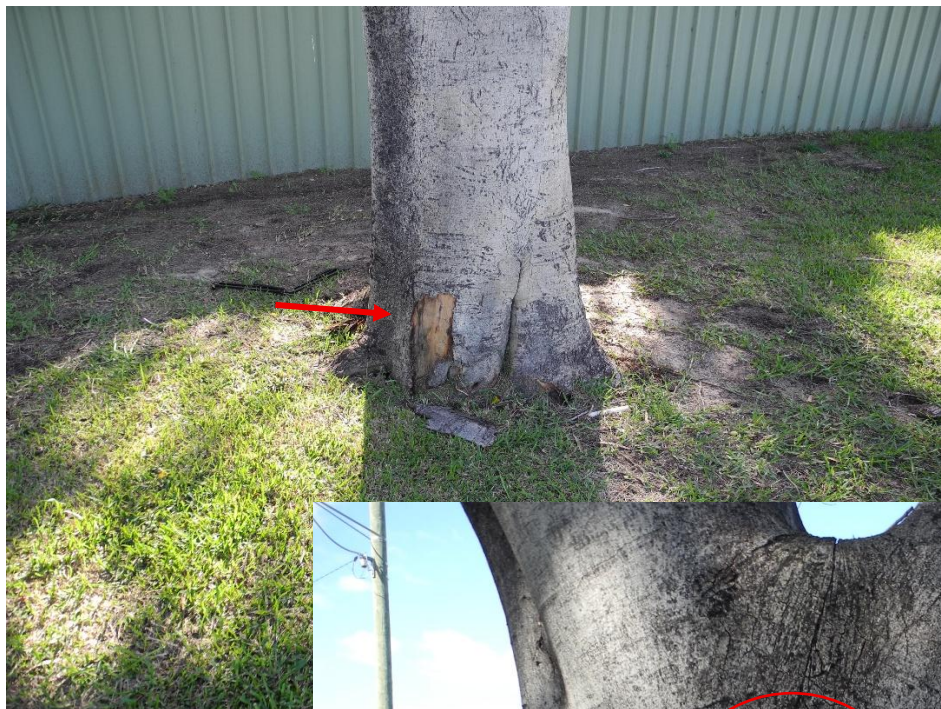
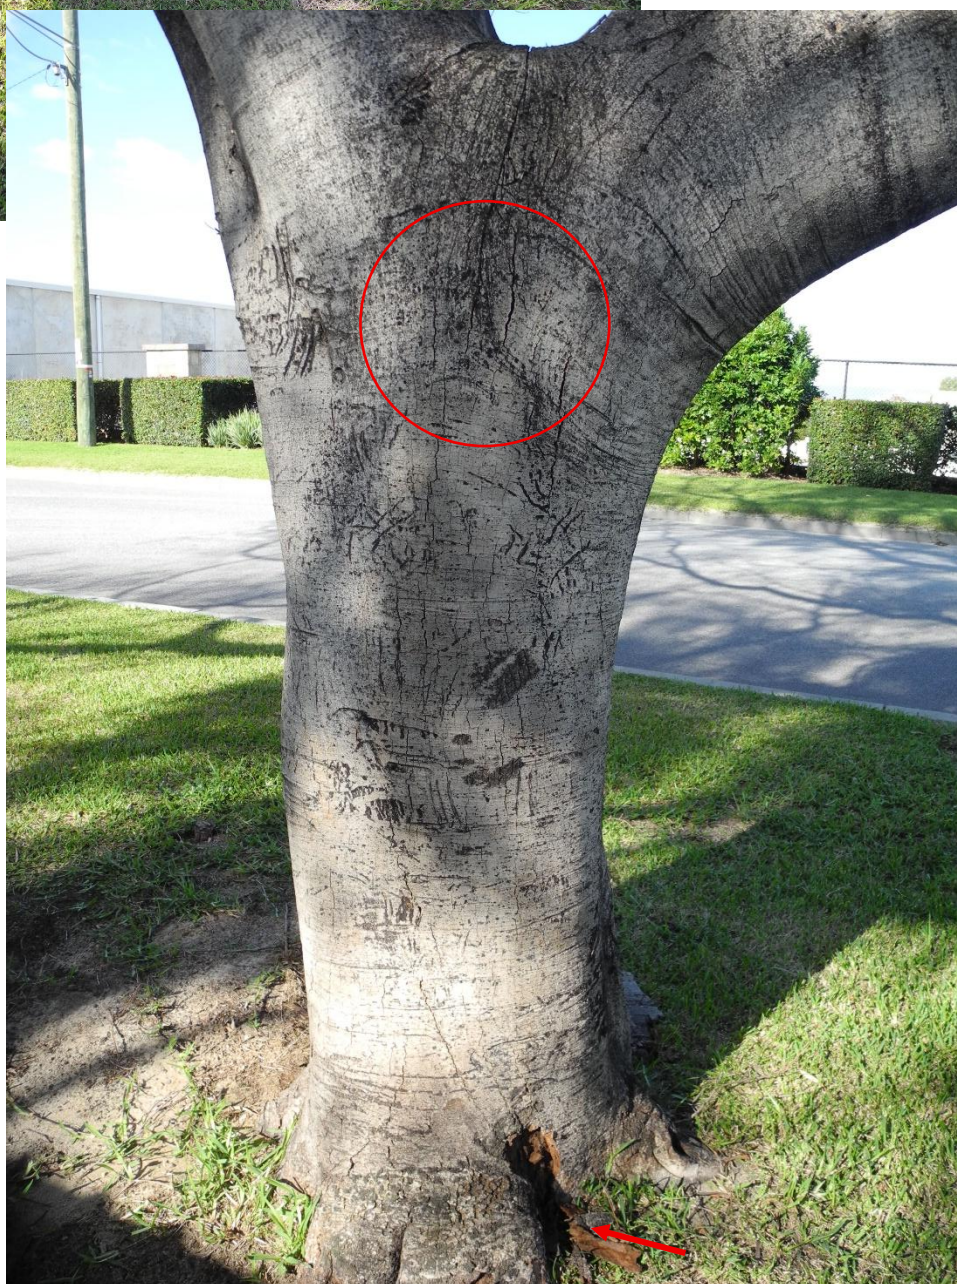
1. Inspection at ground level found evidence of the demise of cambial and vascular tissue around the base and of buttressing roots and associated cracking, lifting and separation of bark and the exposure of underlying wood was evident.

2. There was no evidence of fungal decay or cavities within the base or lower trunk.
3. Manual excavation of sections of the root crown by this consultant found no evidence of drill holes to indicate the tree has been poisoned.

Figures 2 & 3 Displaying the base and trunk of the tree and indicating areas of dead tissue removed and splitting as the tree's vascular tissue and bark has died and become separated from the underlying wood.

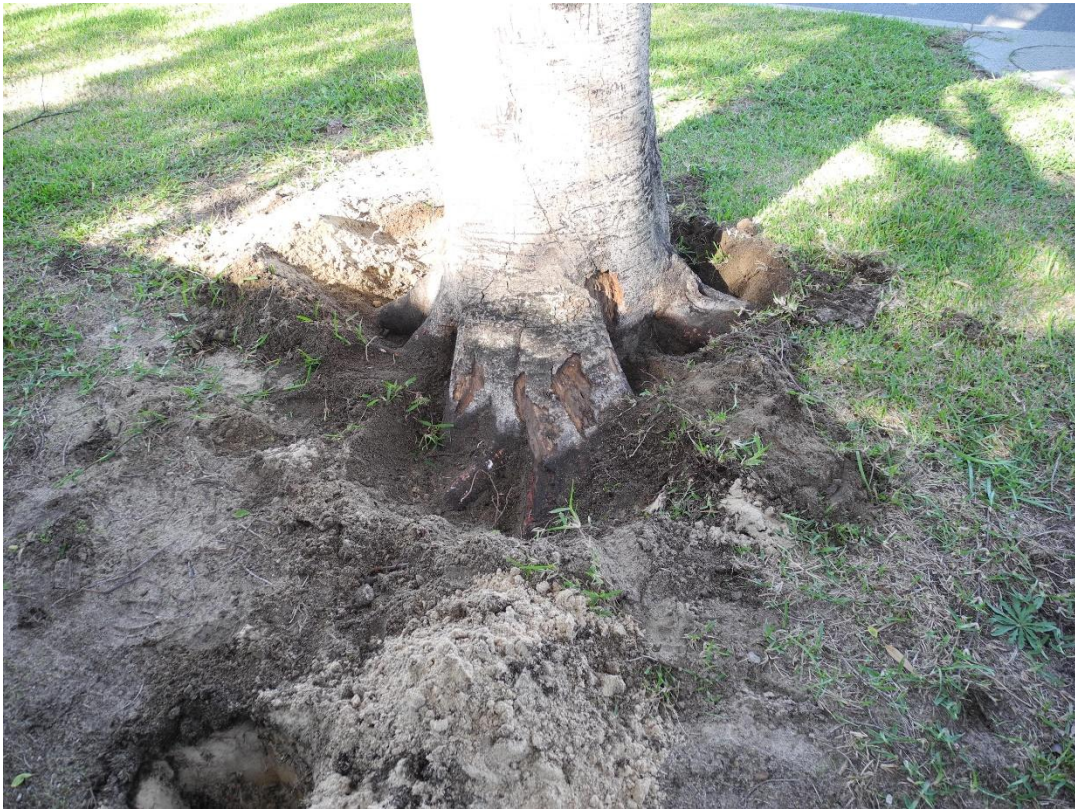
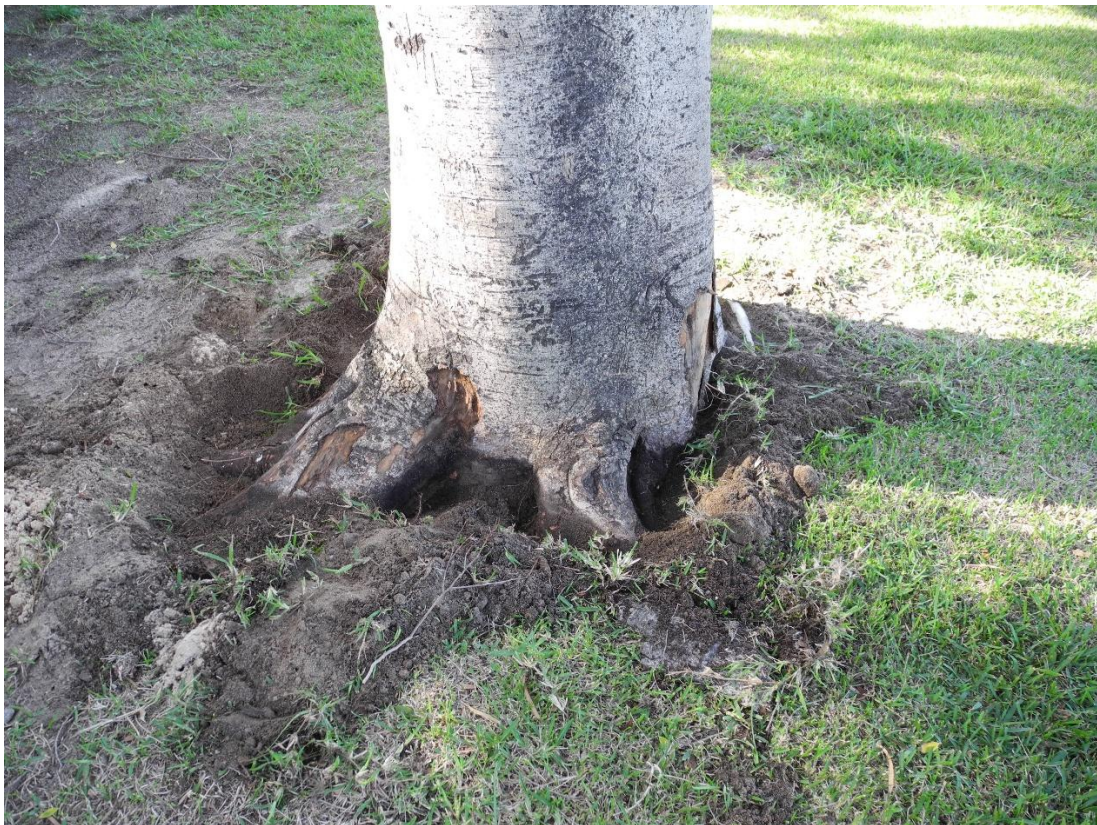
4. The soil profile west of the tree was found to be previously disturbed with imported sand fill present.
5. Major branches were found to remain soundly attached and there was no evidence of significant bark inclusion or recent significant branch failure.

Figures 4 & 5 Displaying the base of the tree with the root crown exposed by this consultant.

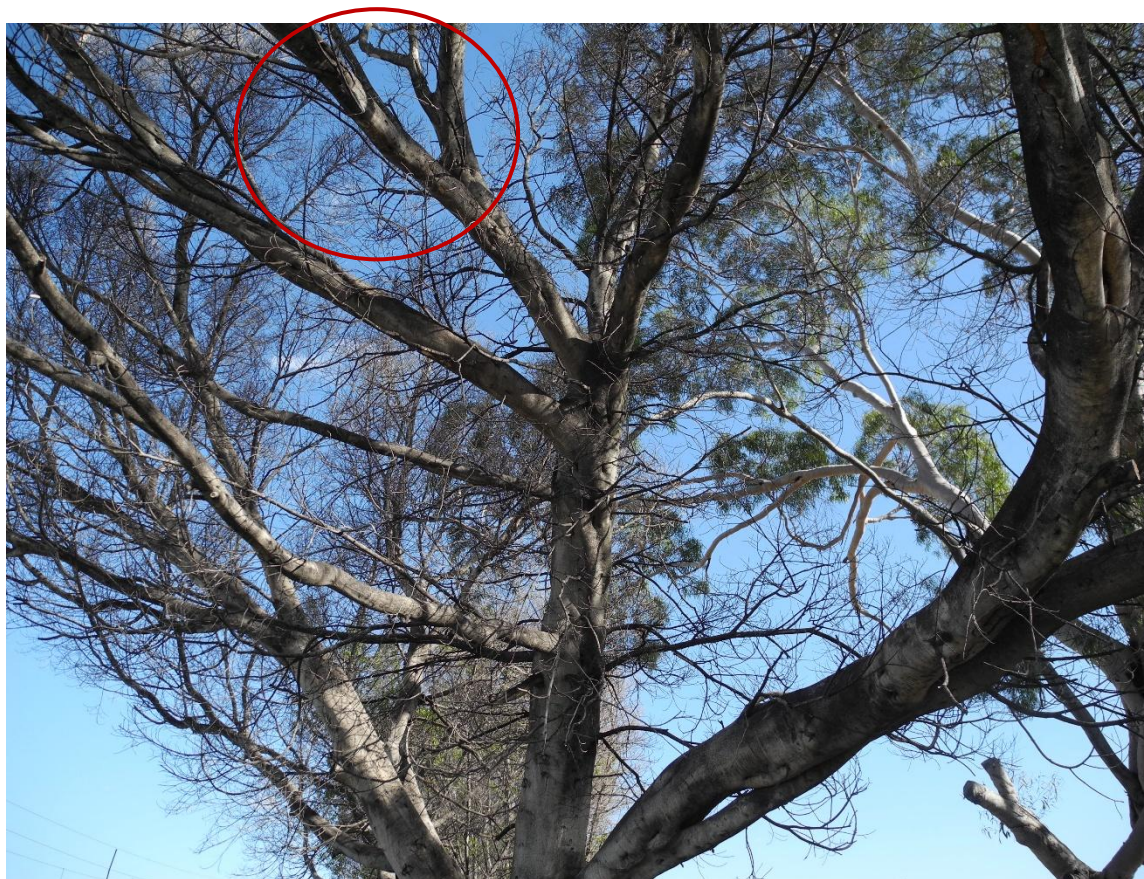
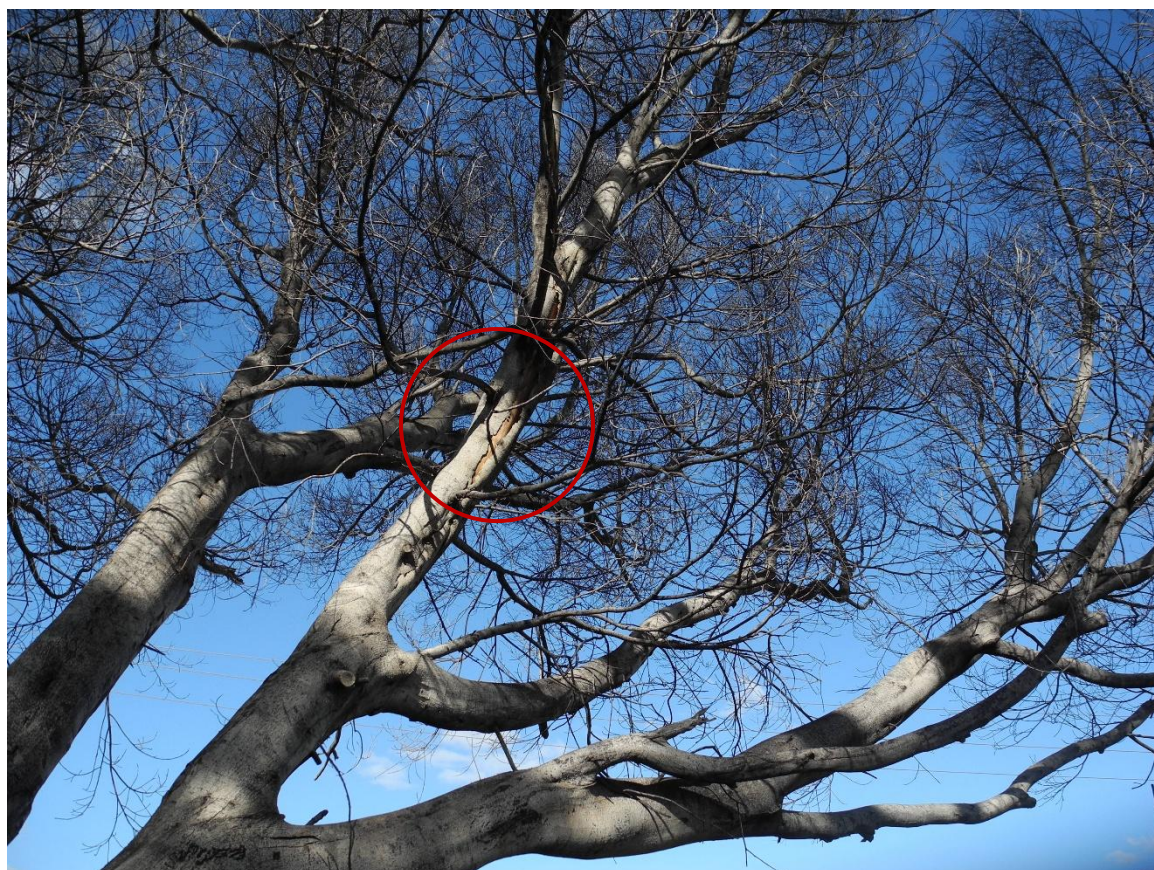
7. There was no live foliage remaining within the crown and there was no evidence of emerging epicormic re-growth.
8. A few desiccated leaves remain in the crown and areas of desiccated and lifted bark on second, third and fourth order branches were visible from ground level.

Figures 6 & 7 Displaying sections of the defoliated crown and indicating sections of dead and lifted bark visible from ground level.
