VICTORIA PARK LIBRARY & SUSSEX STREET COMMUNITY LAW SERVICE

BUILDING CONDITION ASSESSMENT & STRATEGIC ASSET REVIEW

April 2019

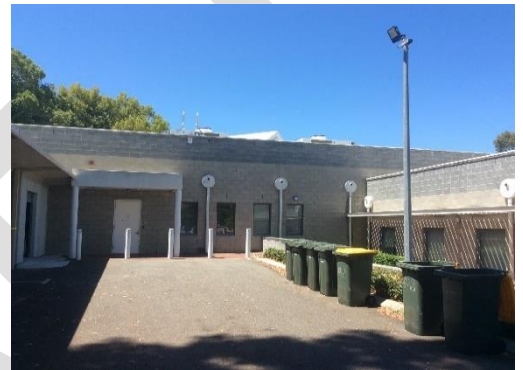
Figure 7 – Library Rear

- \ There is a rear storage shed at the back of the Library, however, due to the lack of space provided, staff also utilise storage facilities within a toilet block located at John MacMillan Park. This is likely to be discontinued with a proposed masterplan of John MacMillan Park likely to cease access to this storage facility, at least for a period of time.
