Victoria Park-Canning Level Crossing Removal TREE MANAGEMENT PLAN SUMMARY September 2022

Preliminary Tree Survey

Location: Armadale Line Upgrade; Leach Highway to Miller Street

Date: 18 August 2022

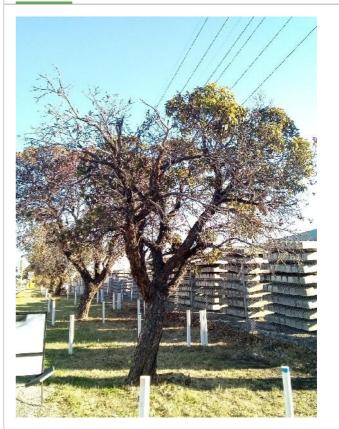
Tree Location	
Longitude:	115.927255
Latitude:	-31.998454

Tree Details	
Latin Name:	Corymbia ficifolia
Common Name:	Flowering Gum
Tree Age:	Semi mature
Health:	Poor
Structure:	Poor
Tree Height (Estimated) [m]:	6
Canopy Spread [m]:	6
DBH [cm]:	37
DBH Range:	30-45cm
Diameter at Root Flare (DRF) [m]:	0.462
Tree Protection Zone (TPZ) [m]:	4.44
Structural Root Zone (SRZ) [m]:	2.39
Useful Life Expectancy:	11-20 years
Origin:	Exotic
Habitat value:	Low
QTRA Risk Category:	Broadly Acceptable
Observation Comments:	This tree is in poor condition, likely due to compacted soil around it remove all grass for radius of 3 m and replace with mulch Myer prime at 1% and remove all dead wood over 25 mm in diameter.
Foraging species:	No

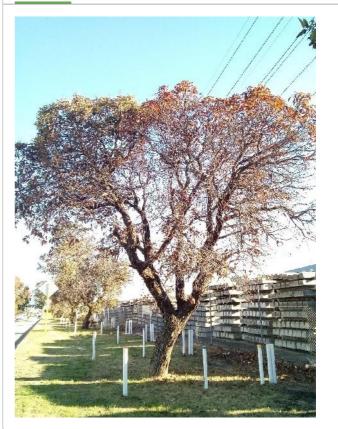
Tree Location	
Longitude:	115.927179
Latitude:	-31.998397

Tree Details	
Latin Name:	Corymbia ficifolia
Common Name:	Flowering Gum
Tree Age:	Semi mature
Health:	Poor
Structure:	Poor
Tree Height (Estimated) [m]:	8
Canopy Spread [m]:	7
DBH [cm]:	54
DBH Range:	46-60cm
Diameter at Root Flare (DRF) [m]:	0.556
Tree Protection Zone (TPZ) [m]:	6.48
Structural Root Zone (SRZ) [m]:	2.59
Useful Life Expectancy:	11-20 years
Origin:	Exotic
Habitat value:	Low
QTRA Risk Category:	Broadly Acceptable
Observation Comments:	This tree is in poor condition likely due to compacted soil around it remove all grass for radius of 3 m and replace with mulch Myer prime at 1% and remove all dead wood over 25 mm in diameter.
Foraging species:	No

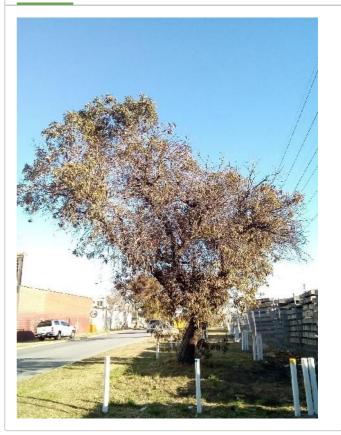
Tree Location	
Longitude:	115.927030
Latitude:	-31.998282

Tree Details	
Latin Name:	Corymbia ficifolia
Common Name:	Flowering Gum
Tree Age:	Semi mature
Health:	Poor
Structure:	Poor
Tree Height (Estimated) [m]:	9
Canopy Spread [m]:	7
DBH [cm]:	44.7
DBH Range:	30-45cm
Diameter at Root Flare (DRF) [m]:	0.535
Tree Protection Zone (TPZ) [m]:	5.36
Structural Root Zone (SRZ) [m]:	2.54
Useful Life Expectancy:	11-20 years
Origin:	Exotic
Habitat value:	Low
QTRA Risk Category:	Broadly Acceptable
Observation Comments:	This tree is in poor condition likely due to compacted soil around it remove all grass for radius of 3 m and replace with mulch Bioprime at 1%. Remove all dead wood over 25 mm in diameter, basal suckers and uplift the canopy to 2m above ground level.

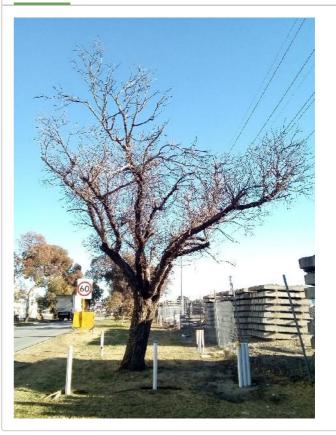
Tree Location	
Longitude:	115.926867
Latitude:	-31.998156

Tree Details	
Latin Name:	Corymbia ficifolia
Common Name:	Flowering Gum
Tree Age:	
Health:	Dead
Structure:	
Tree Height (Estimated) [m]:	
Canopy Spread [m]:	
DBH [cm]:	
DBH Range:	N/A
Diameter at Root Flare (DRF) [m]:	
Tree Protection Zone (TPZ) [m]:	
Structural Root Zone (SRZ) [m]:	
Useful Life Expectancy:	0 years
Origin:	Exotic
Habitat value:	Low
QTRA Risk Category:	
Observation Comments:	This tree is dead remove to ground level and stump grind.
Foraging species:	No
Comments:	remove to ground level and stump grind.

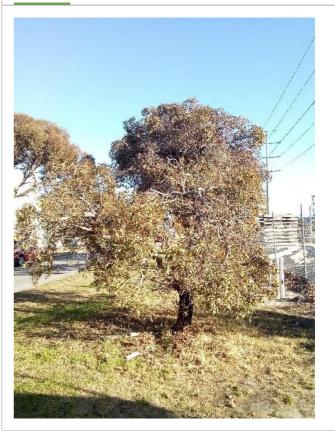
Tree Location	
Longitude:	115.926699
Latitude:	-31.998033

Tree Details	
Latin Name:	Corymbia ficifolia
Common Name:	Flowering Gum
Tree Age:	Semi mature
Health:	Fair
Structure:	Poor
Tree Height (Estimated) [m]:	3
Canopy Spread [m]:	4
DBH [cm]:	13
DBH Range:	8-16cm
Diameter at Root Flare (DRF) [m]:	0.22
Tree Protection Zone (TPZ) [m]:	2
Structural Root Zone (SRZ) [m]:	1.75
Useful Life Expectancy:	11-20 years
Origin:	Exotic
Habitat value:	Low
QTRA Risk Category:	Broadly Acceptable
Observation Comments:	This tree is in poor condition likely due to compacted soil around it remove all grass for radius of 3 m and replace with mulch Bioprime at 1%. Remove all dead wood over 25 mm in diameter, basal suckers and uplift the canopy to 2m above ground level.

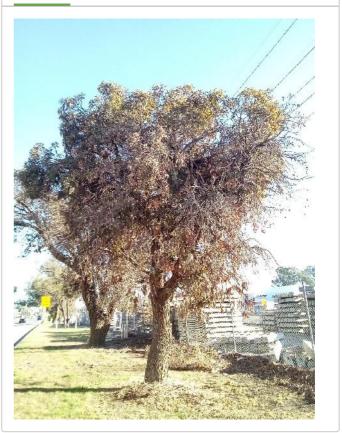
Tree Location	
Longitude:	115.926632
Latitude:	-31.997980

Tree Details	
Latin Name:	Corymbia ficifolia
Common Name:	Flowering Gum
Tree Age:	Semi mature
Health:	Poor
Structure:	Poor
Tree Height (Estimated) [m]:	7
Canopy Spread [m]:	6
DBH [cm]:	41.2
DBH Range:	30-45cm
Diameter at Root Flare (DRF) [m]:	0.53
Tree Protection Zone (TPZ) [m]:	4.94
Structural Root Zone (SRZ) [m]:	2.53
Useful Life Expectancy:	11-20 years
Origin:	Exotic
Habitat value:	Low
QTRA Risk Category:	Broadly Acceptable
Observation Comments:	This tree is in poor condition likely due to compacted soil around it remove all grass for radius of 3 m and replace with mulch Myer prime at 1% and remove all dead wood over 25 mm in diameter.
Foraging species:	No

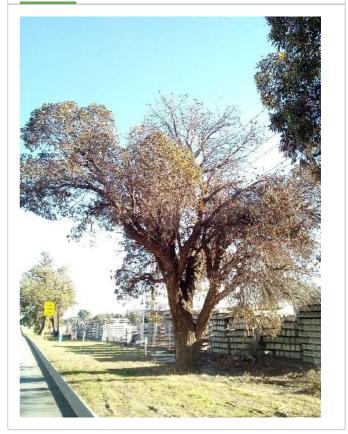
Tree Location	
Longitude:	115.926552
Latitude:	-31.997919

Tree Details	
Latin Name:	Corymbia ficifolia
Common Name:	Flowering Gum
Tree Age:	Semi mature
Health:	Poor
Structure:	Very Poor
Tree Height (Estimated) [m]:	8
Canopy Spread [m]:	9
DBH [cm]:	41.2
DBH Range:	30-45cm
Diameter at Root Flare (DRF) [m]:	0.53
Tree Protection Zone (TPZ) [m]:	4.94
Structural Root Zone (SRZ) [m]:	2.53
Useful Life Expectancy:	11-20 years
Origin:	Exotic
Habitat value:	Low
QTRA Risk Category:	Broadly Acceptable
Observation Comments:	This tree is in poor condition likely due to compacted soil around it remove all grass for radius of 3 m and replace with mulch Myer prime at 1% and remove all dead wood over 25 mm in diameter.
Foraging species:	No
