**Justification Statement for Proposed Works at 36A Geddes Street, Victoria Park**  
Character Retention Area – Raphael Residential Precinct

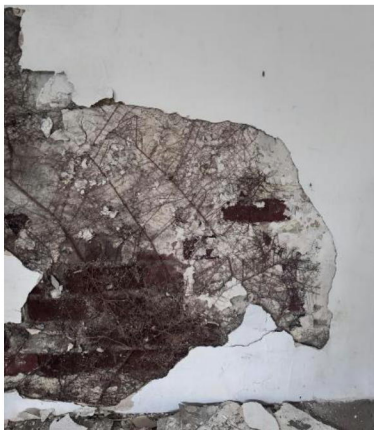
*Image – Plaster damage and mould to inside face of façade parapet wall*

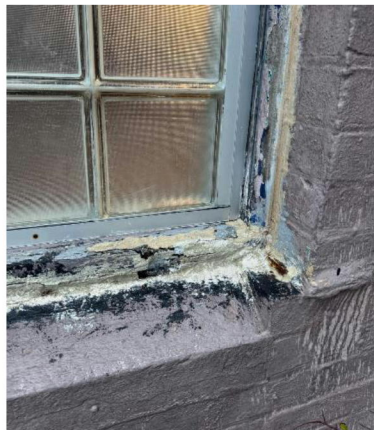
*Image – Existing opening damaged by water*

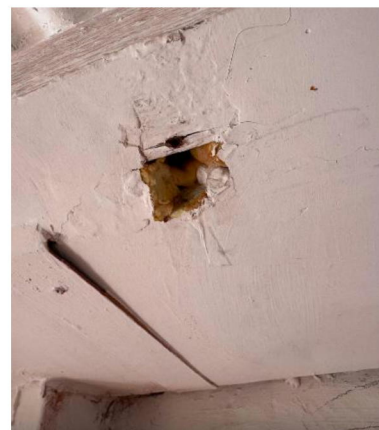
*Image – Existing broken boxed gutter*

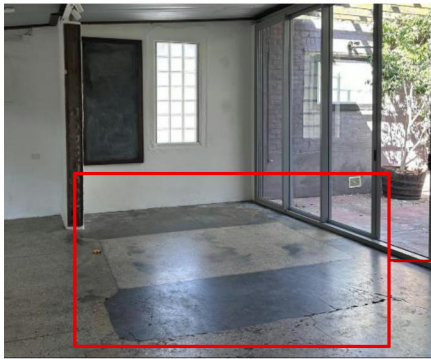
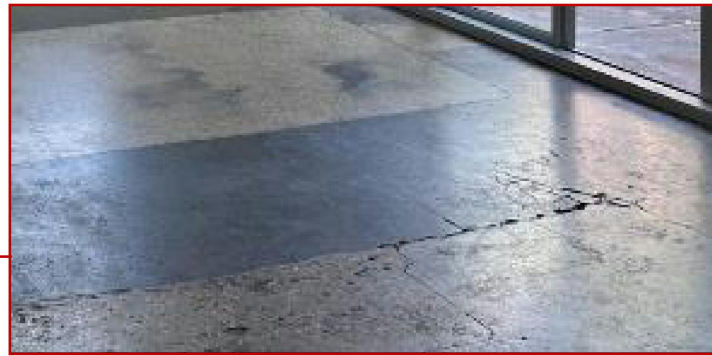
*Image – Existing slab evidence of cracking and inadequate patching due to be replaced*

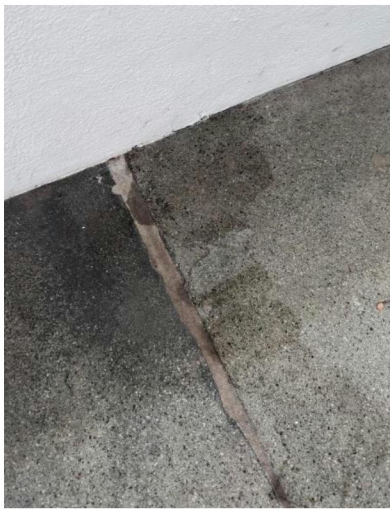
*Image – Rising damp existing slab*

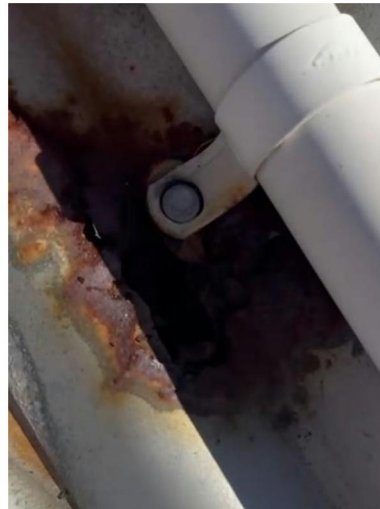
*Image – Existing roof corroded and broken*

- Replacement of the tiled roof on the upper floor with **lightweight Colorbond cladding**, reducing overall load and preventing further structural stress.
- Construction of the upper floor extension in **light steel framing**, providing strength without burdening the existing masonry structure.
- **Removal and replacement of compromised floor slabs** within ground-floor living areas to eliminate root intrusion and rectify rising damp conditions.
- **Isolation of the new structural elements** from the original fabric wherever practical, allowing the existing building to perform independently and minimising risk of further cracking or displacement.
- Introduction of **weatherproofing upgrades** to the upper-level balcony to prevent further water penetration into the ceiling below, addressing both liveability and health concerns.

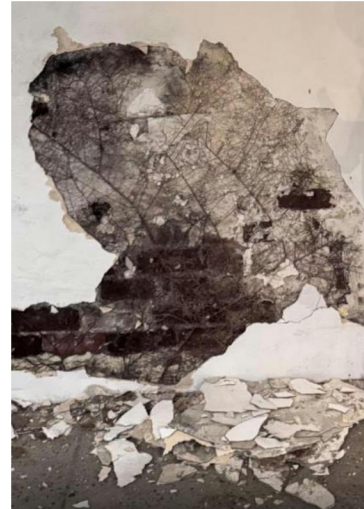
*Image – Existing plaster cracking water and roots damage*

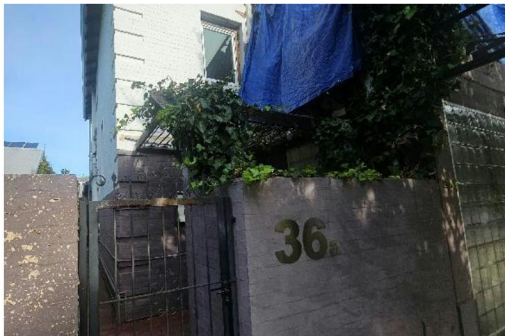
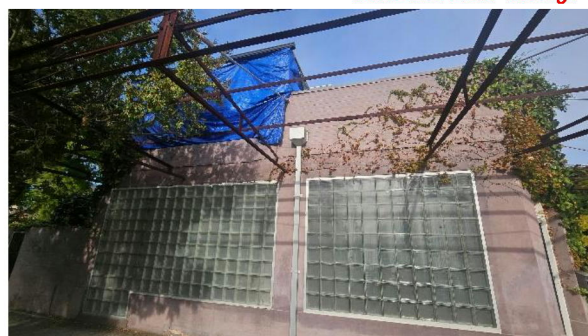
*Images – Existing Façade tarps in place over existing balcony to protect from further weather damage – Geddes Street*

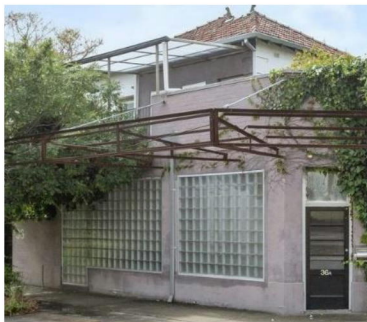
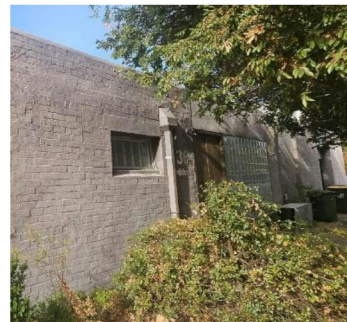
*Images – Existing downpipes on the external Façade – Geddes Street and Washington St*

The existing downpipes, already located along the parapet façade, will be retained and supplemented with **additional downpipes** that match in material and profile to ensure cohesive integration. These visible stormwater elements will be finished in complementary tones and will respect the visual alignment of the existing parapet articulation.

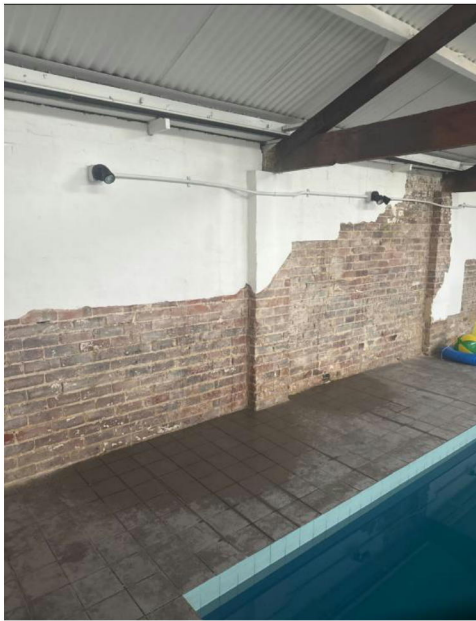
Image – Existing Parapet wall and water damage

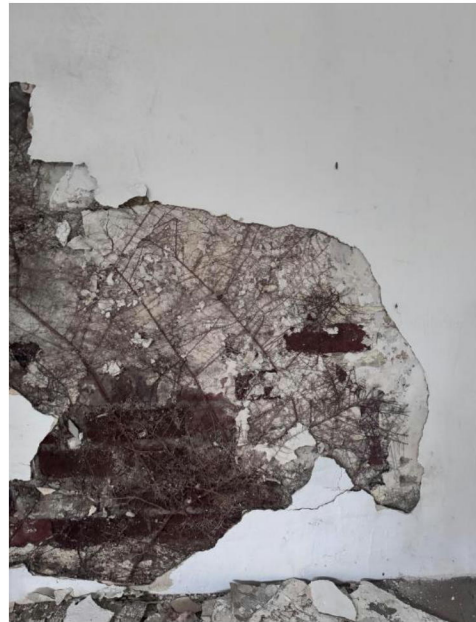
Image – view of front façade damage, internal, water and mould and plant root Existing Façade – Washington Street

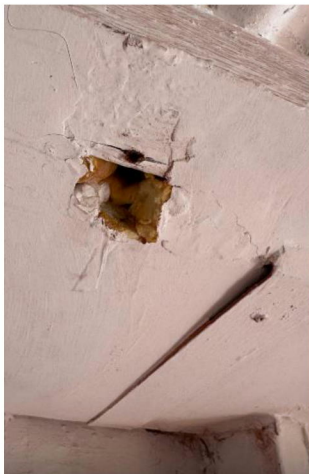
As part of the remedial works, a critical issue identified was the failure of the existing boxed gutters and internal stormwater pipes. These have led to substantial water ingress within the building, resulting in plaster damage, mould growth, and ceiling deterioration. The proposal addresses this through a pragmatic yet aesthetically sensitive solution: the use of **external façade-mounted downpipes**.

Image– Existing boxed gutter  
Broken gutter

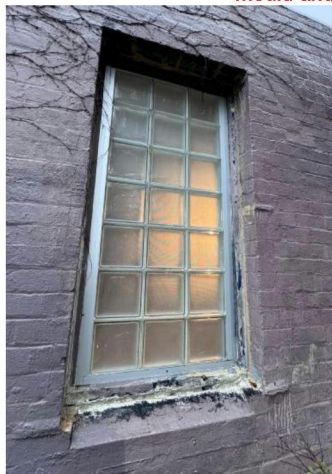
Image– Existing glass blocks to façade  
shows evidence of water damage boxed

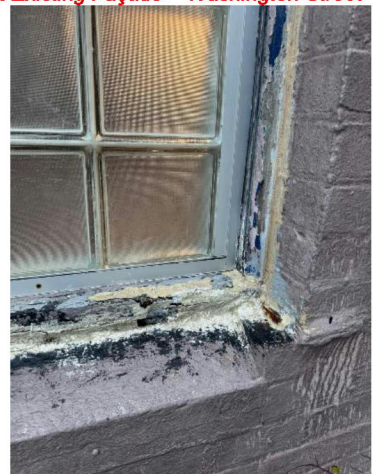
Image– shows extent of damage

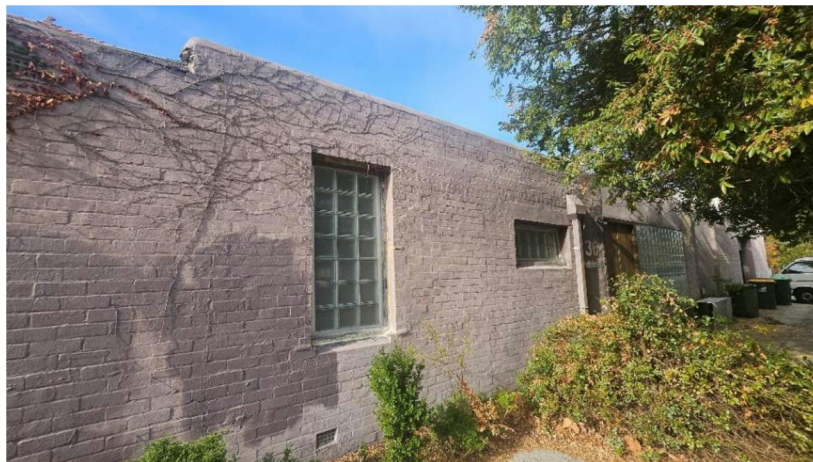
Image – Existing Façade – Washington St – water damage evident on existing wall

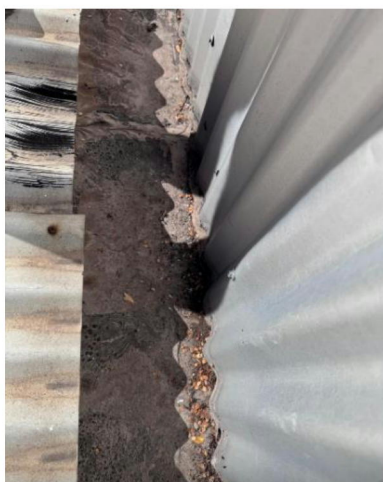
*Image– Existing boxed gutter*

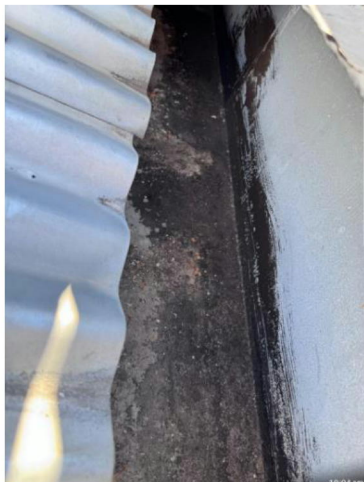
*Image– Existing boxed gutter*

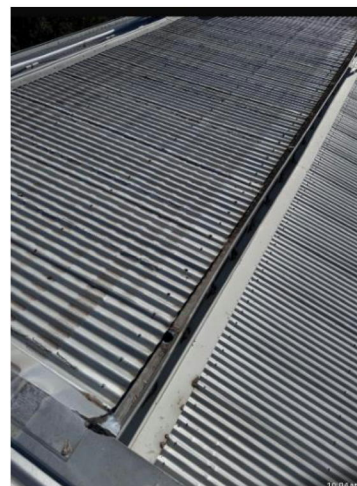
*Image– Broken ridge roof line*

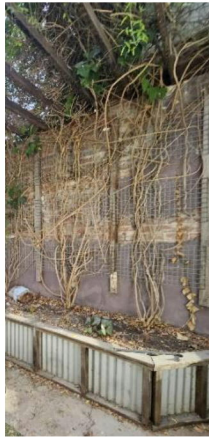
*Image – Existing Landscaping to be removed, and new landscaping to be provided to reduce further destruction of the structure*
