Victoria Park Croquet Club (fmr)
31 Rushton Street, Burswood
HERITAGE IMPACT STATEMENT
by
HOCKING HERITAGE + ARCHITECTURE
November 2022

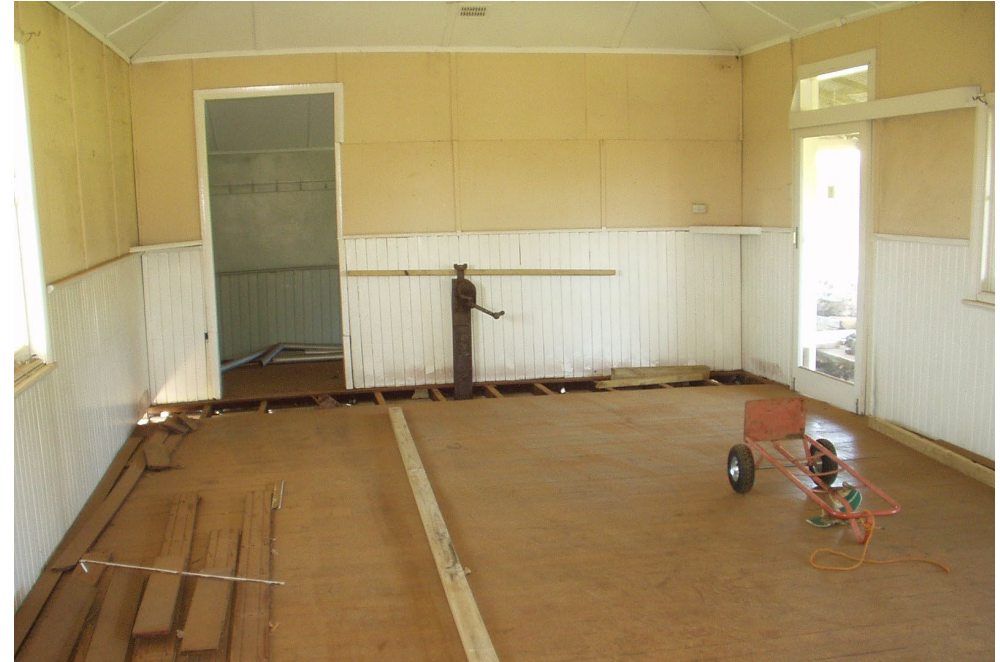
Figure 9: Internal view showing restumping works, 2006

In c2006, the Clubroom Pavilion was upgraded. The works included restumping, partial recladding and a ramp added for improved access.¹⁸ The works retained significant original detail and form.

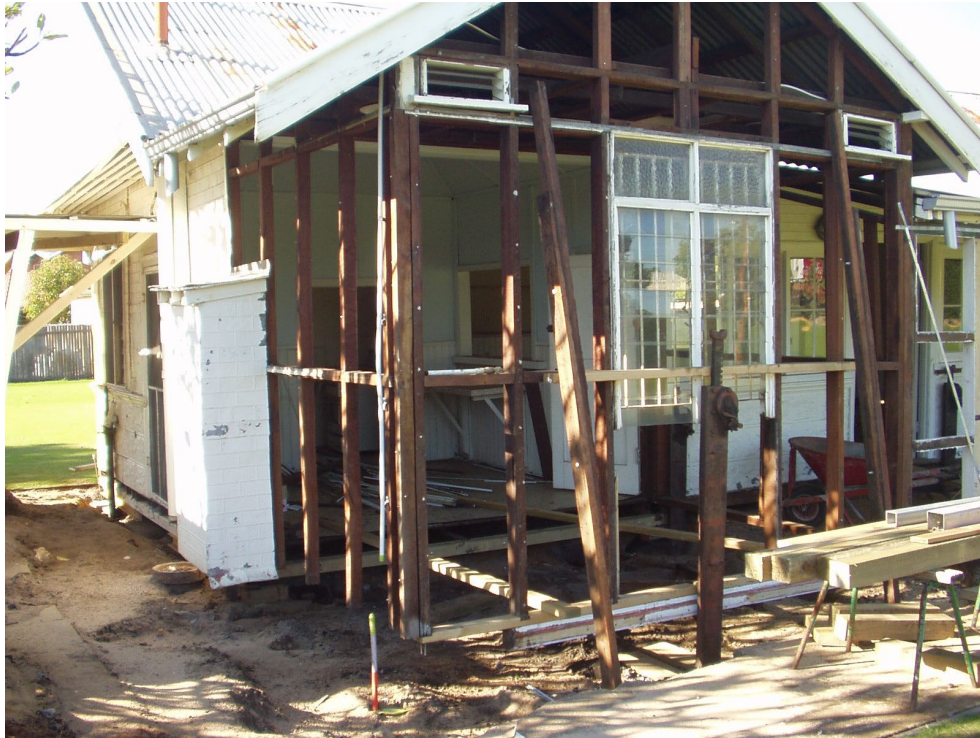
Figure 10: Recladding and restumping of servery, 2006
Courtesy Town of Victoria Park.

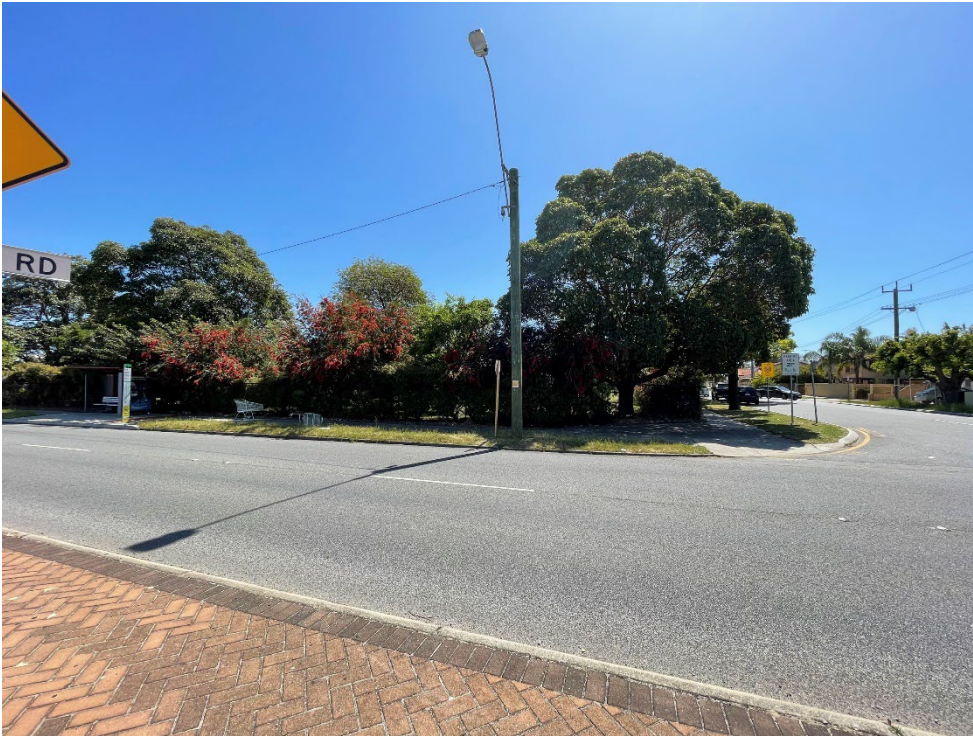
Figure 14: View of the site across Shepperton Road

- Buildings are obscured by plantings in this street view

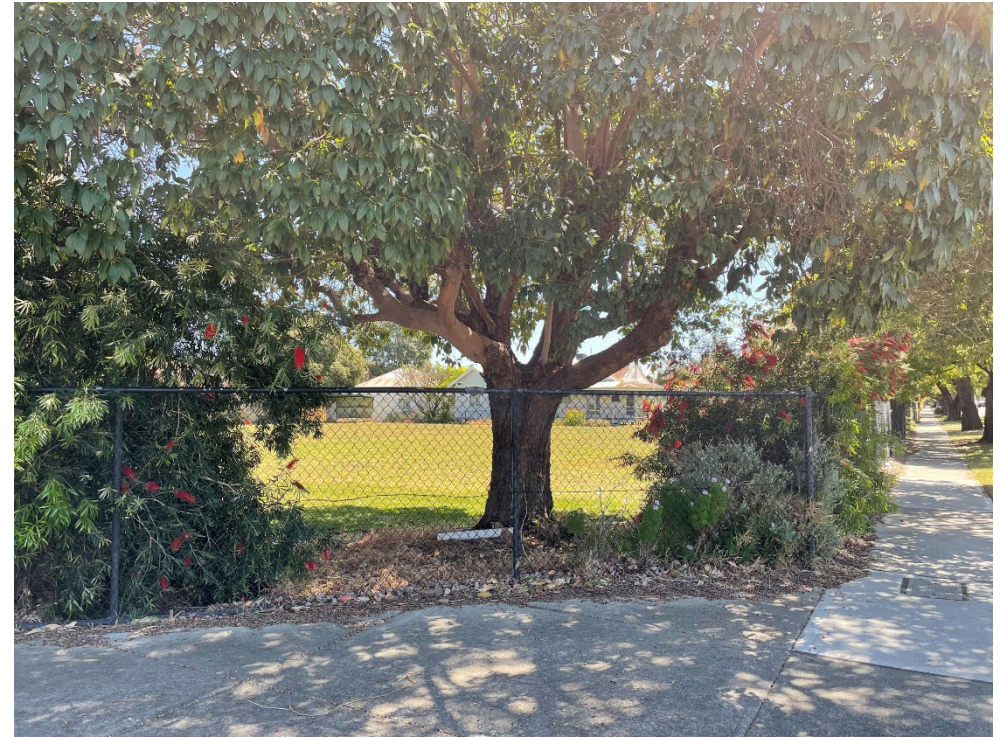
Figure 15: View from corner of Shepperton Rd and Rushton Rd.

- Wire mesh fencing is located on the Shepperton Road and Rushton Road property boundaries
- Mature plantings of exotic and native species screen the site

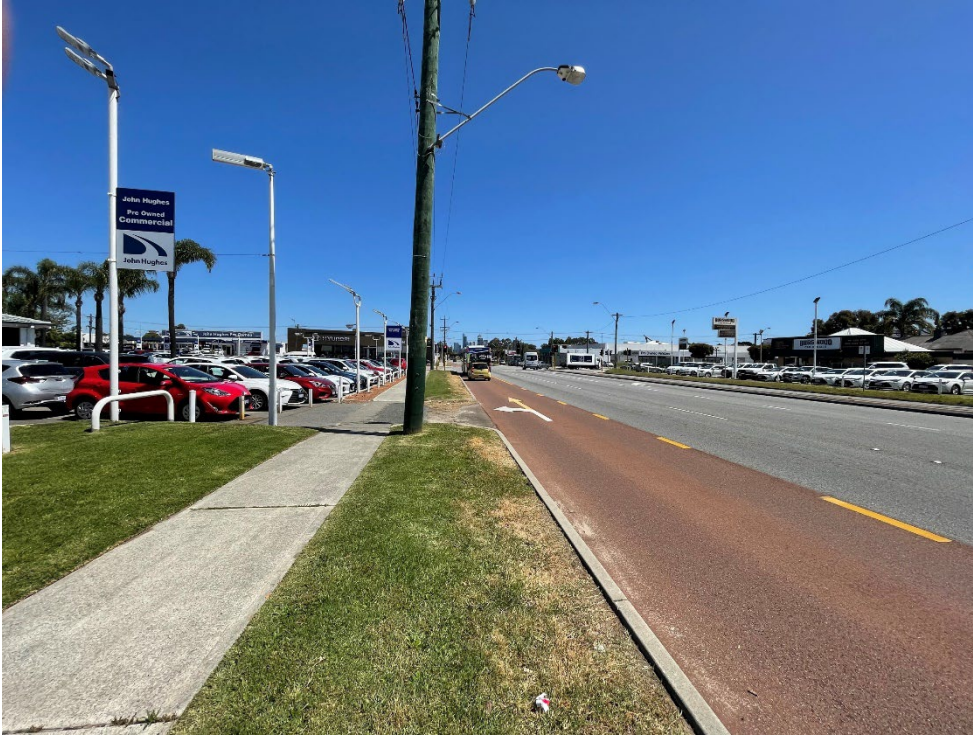
Figure 16: View of Shepperton Road looking north

- Properties adjacent to the former croquet club site are dominated by commercial properties and largely car sales yards.

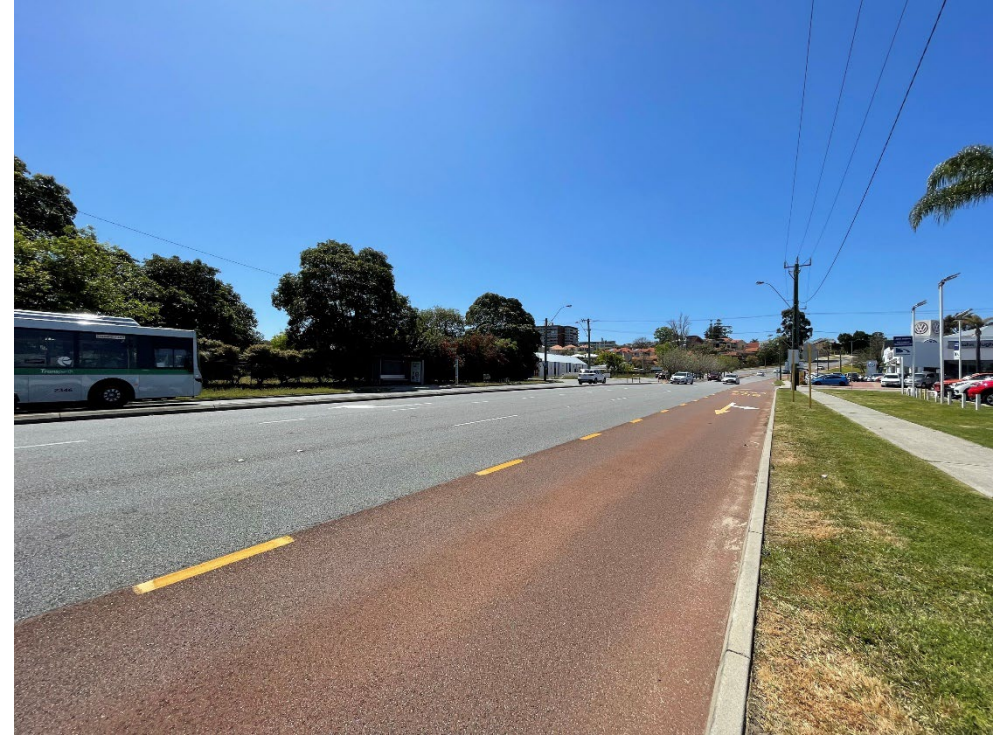
Figure 17: View of Shepperton Road looking south

- The former Croquet Club at left is marked by mature plantings in contrast to the adjacent properties.

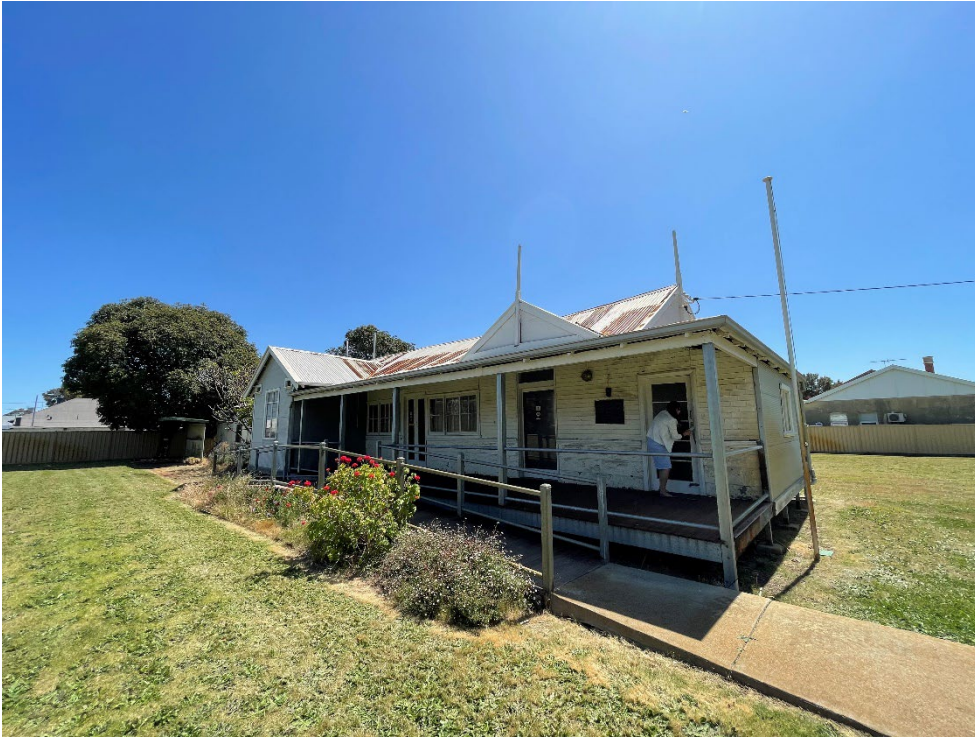
Figure 18: Clubroom Pavilion

- Paintwork on the exterior is deteriorated.
- The addition at the left is a later addition

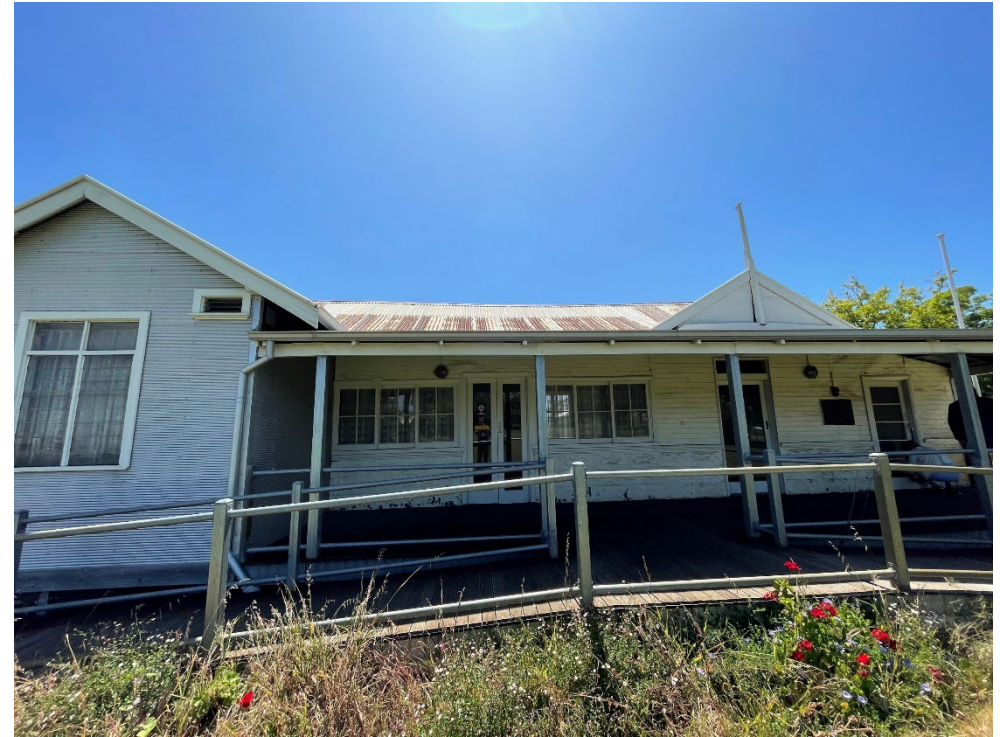
Figure 19: Front elevation of the Clubroom Pavilion

- Mixed materials used in cladding
- Glazing in a mix of styles
- Ramp extension built 2006

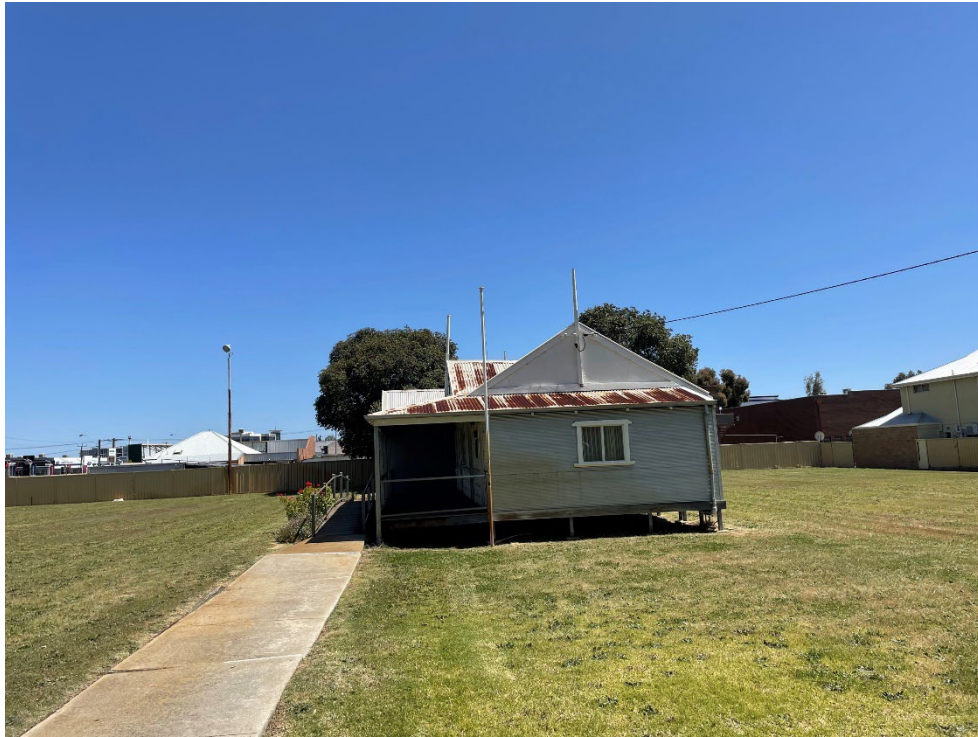
Figure 20: East elevation of Clubroom Pavilion

- Deteriorated roof cladding
- Concrete pathways

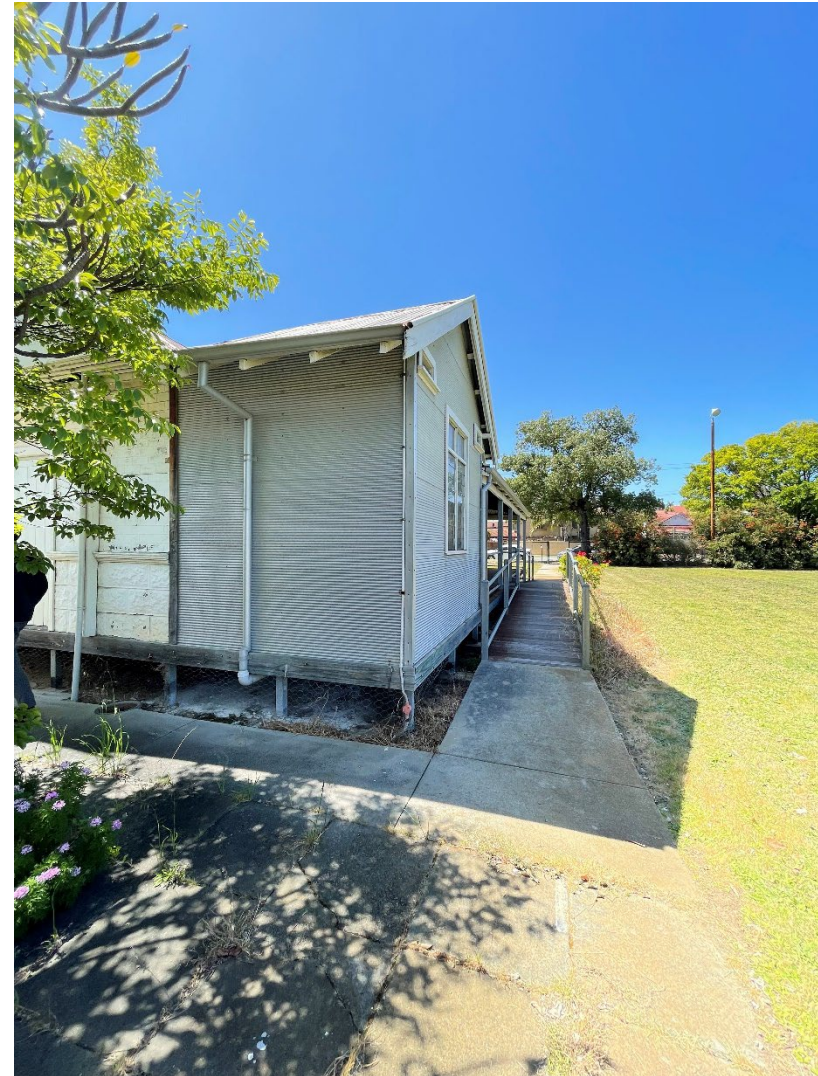
Figure 21: Ramp to verandah

- Mini orb cladding and earlier pressed metal sheeting.
- Enclosed verandah with mini orb cladding is a later addition.

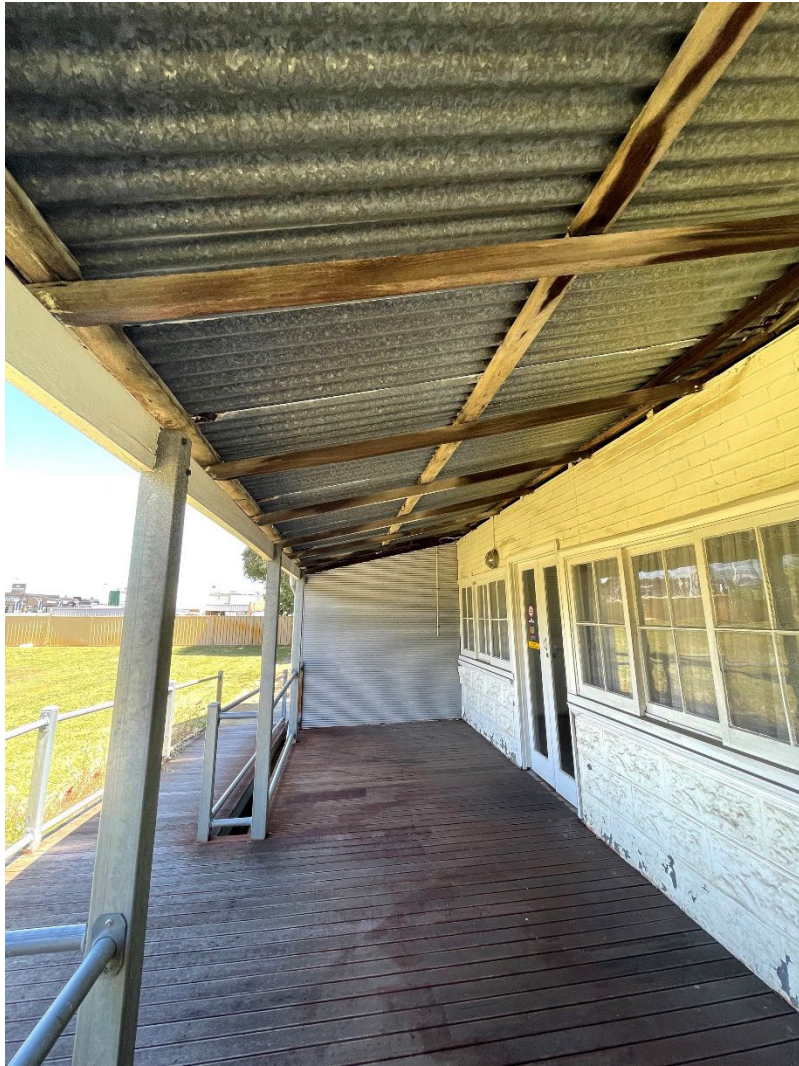
Figure 22: Clubroom Pavilion verandah

- Deck floorboards and ramp from 2006 works
- Metal balustrades and metal uprights from 2006 works

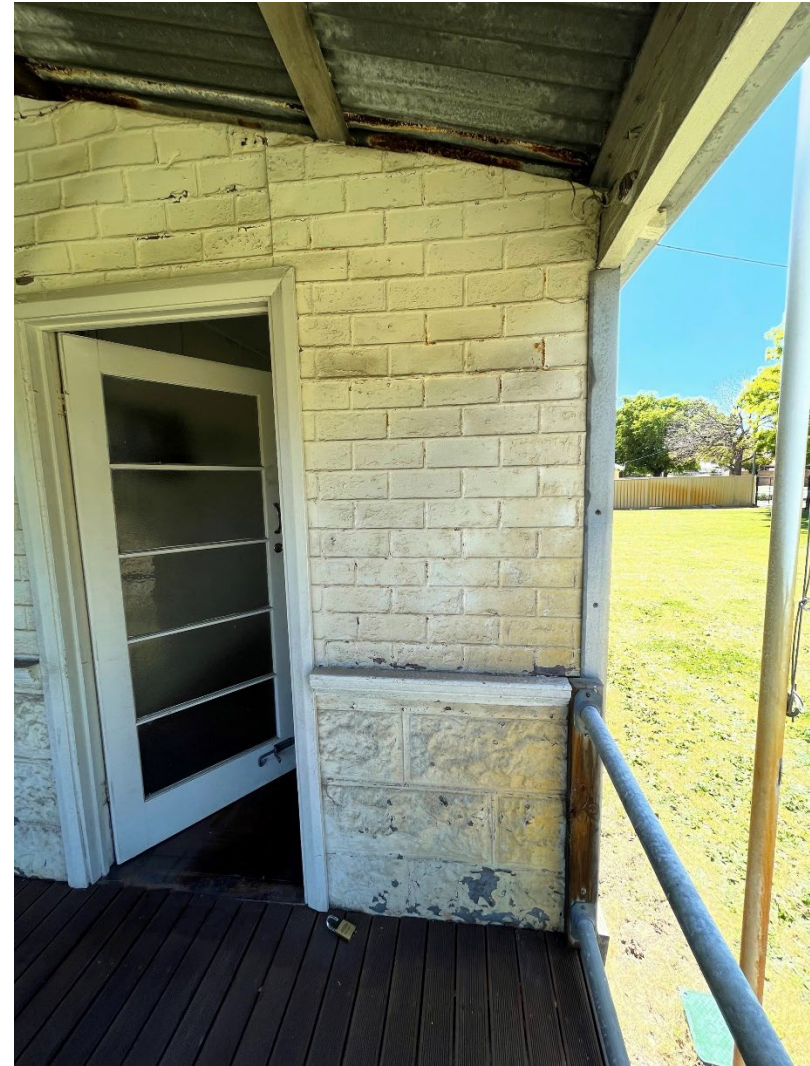
Figure 23: Pressed metal cladding on south elevation

- The metal cladding mimics brick and stone construction
- Presumed to be an original detail from the 1910s

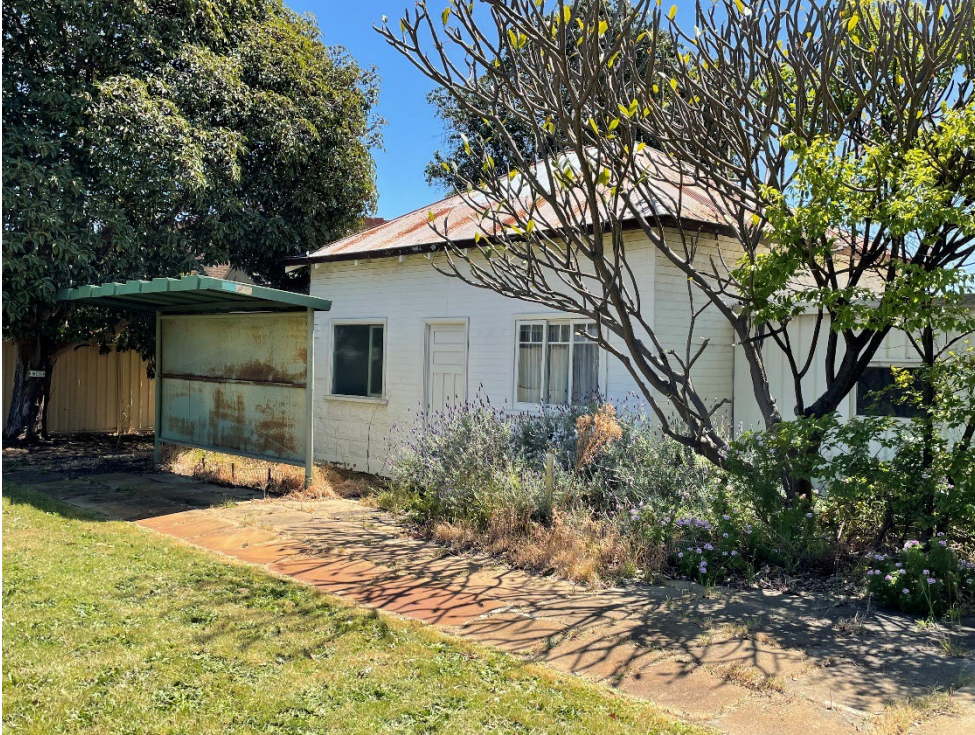
Figure 24: Croquet Equipment Store

- Timber frame with pressed metal cladding in a range of styles.
- Built, or relocated to this site c1930s.
- Small store at right is accessed from inside the Croquet Equipment Store
- Former bus shelter adjacent

It is therefore recommended therefore that the Clubroom Pavilion and Croquet Equipment Store are relocated if the property is sold for development.

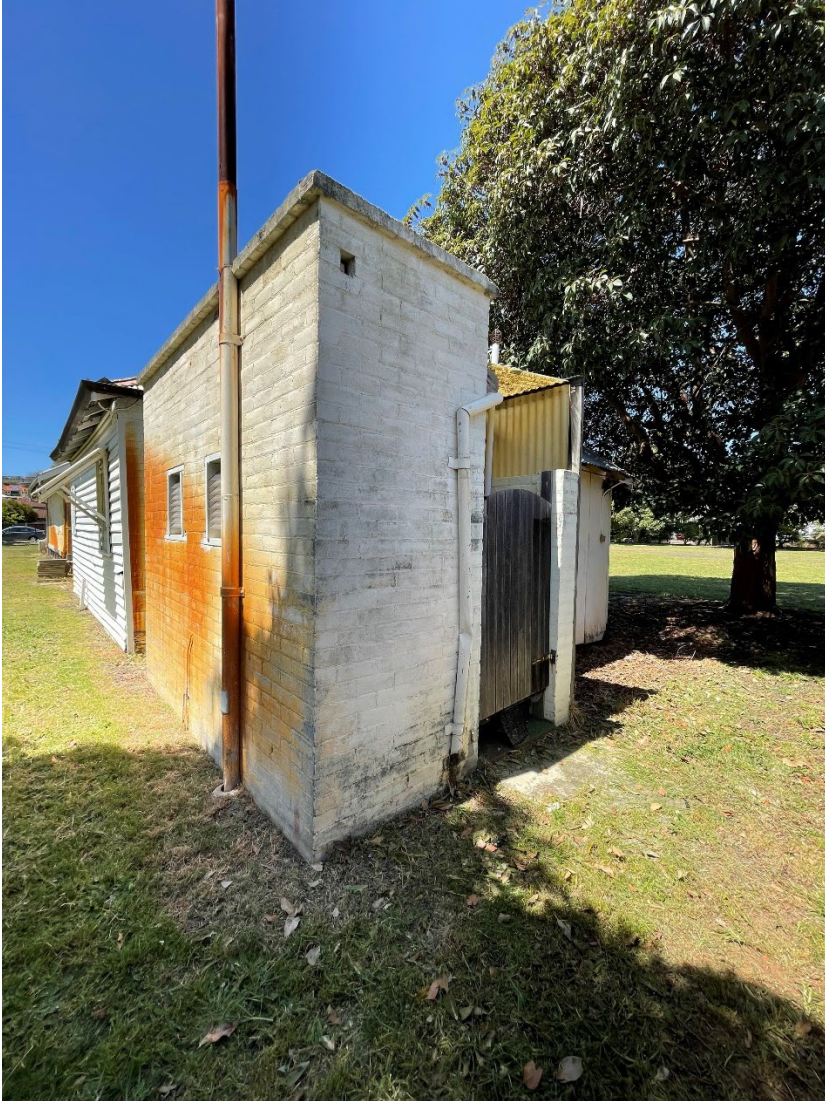
Figure 26: Toilets

- Brick structure of no heritage value

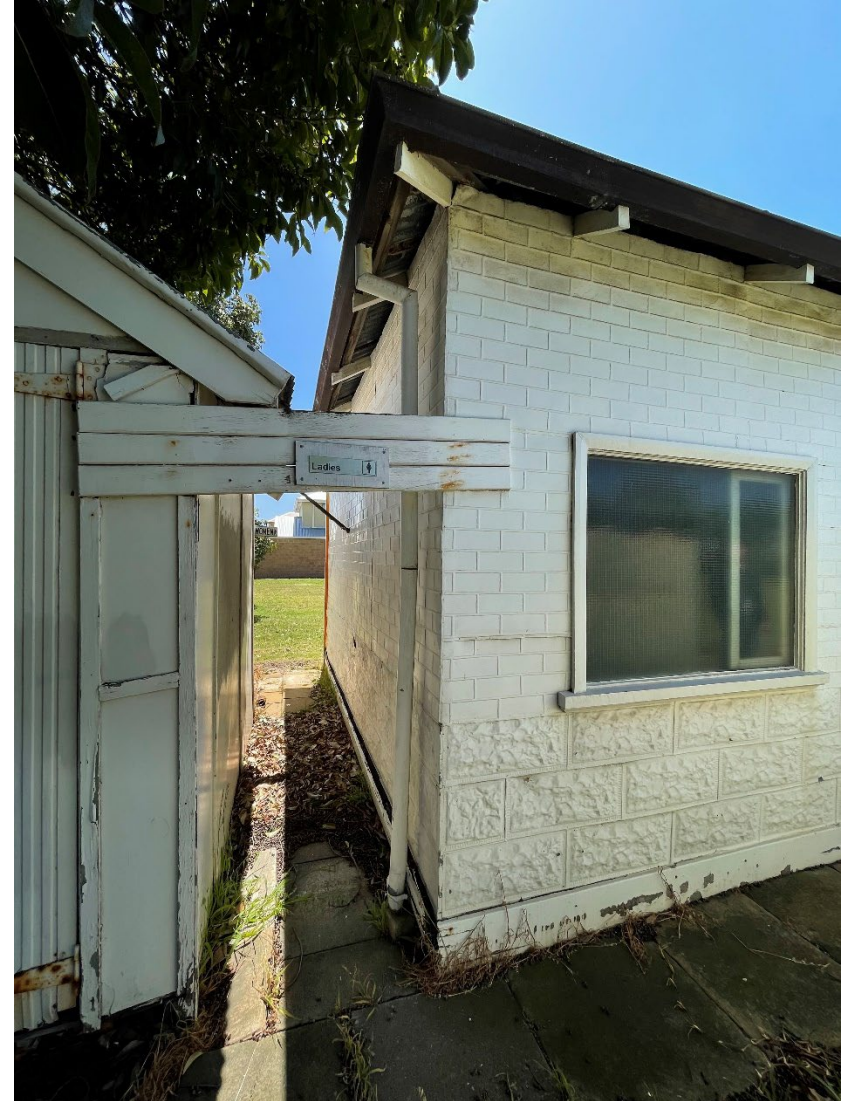
Figure 27: Path between Mowing Shed and Croquet Equipment Store

- Showing the range of materials consistent with the Clubroom Pavilion

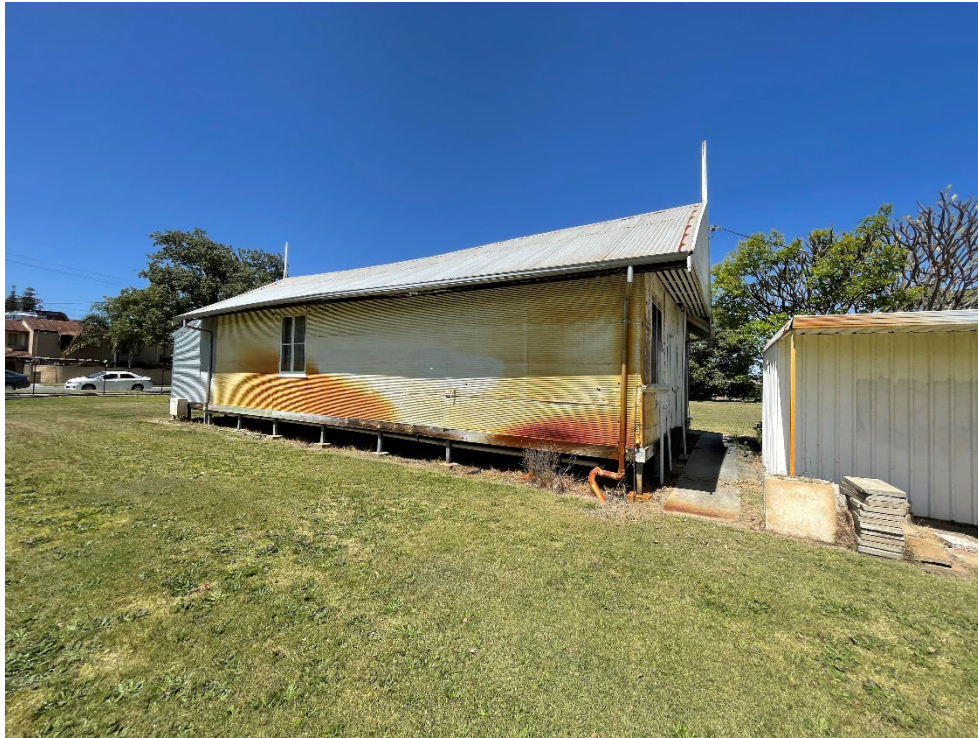
Figure 28: Rear view of Clubroom Pavilion

- Cladding in poor condition

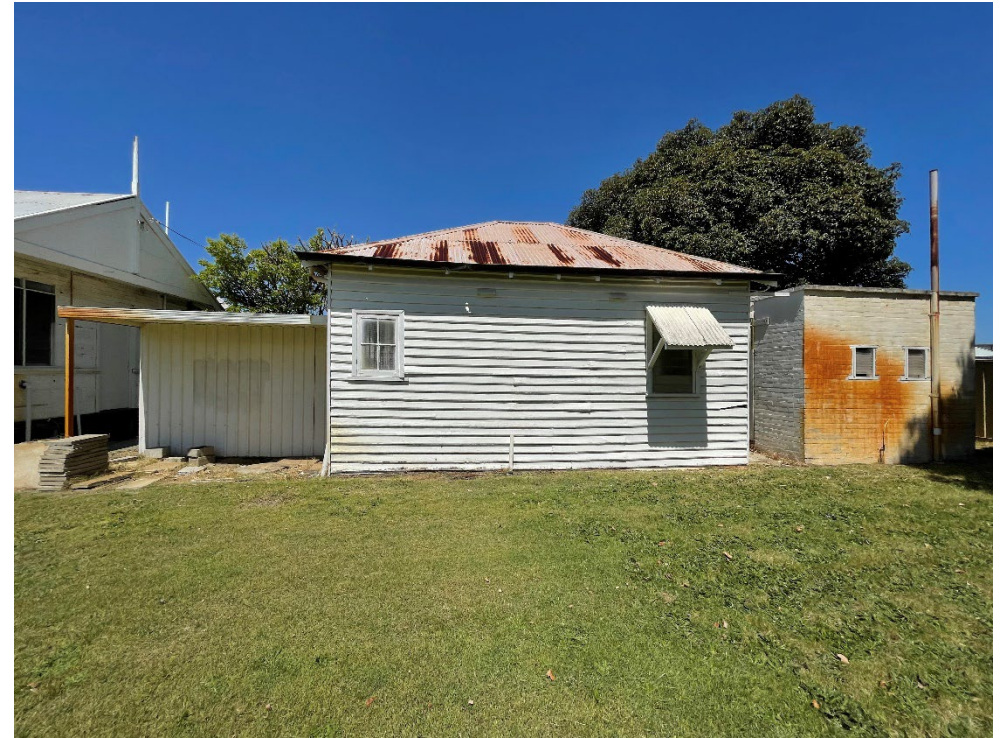
Figure 29: Rear view of Croquet Equipment Store and toilets

- Weatherboard cladding of store
- Brick toilet block

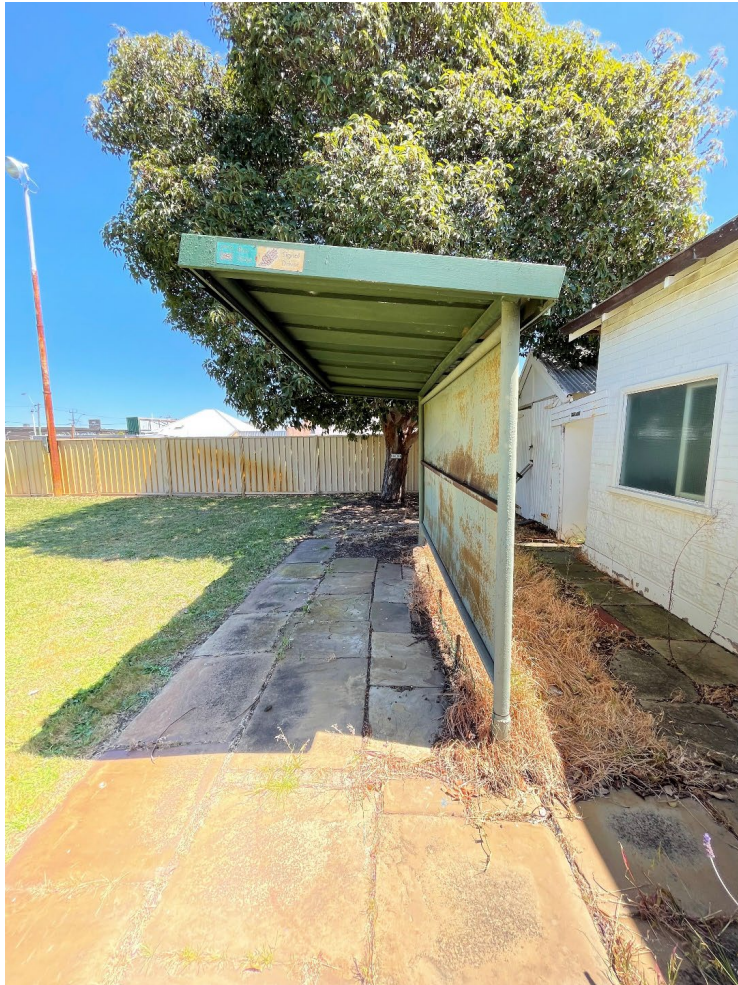
Figure 30: Relocated Bus shelter

- No heritage value

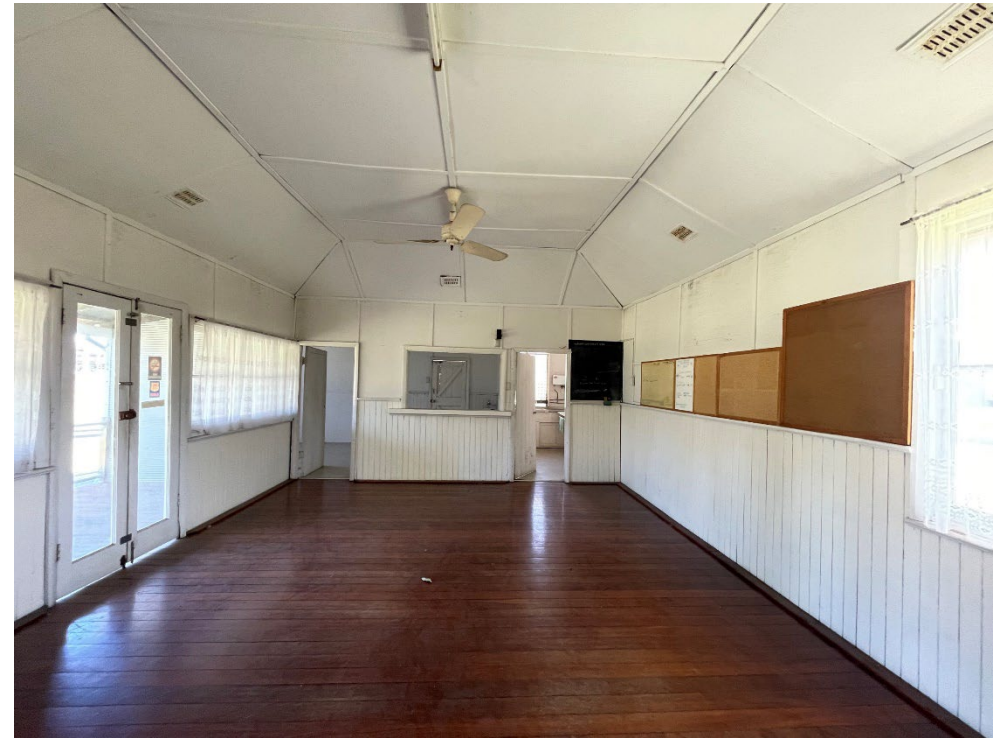
Figure 31: Clubroom Pavilion

- Simple vaulted ceiling
- Asbestos cladding (refer to Asbestos Survey)
- Panelling to dado height
- Floorboards generally in good condition but some variation in dimensions

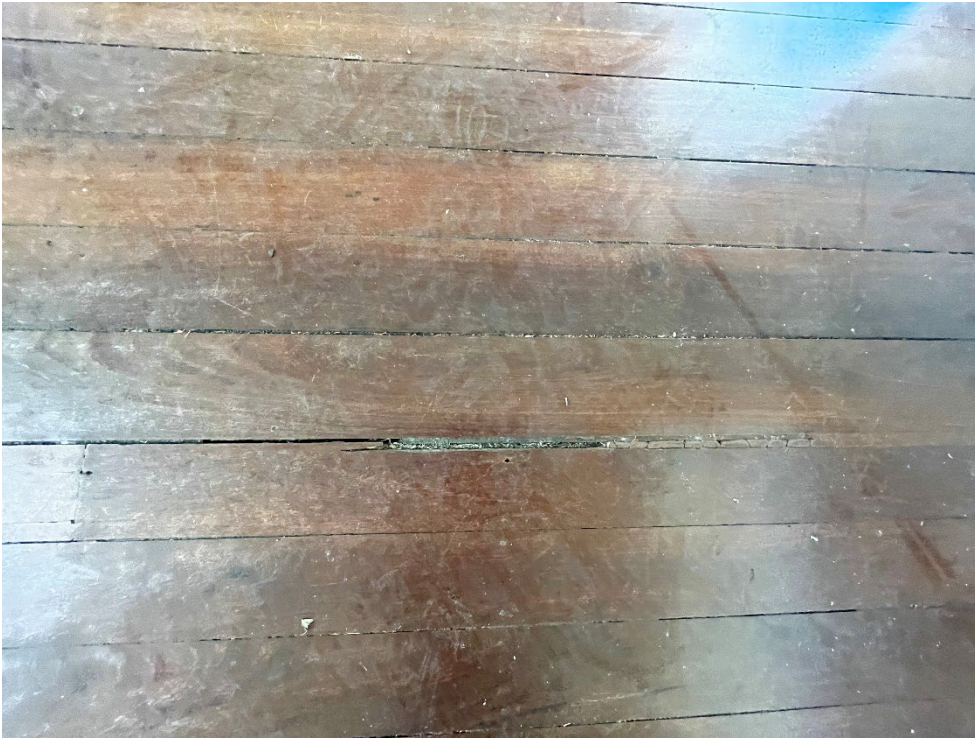
Figure 32: Clubroom Pavilion floorboards detail

- Some minor deterioration and variation in dimensions
- The majority is likely to be from the original construction in the 1910s

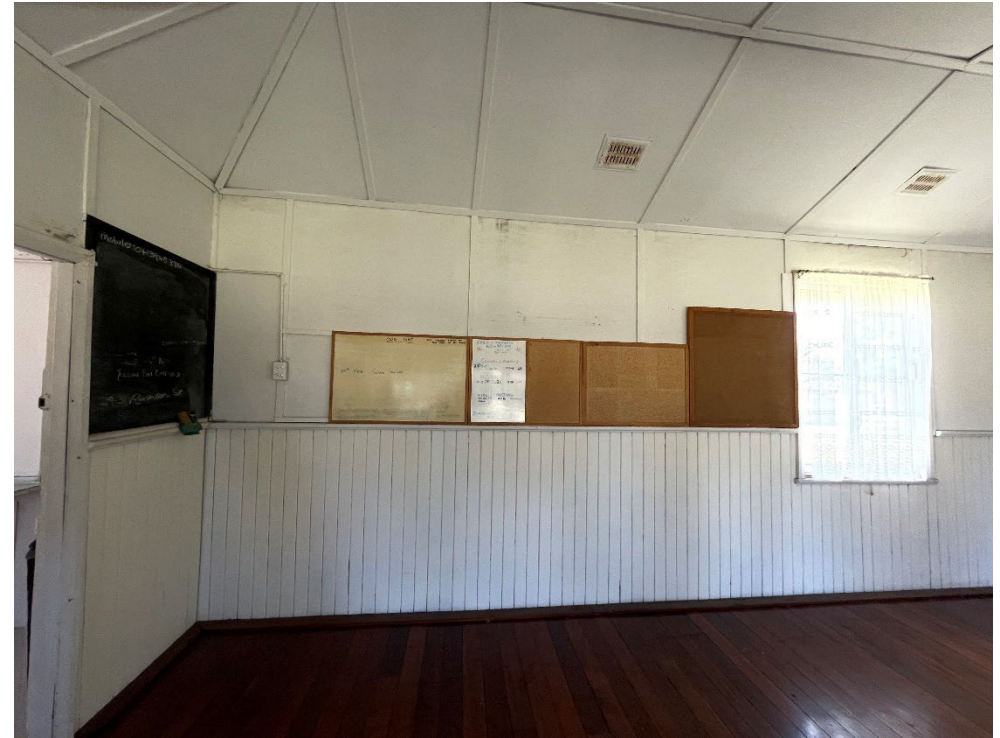
Figure 33: Dado panelling in Clubroom Pavilion

- Panelling is an original detail.
- Asbestos panels above likely to be Post World War Two

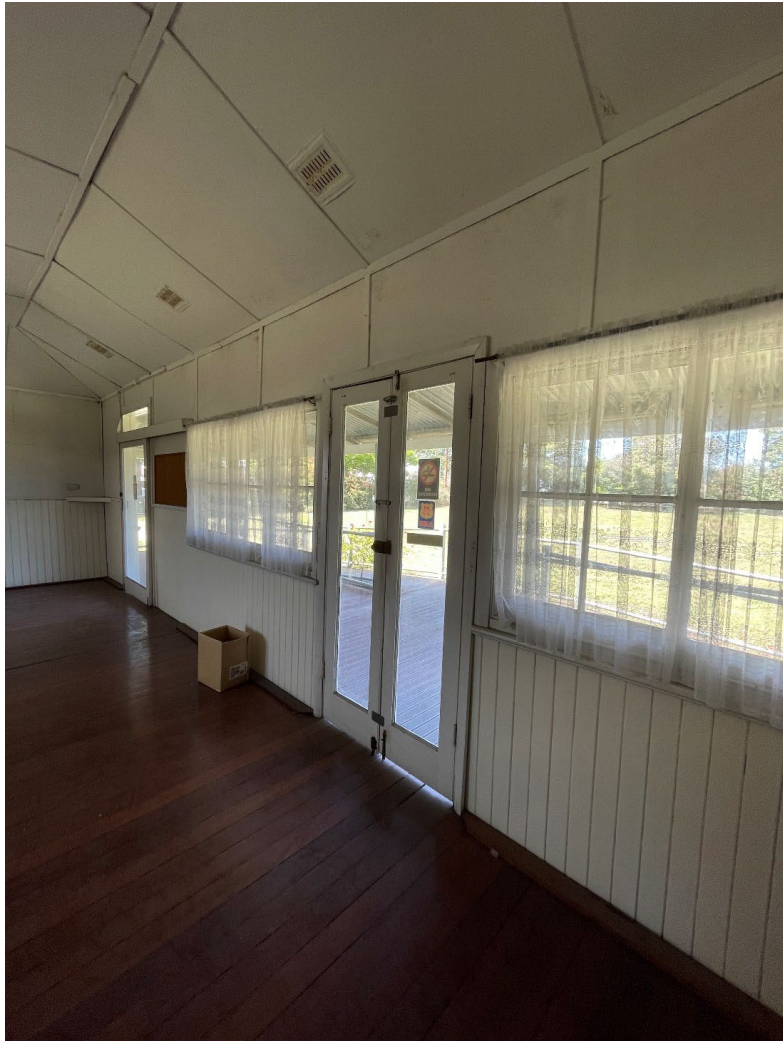
Figure 34: Glazing and roof vents

- Roof vents are likely to be original detail
- Glazing styles reflect various periods

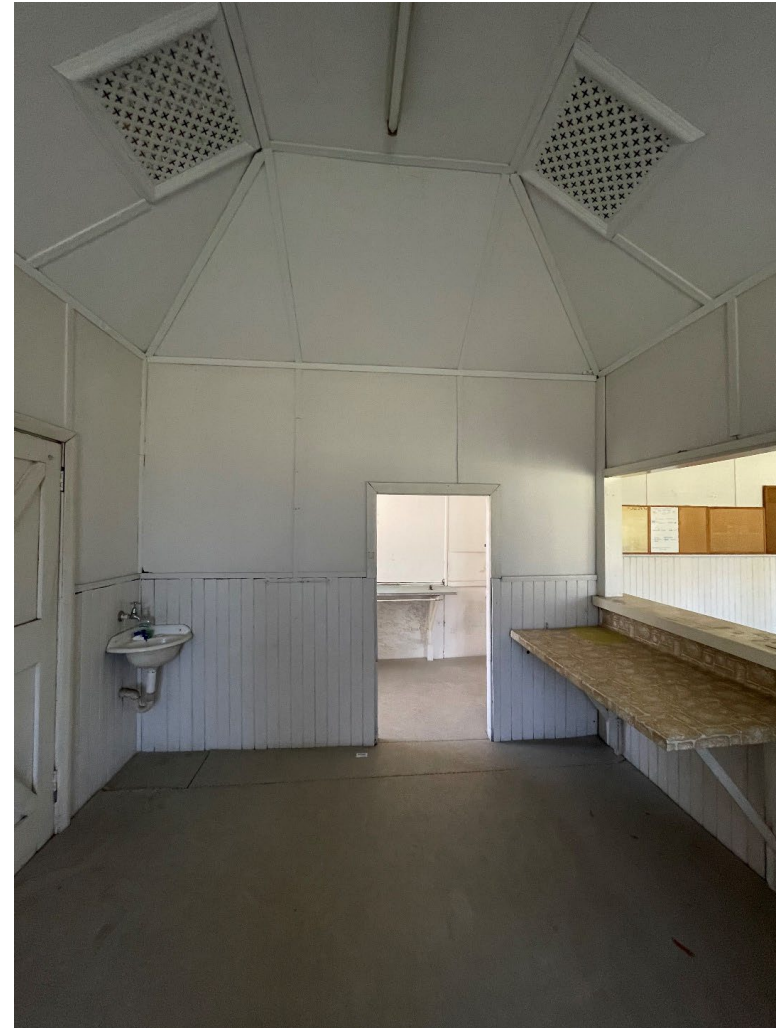
Figure 35: Servery in the Clubroom Pavilion

- Vaulted ceiling with original decorative vents
- Dado panelling original

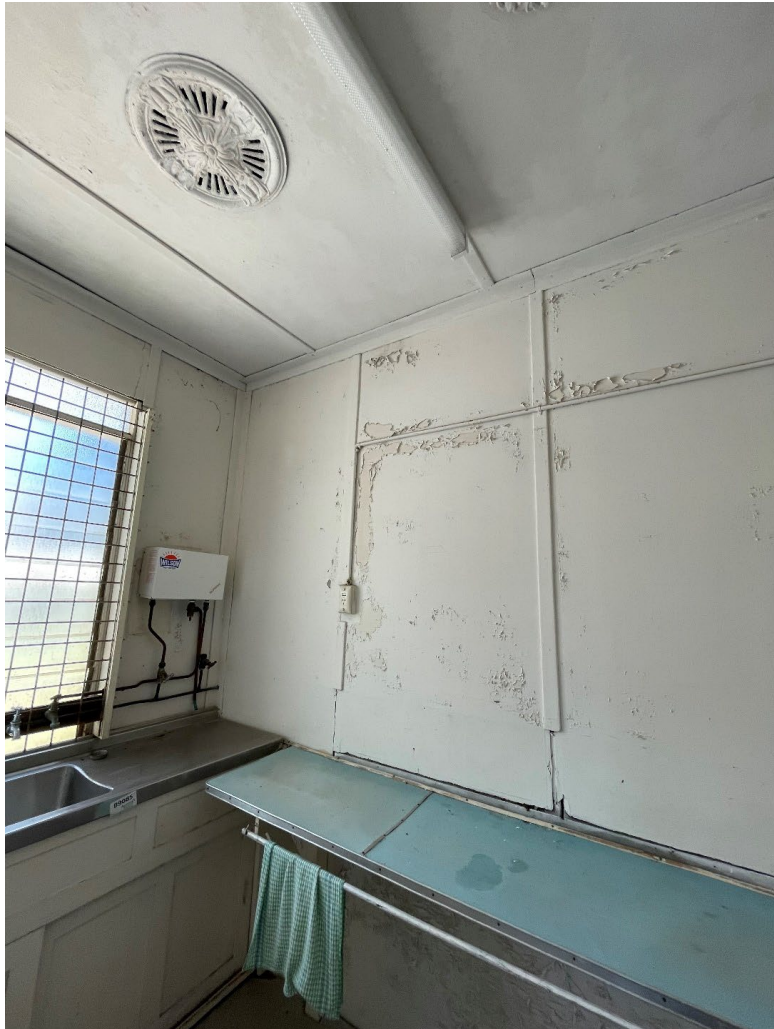
Figure 36: Kitchen

- Flat roof addition
- Ceiling rose
- Outdated fixtures

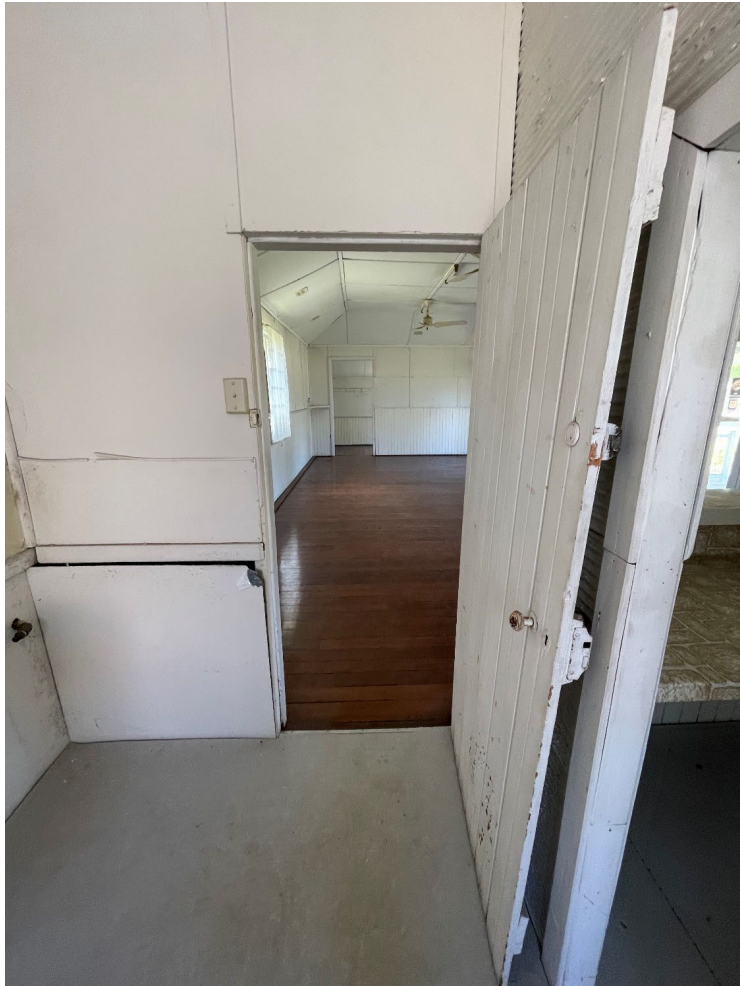
Figure 38: View to Clubroom Pavilion space from kitchen

- Vinyl floorcoverings over timber flooring

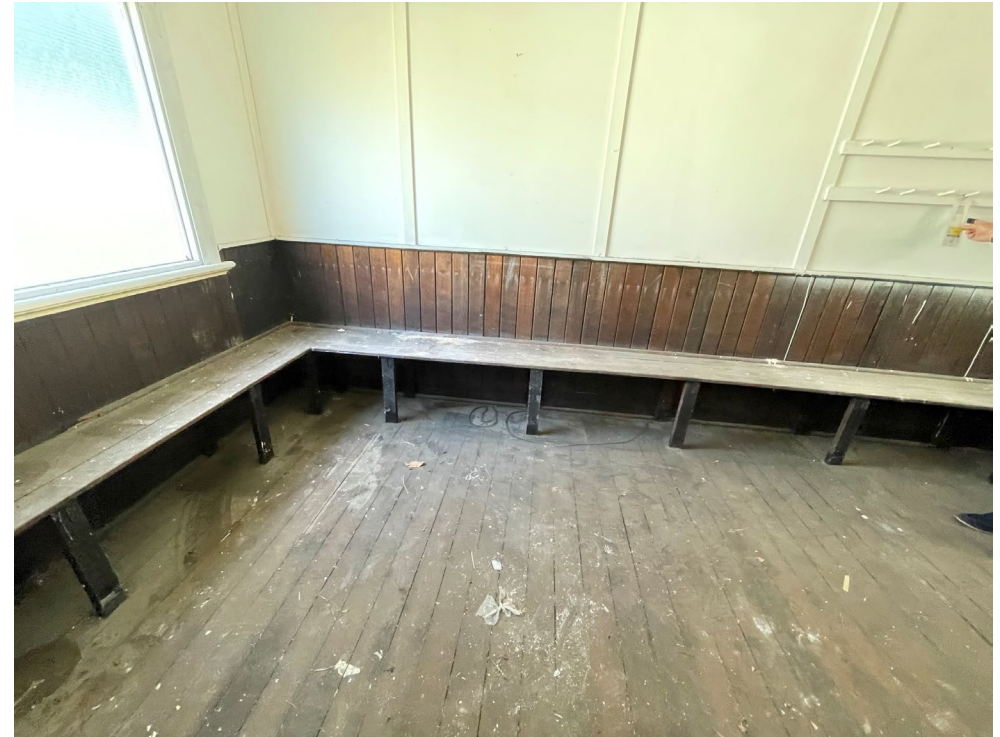
Figure 39: Croquet Equipment Store

- Original timber floors and dado panelling

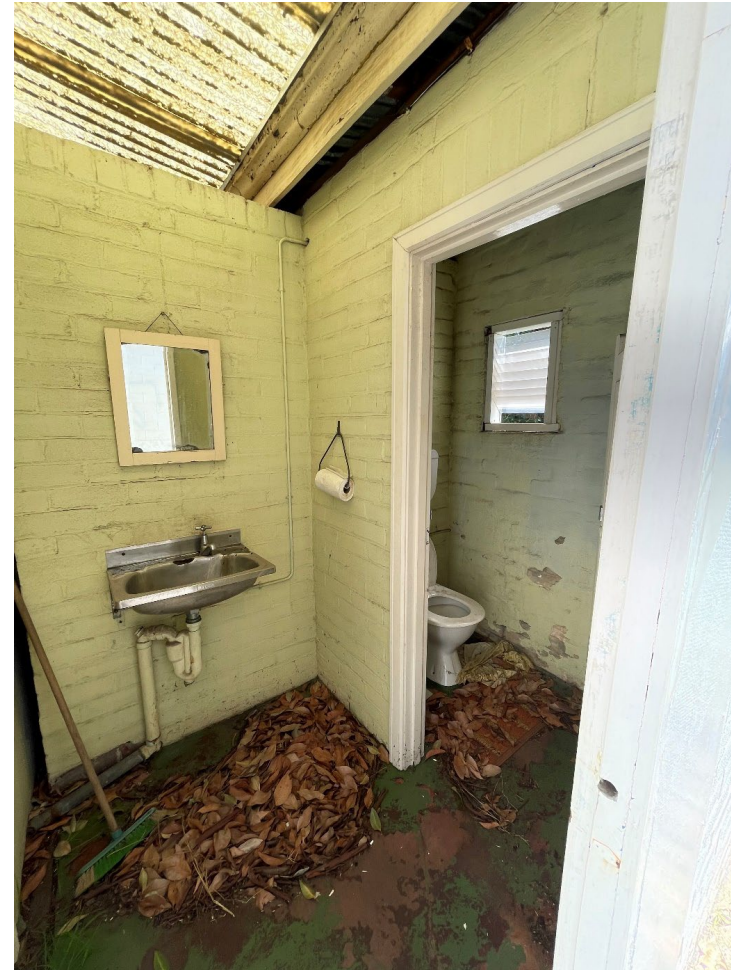
Figure 43: Typical view of brick toilet

- No heritage value
