**Additional Geotechnical
Investigation for Causeway
Pedestrian and Cyclist Bridge:
Factual Report
Causeway Link Alliance**

Document No: C301-CLA-0000-GE-REP-00003

This report presents the factual field and laboratory geotechnical results obtained during the Phase 2 Ground Investigation (GI) carried out to inform the detailed design of the Causeway Pedestrian and Cyclist Bridge (CPCB) project.

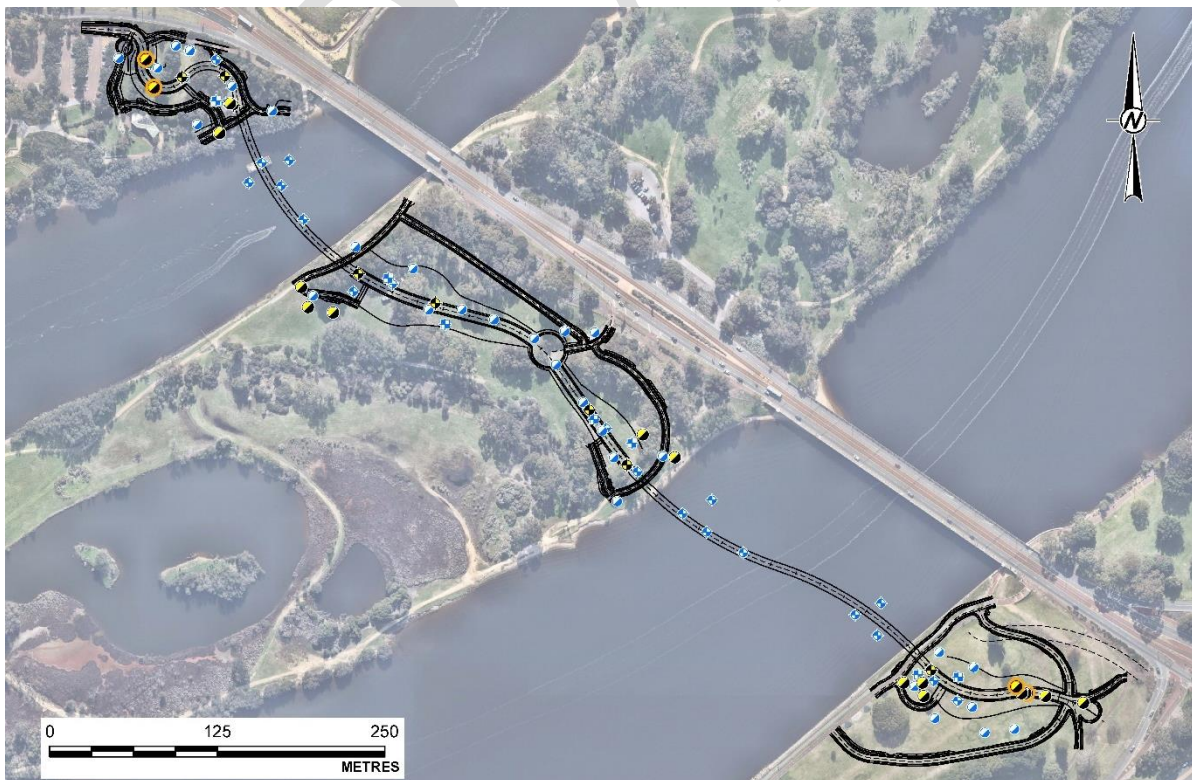
Figure 1: Phase 1 and 2 Investigation Test Locations

Figure 1 shows the Phase 1 and 2 investigation location relative to the CPCB alignment. Drawings SK01A to SK01C (presented after text) present the CPCB alignment and Phase 1 and 2 GI test locations.

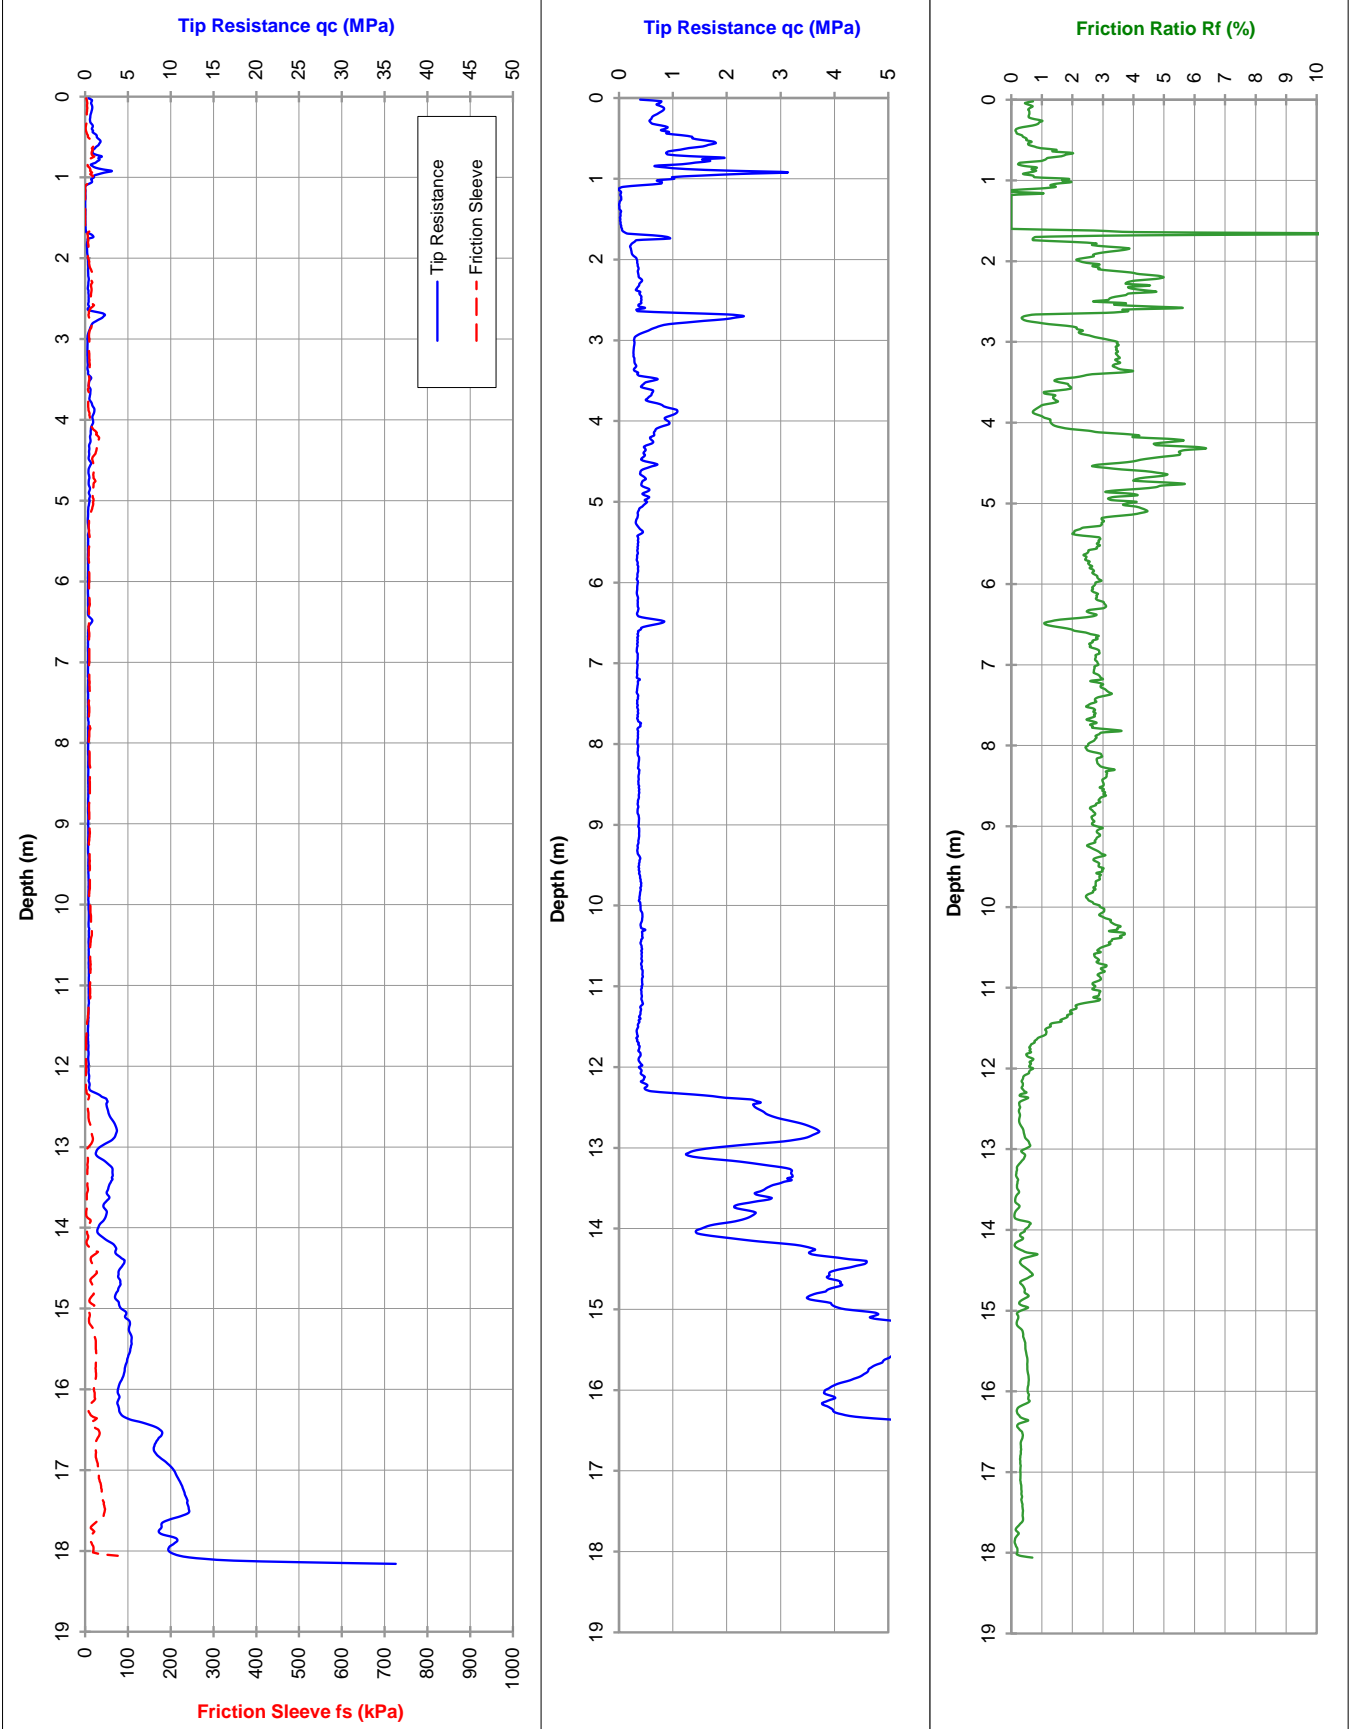
CPT 03

Tested in accordance with AS 1289.6.5.1-1999 and IRTF 2001 for friction reducer

Approx. water (m): 1.3

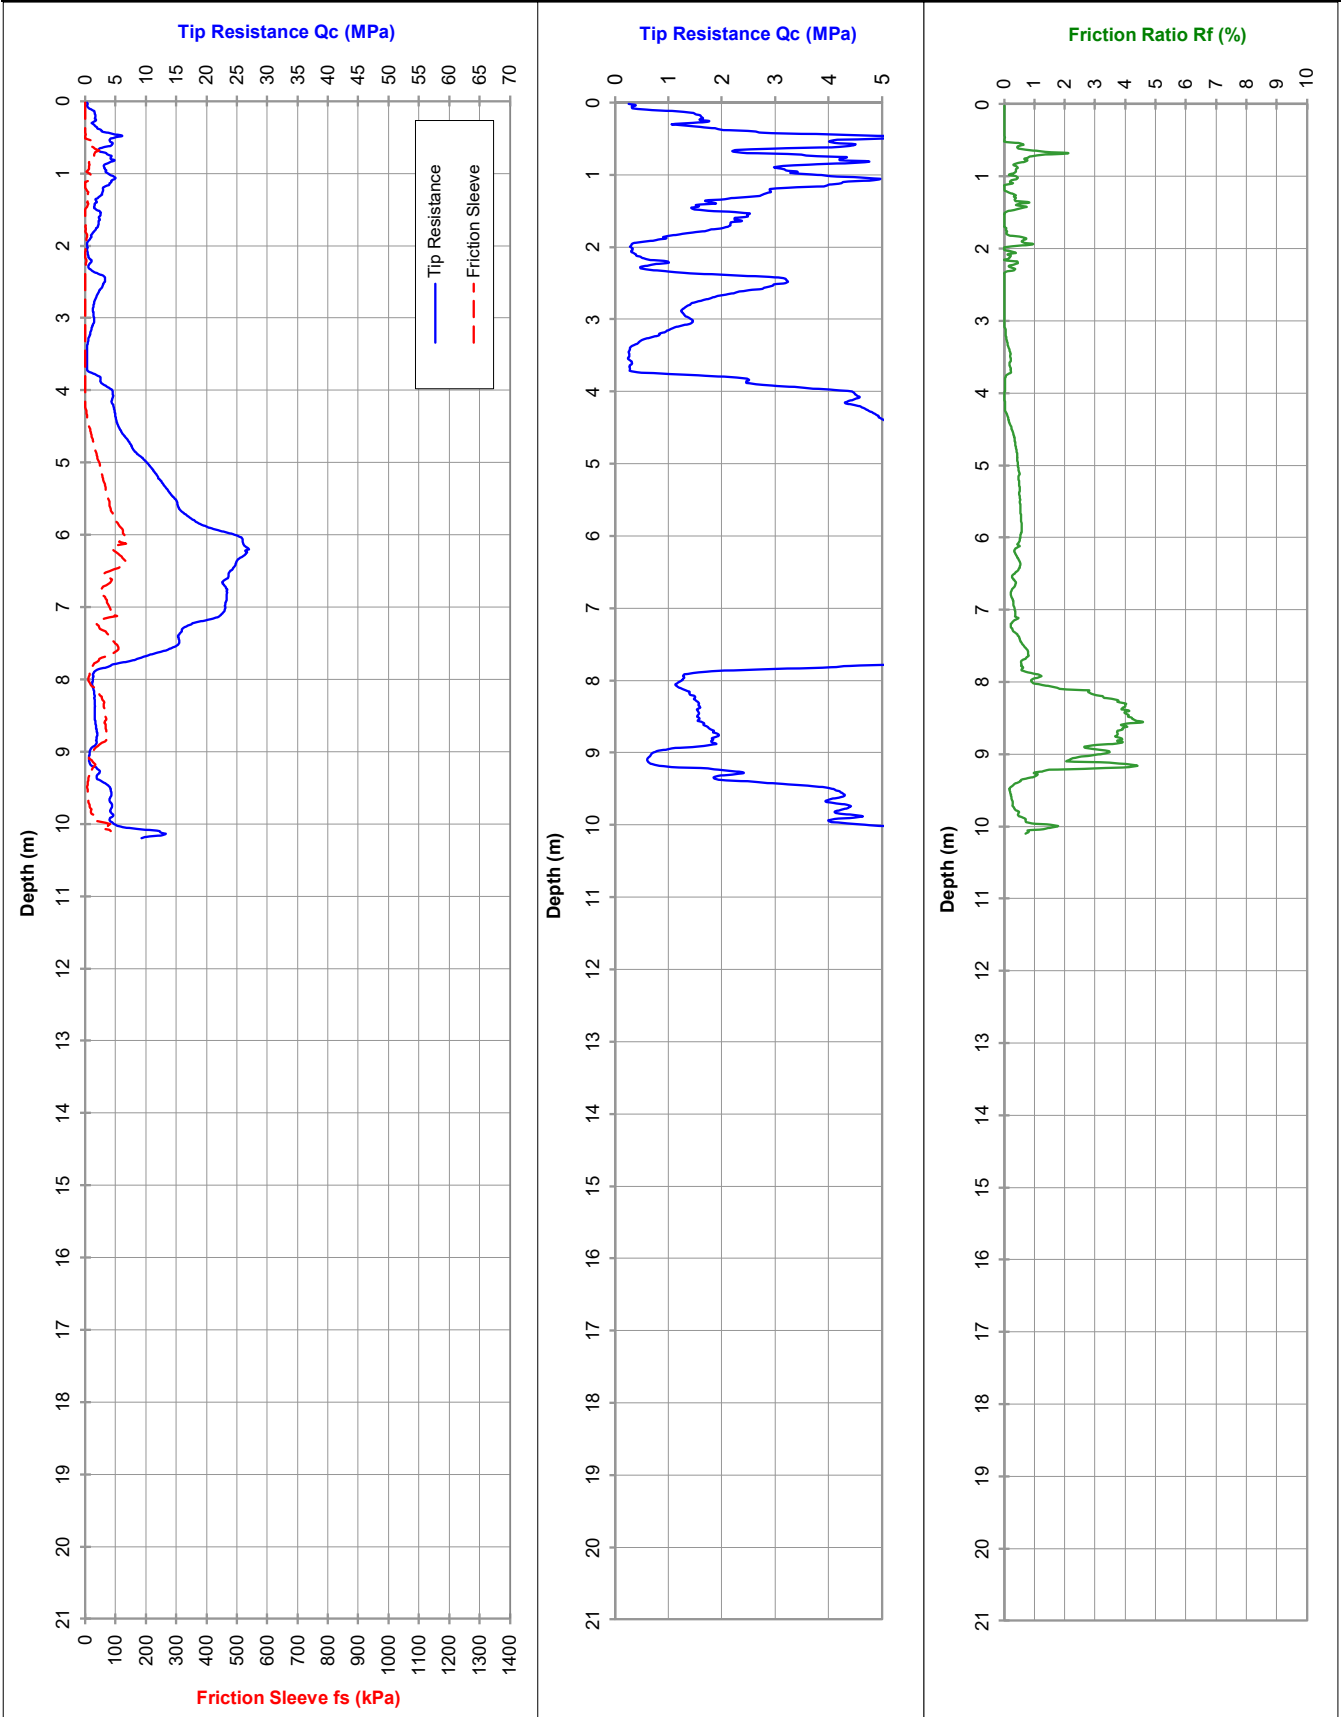
**CPCB-
CPT 11**

Tested in accordance with AS 1289.6.5.1-1999 and IRTF 2001 for friction reducer

Approx. water (m): 1.2

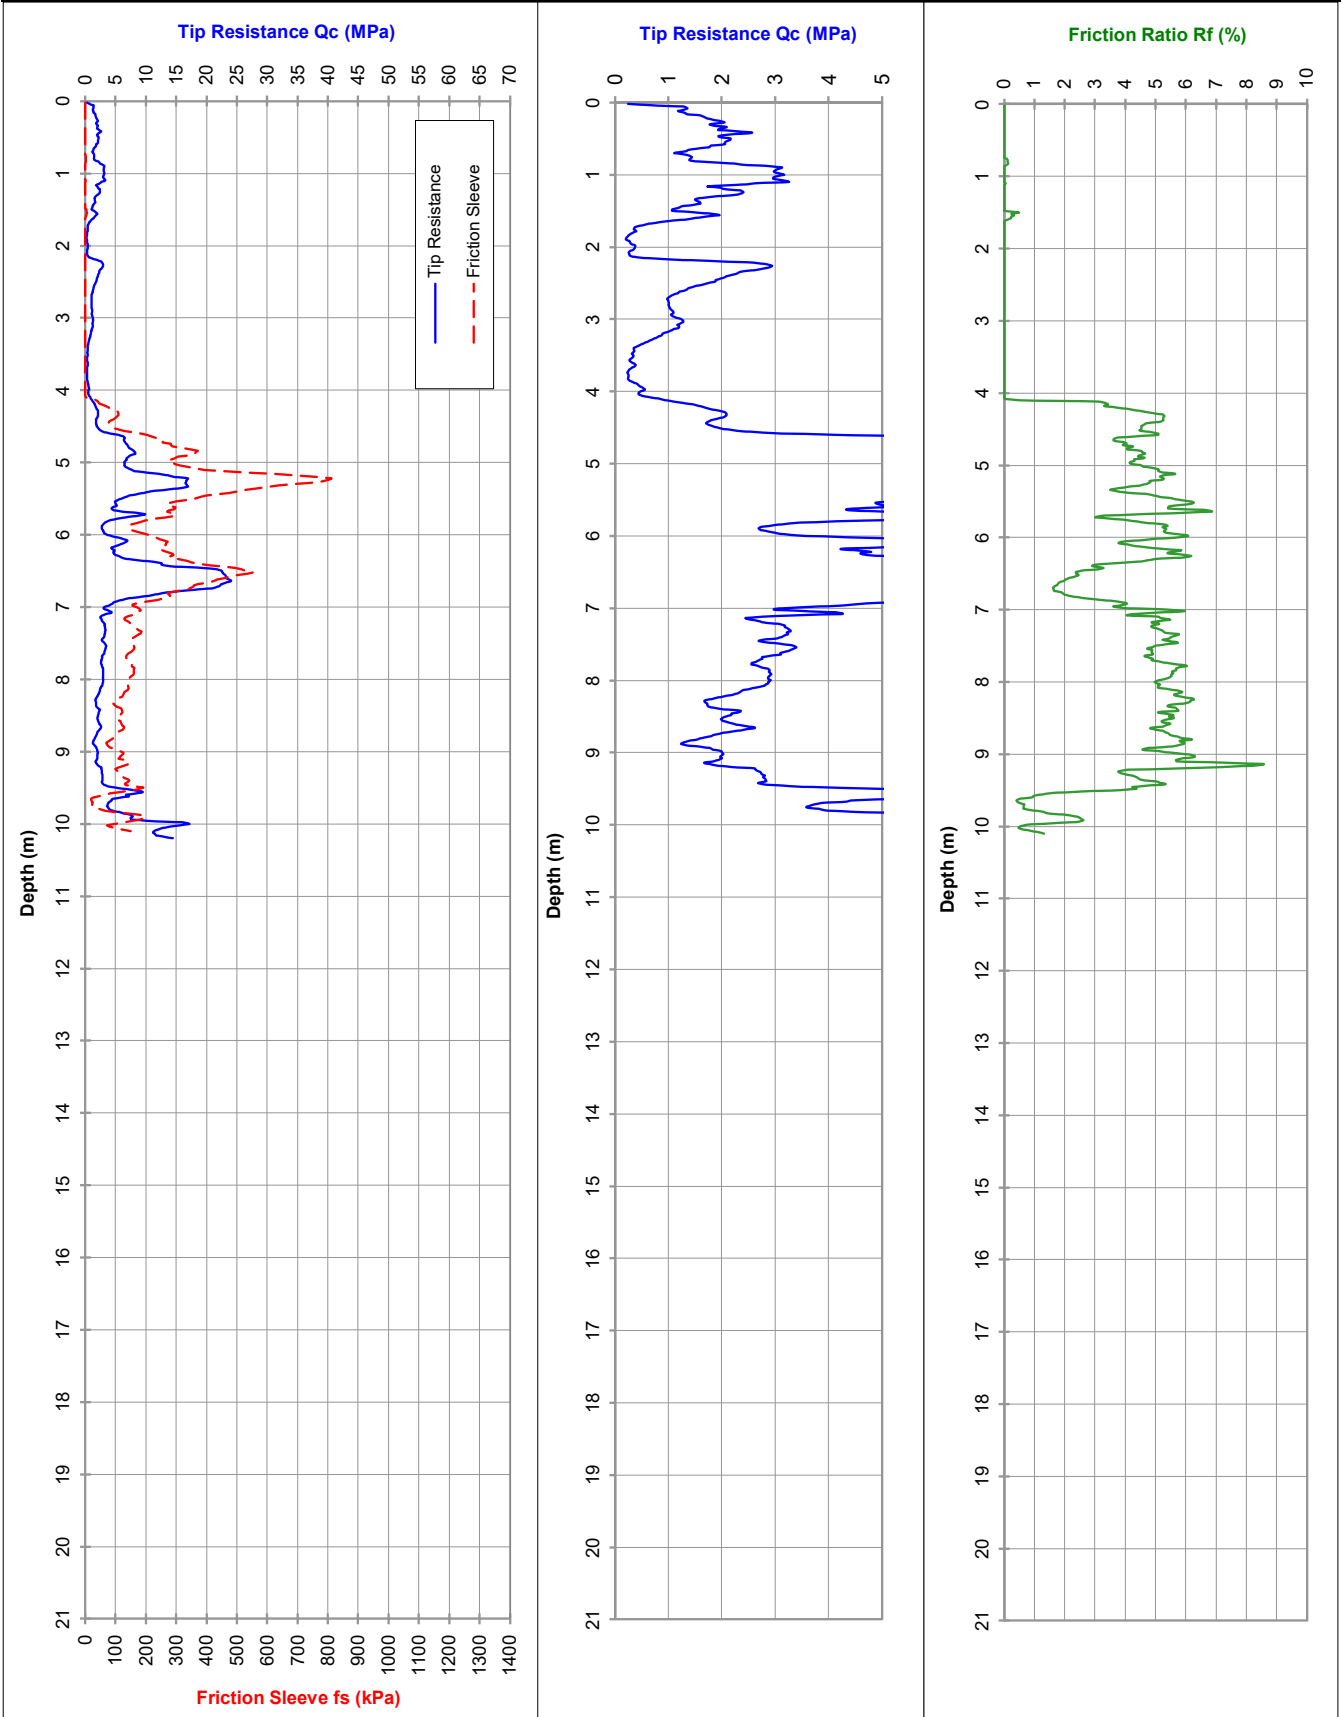
**CPCB-
CPT 12**

Tested in accordance with AS 1289.6.5.1-1999 and IRTF 2001 for friction reducer

Approx. water (m): 1.3

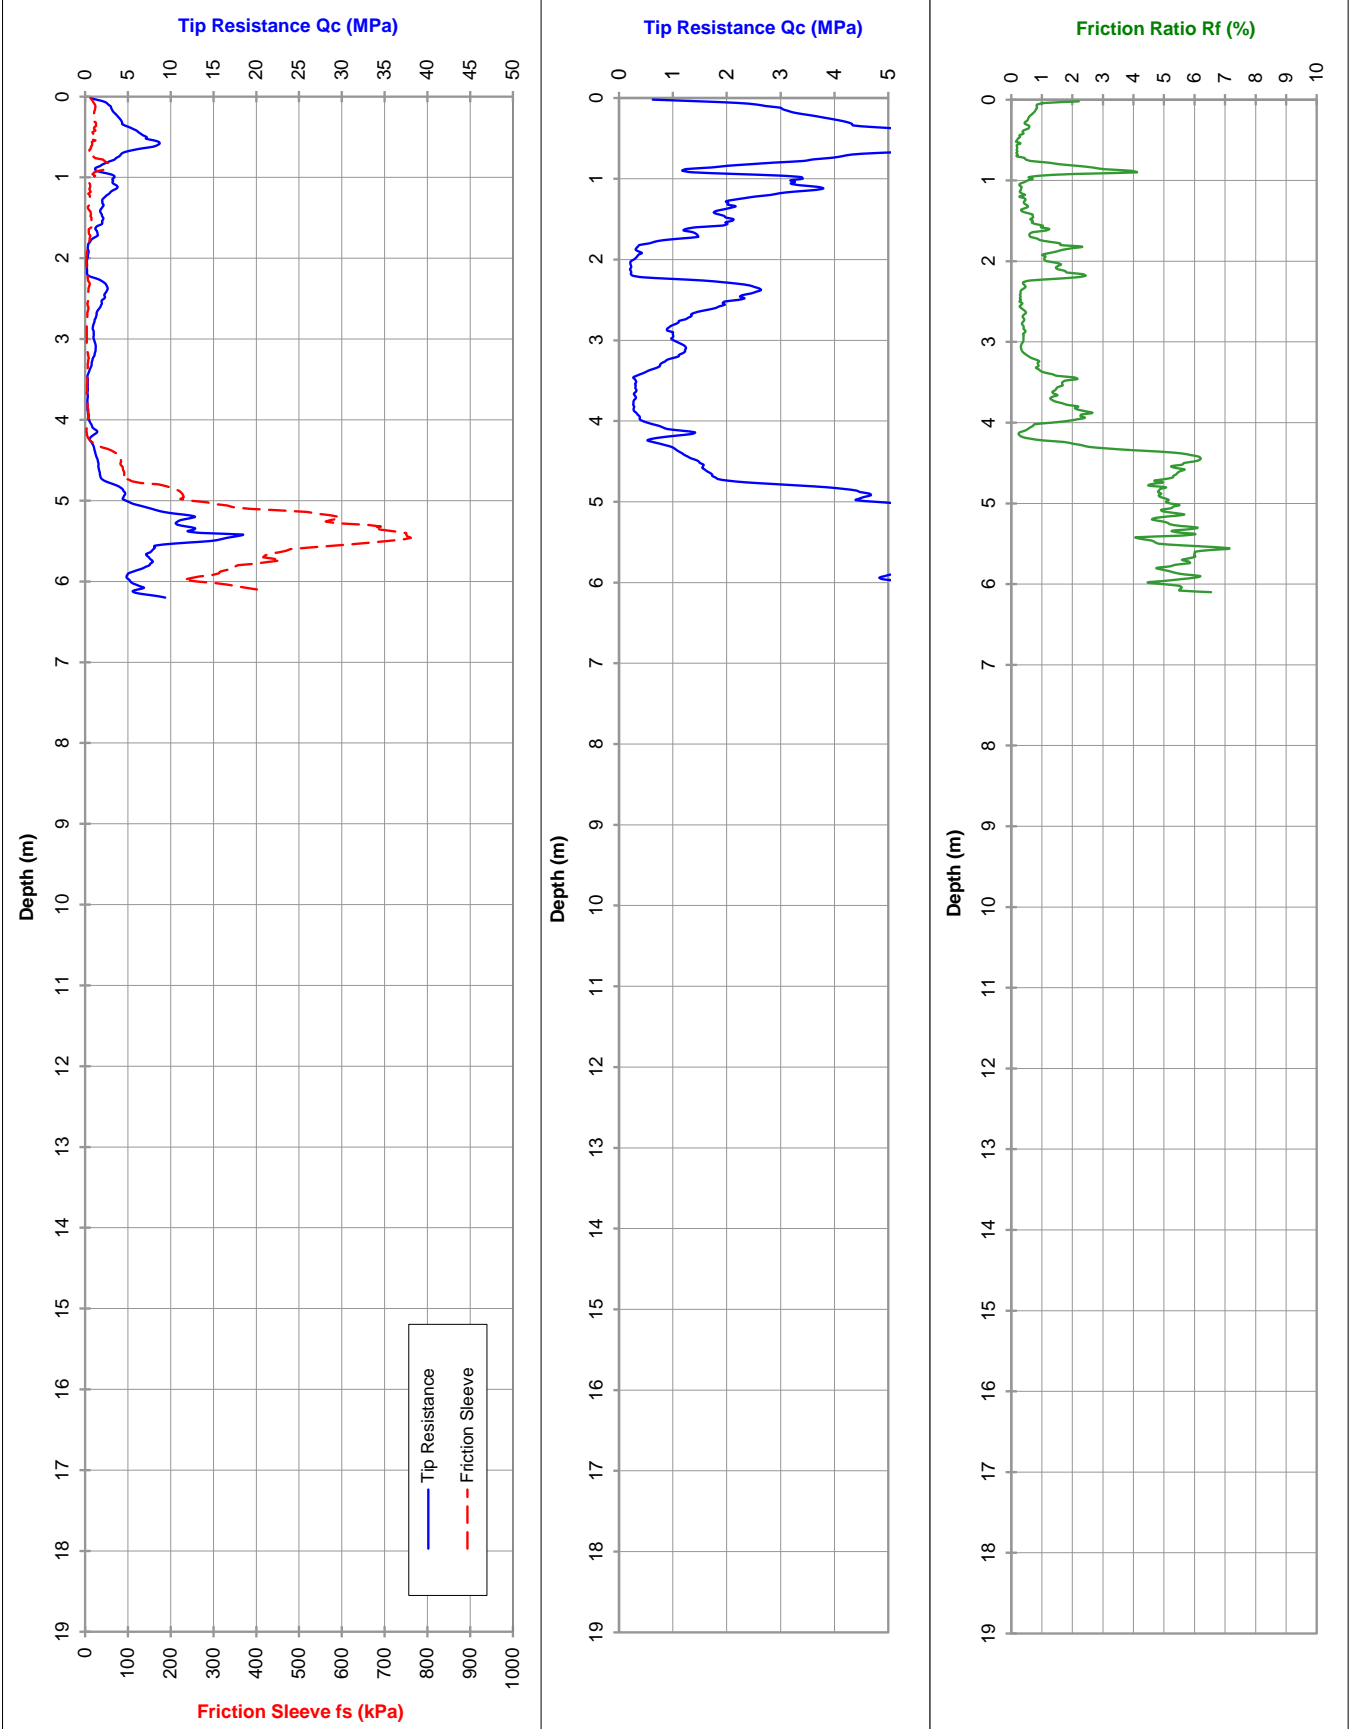
CPT 12A

Tested in accordance with AS 1289.6.5.1-1999 and IRTP 2001 for friction reducer

Approx. water (m): 0.9

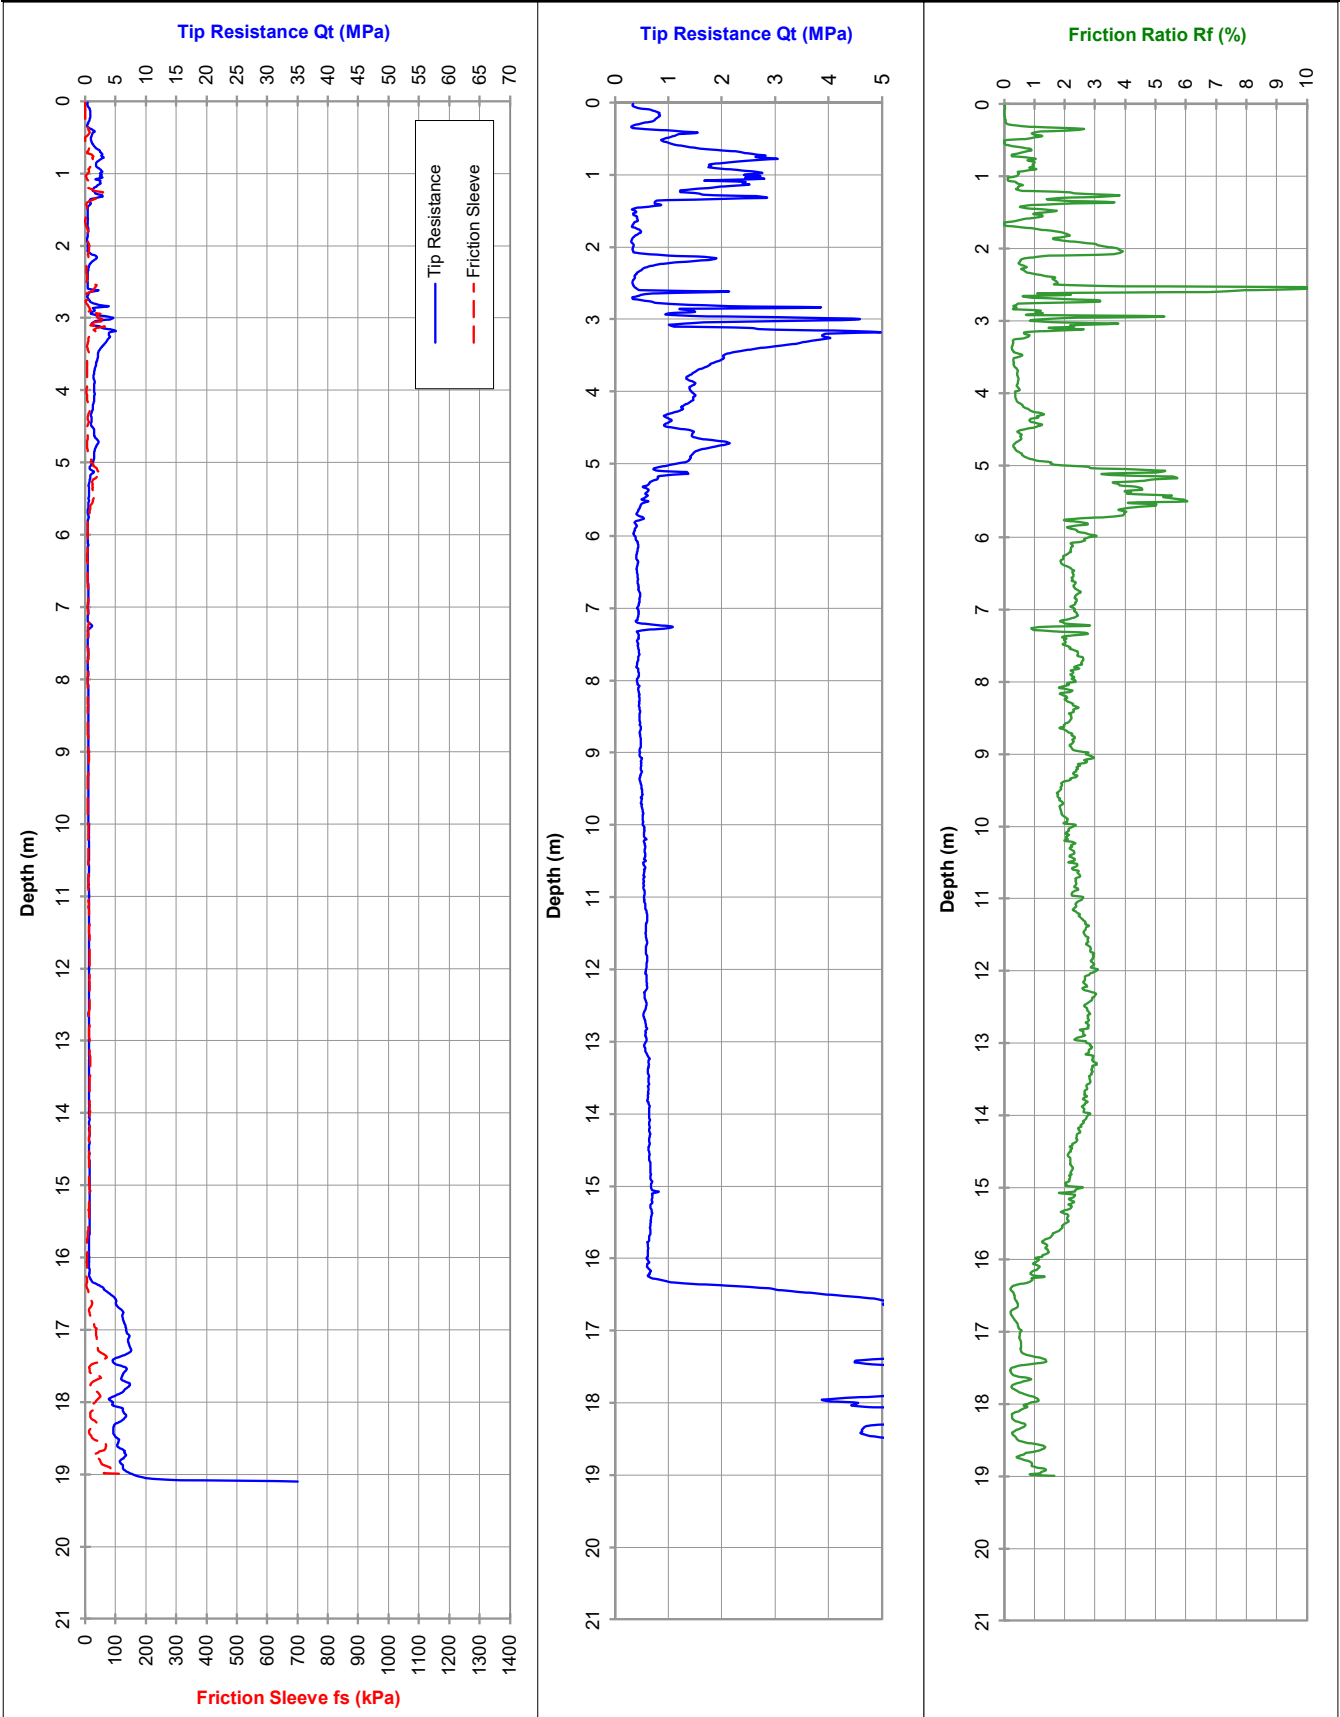
Probe I.D
**CPCB-
 CPTU 02**
 05-Jul-22

Tested in accordance with AS 1289.6.5.1-1999 and IRTF 2001 for friction reducer

Approx. water (m): 1.6
 Vacuum Holed to (m): 2.0 Back Filled
 Refusal: 35 MPa

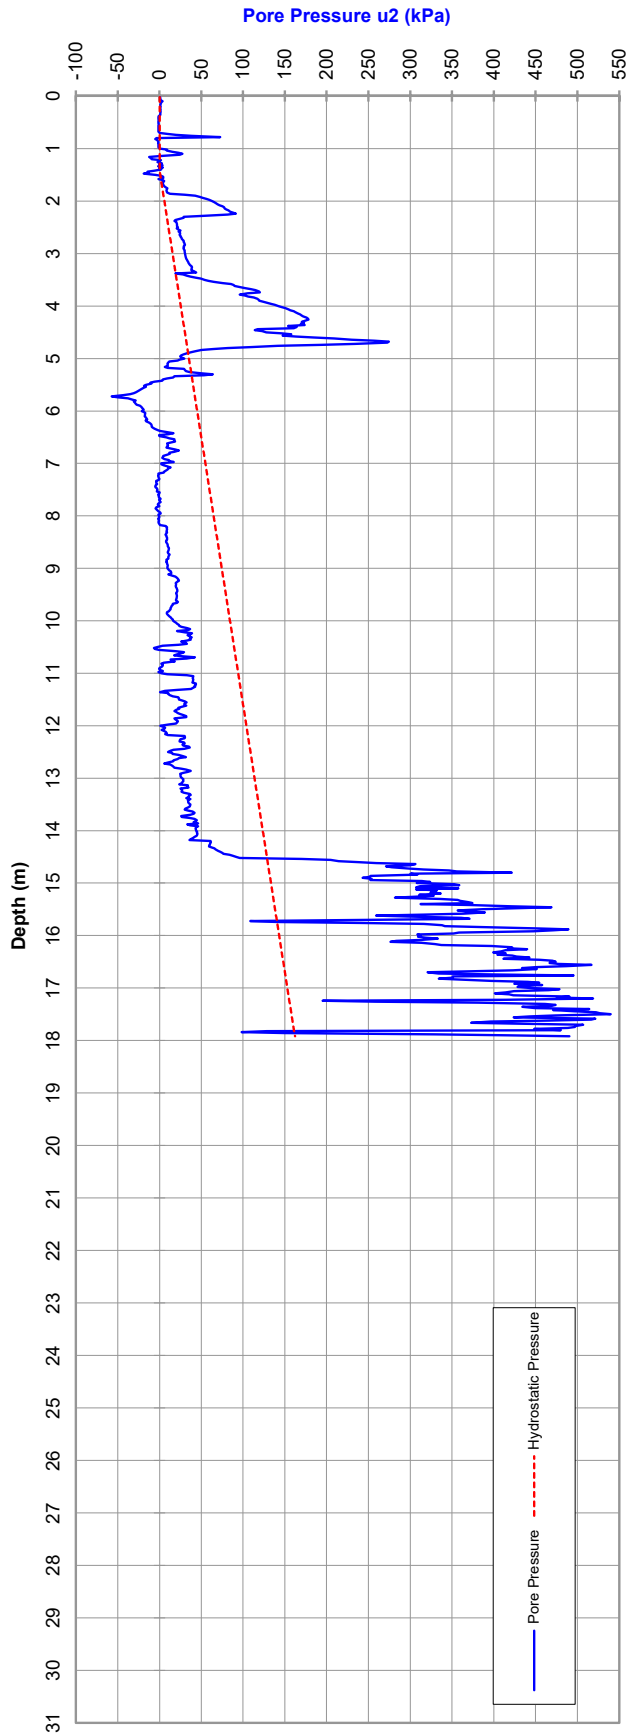
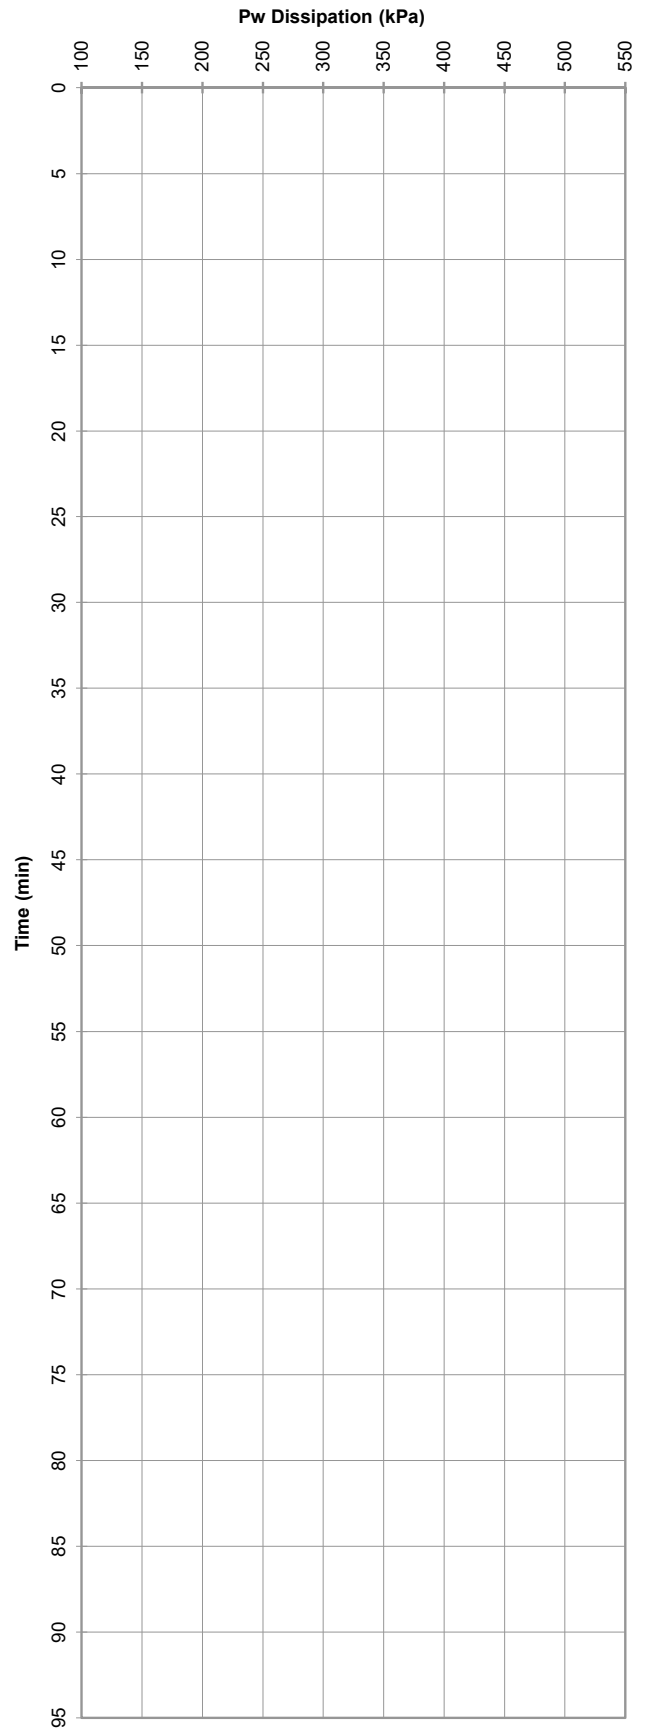
**CPCB-
CPTU06B**
24-Jun-22

Tested in accordance with AS 1289.6.5.1-1999 and IRTP 2001 for friction reducer

Please note: Hydrostatic Line is taken from the water level manually dipped by the CPT Operator following completion of the probe and, as such, should be used as a guide only.

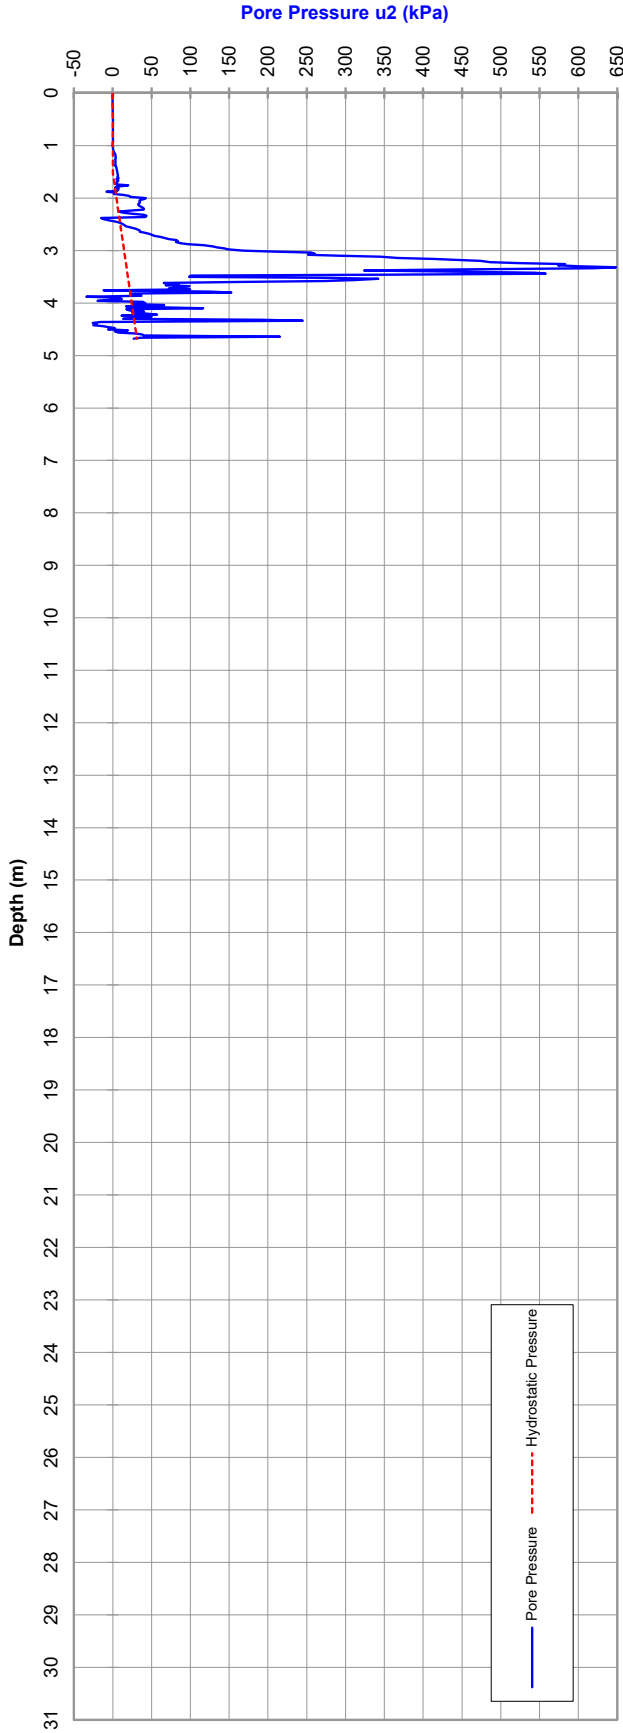
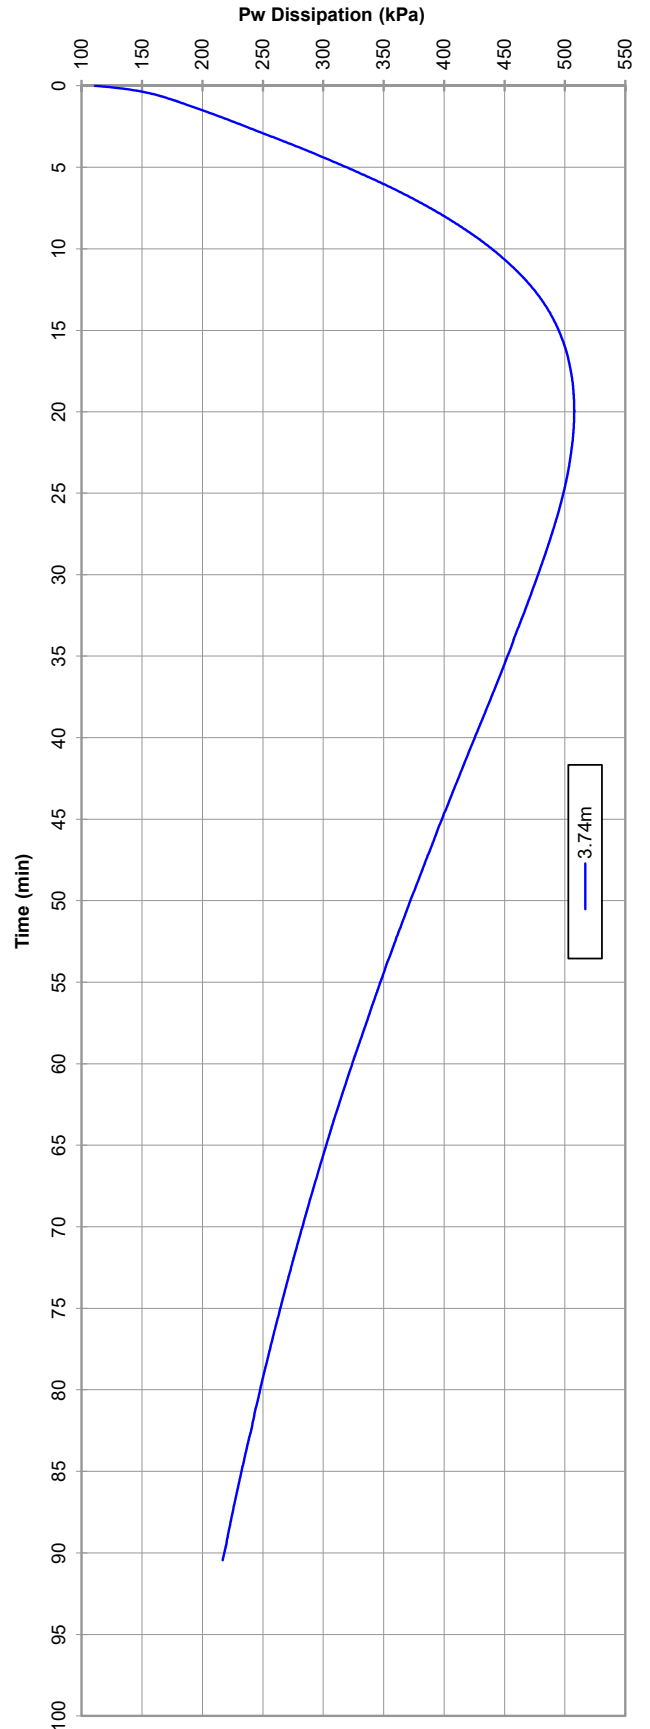
**CPCB-
CPTU07**
 23-Jun-22

Tested in accordance with AS 1289.6.5.1-1999 and IRTP 2001 for friction reducer

Please note: Hydrostatic Line is taken from the water level manually dipped by the CPT Operator following completion of the probe and, as such, should be used as a guide only.

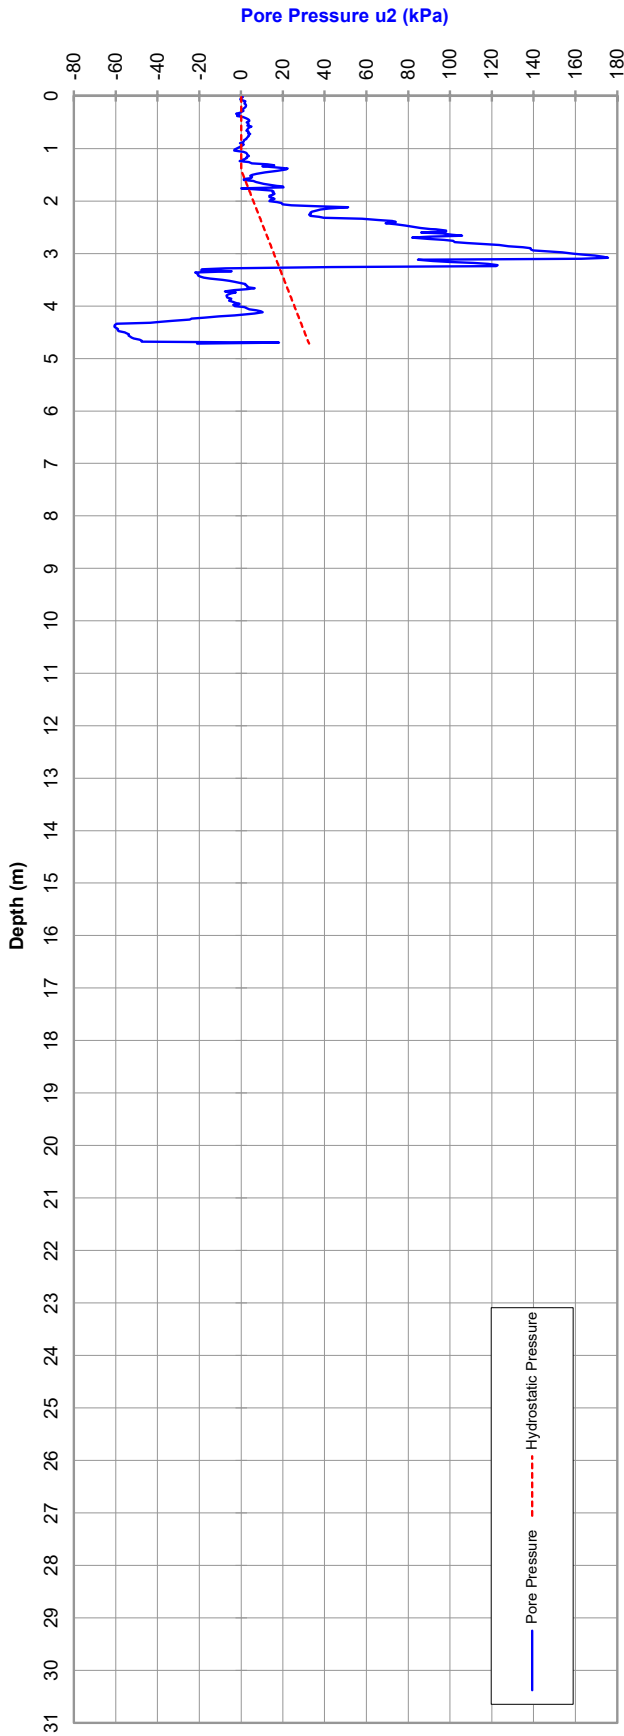
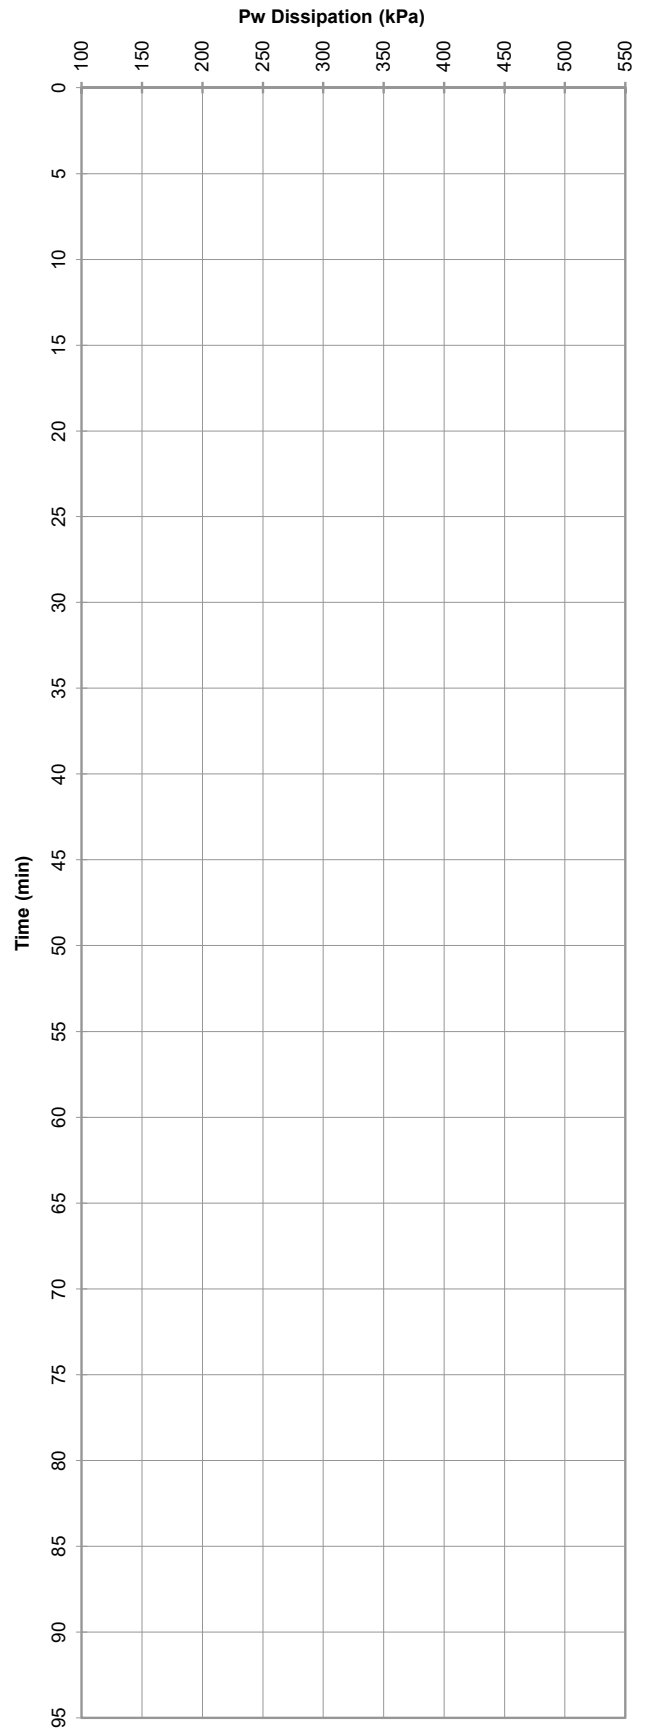
**CPCB-
CPTU07B**
24-Jun-22

Tested in accordance with AS 1289.6.5.1-1999 and IRTP 2001 for friction reducer

Please note: Hydrostatic Line is taken from the water level manually dipped by the CPT Operator following completion of the probe and, as such, should be used as a guide only.

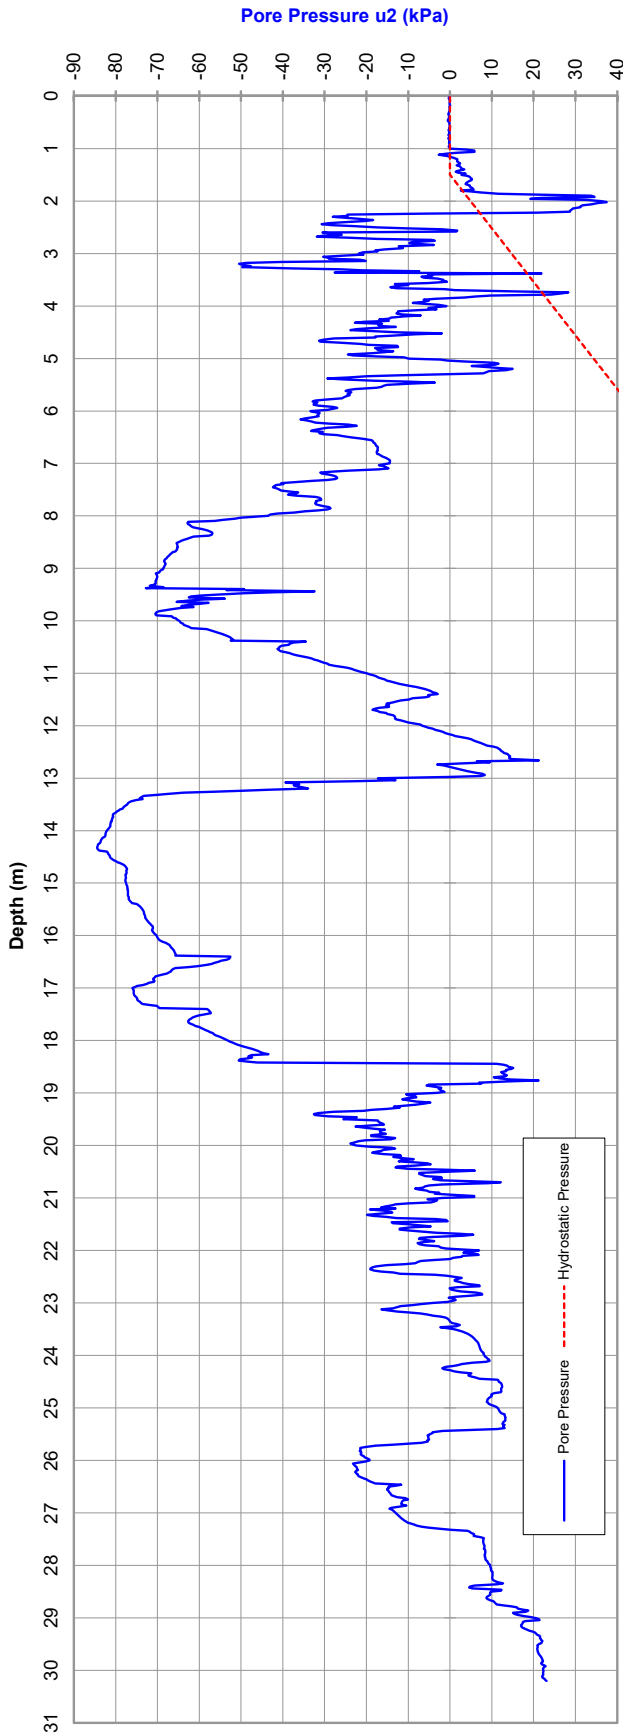
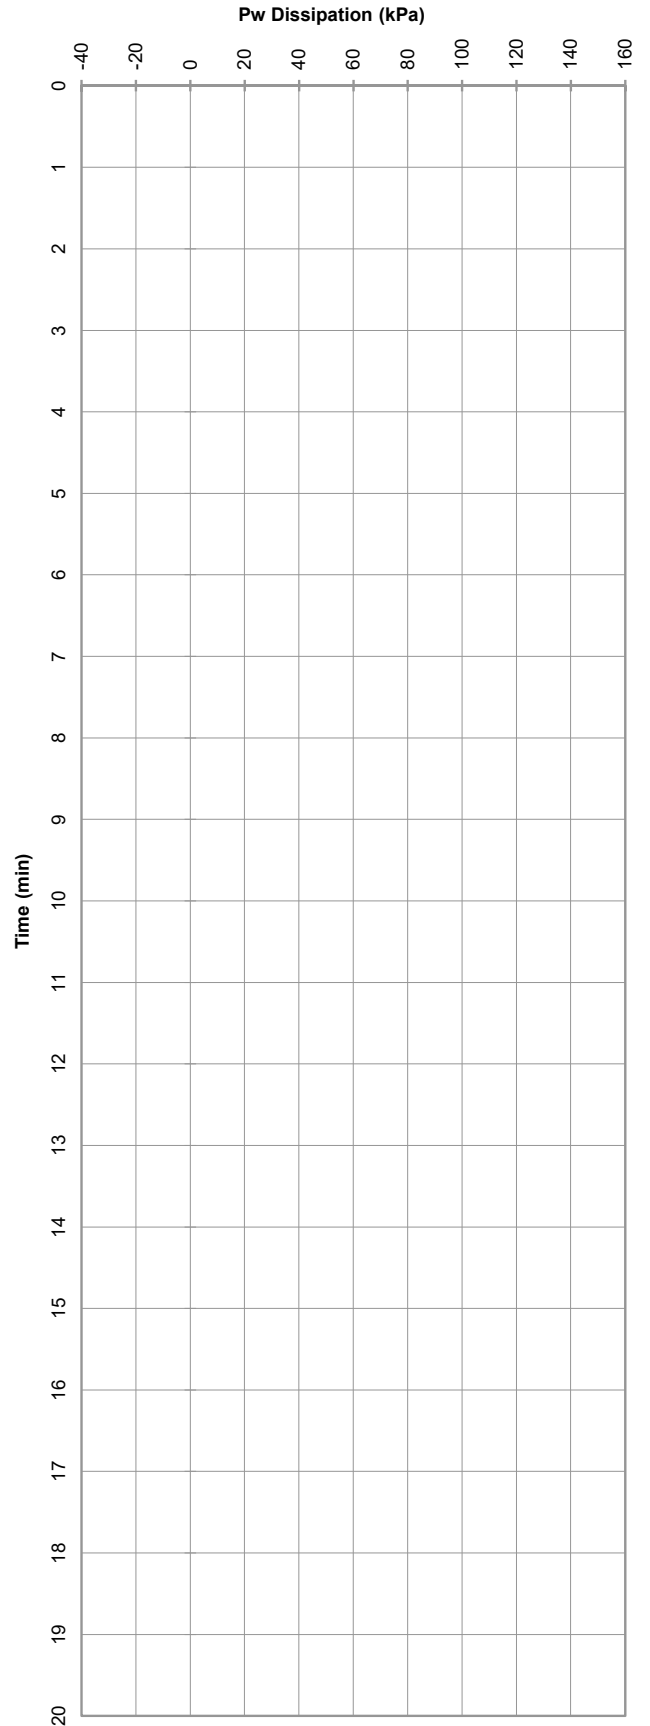
**CPCB-
CPTU09**
23-Jun-22

ELECTRIC FRICTION-CONE PENETROMETER

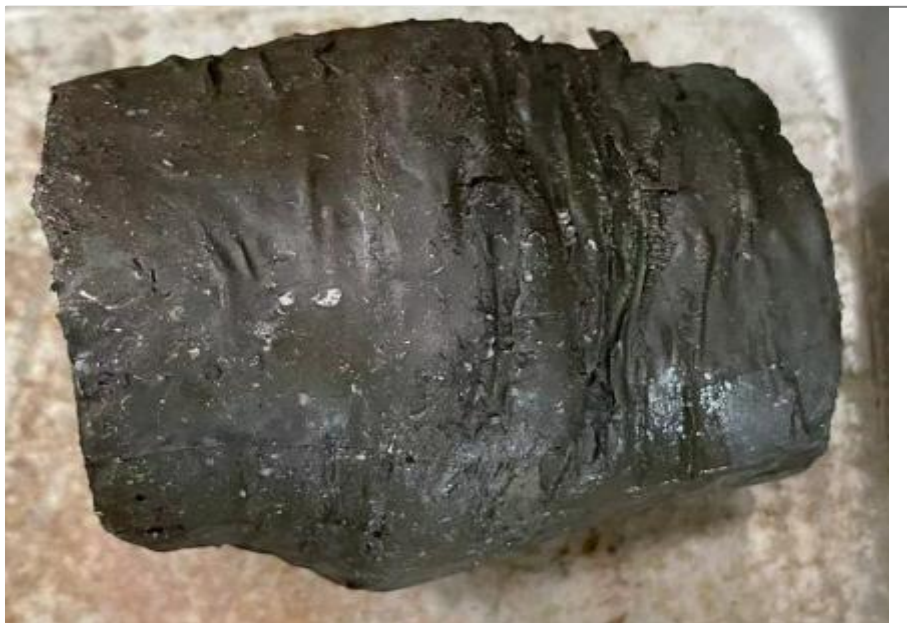
Sample ID:	CPCB-BH06	Depth (m):	8.00 - 8.45
Lab ID:	LPER202207194_CU1	Date Tested:	02-07/08/2022

Failure Mode: **Bulging Failure**

Notes: Sample collected from Shelby Tube
