**Additional Geotechnical
Investigation for Causeway
Pedestrian and Cyclist Bridge:
Factual Report
Causeway Link Alliance**

Document No: C301-CLA-0000-GE-REP-00003

This report presents the factual field and laboratory geotechnical results obtained during the Phase 2 Ground Investigation (GI) carried out to inform the detailed design of the Causeway Pedestrian and Cyclist Bridge (CPCB) project.

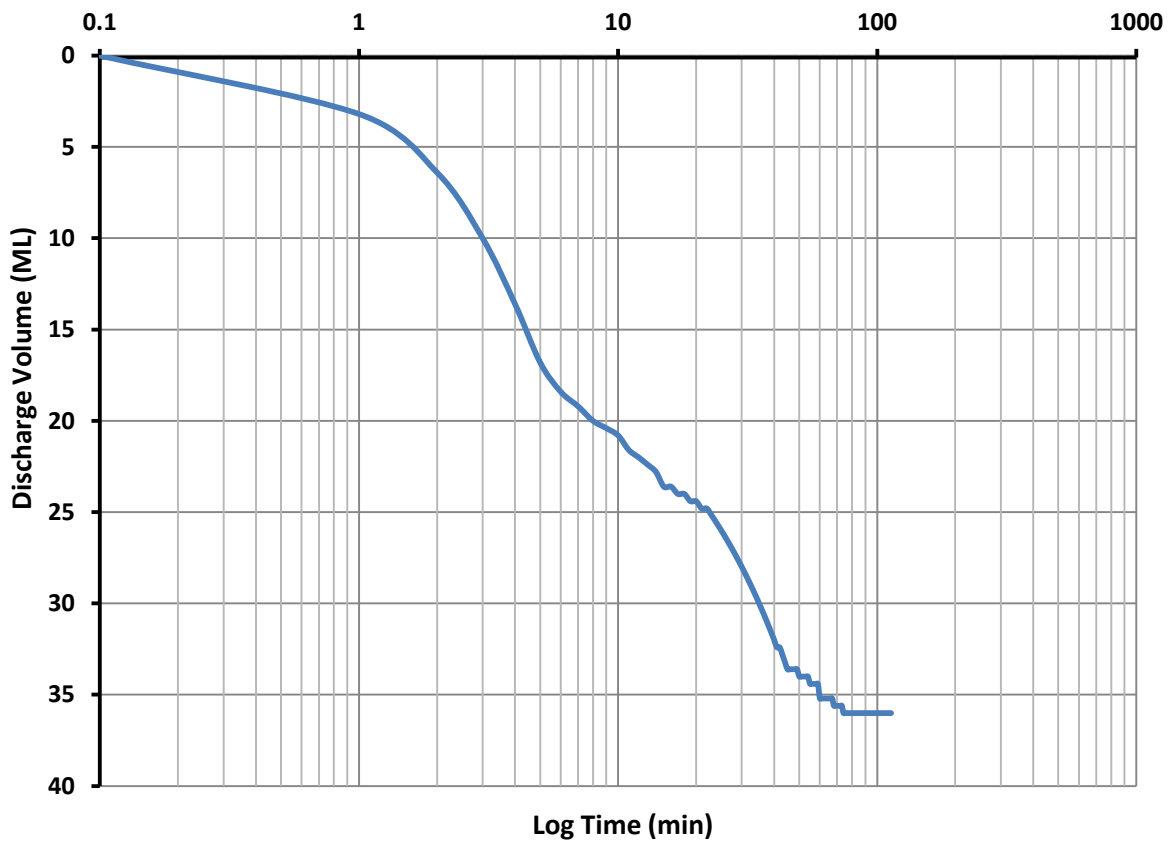
Discharge Volume (ML) Vs Log Time (min)

C_v (cm²/s): 0.018 based on **t₉₀**

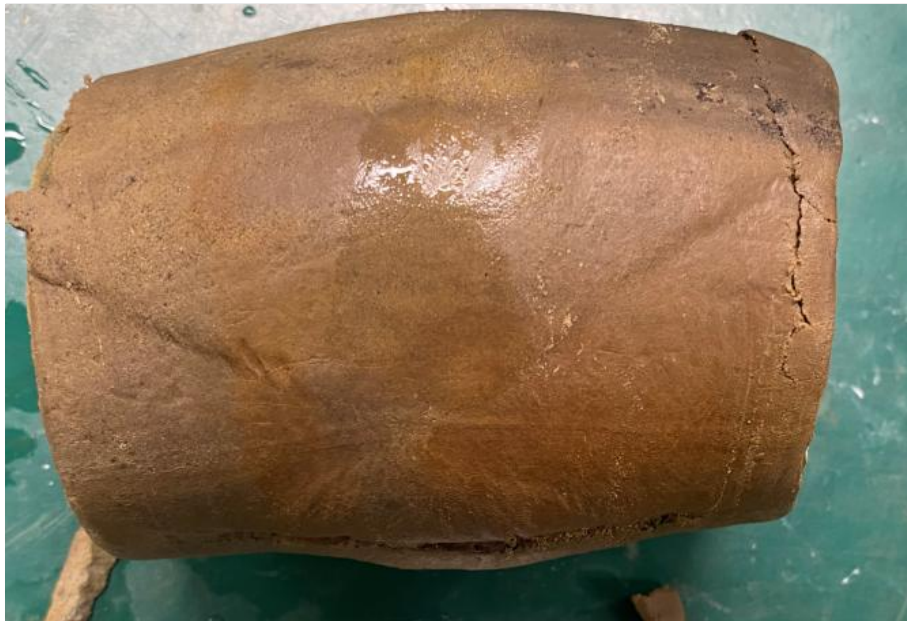
Sample ID: CPCB-BH06	Depth (m): 12.50 - 12.95
Lab ID: LPER202207195_CU1	Date Tested: 02-07/08/2022

Failure Mode: Shear Failure to Vertical @ 37.3°

Notes: Sample collected from Shelby Tube

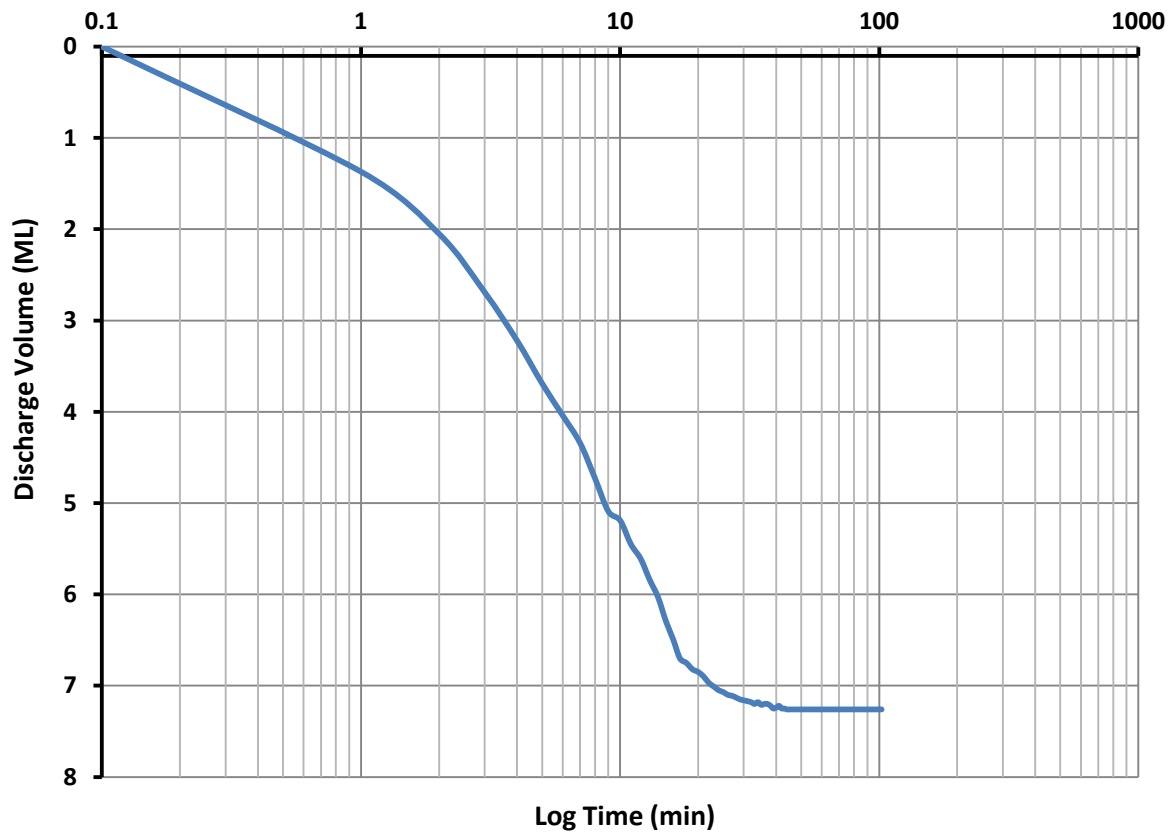
Discharge Volume (ML) Vs Log Time (min)

Cv (cm²/s): 0.201 based on **t₉₀**
