Elizabeth Baillie

Review of Tree Removal and Tree Management Practices

TOWN OF
VICTORIA PARK

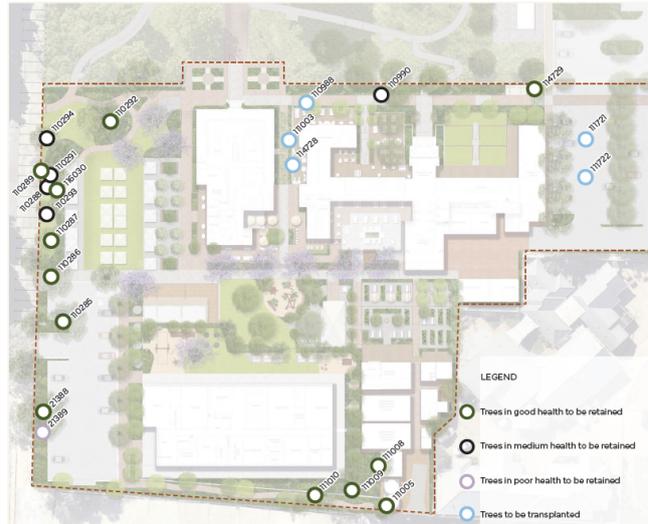
Tree retention plan

The Town of Victoria Park Tree Audit (July 2023) determined which trees were worthy of protecting and which trees were of lower retention value that can be potentially removed. Some trees with high and medium retention value are earmarked for removal due to their proximity to proposed infrastructure (buildings, car parks etc)

Below is a summary of the report for trees to be retained:

Health value	Total trees to be retained
Trees in good health to be retained	12 total
Trees in fair health to be retained	5 total
Trees in poor health to be retained	1 total
Trees to be transplanted	5 total

Tree ID number	Species	Health value
T0285	Pinus radiata	Good
T0286	Pinus radiata	Good
T0287	Melaleuca lanceolata	Good
T0288	Melaleuca lanceolata	Fair
T0289	Melaleuca lanceolata	Good
T0291	Callitris prelessi	Fair
T0292	Ficus rubiginosa	Good
T0293	Acacia tree-phylla	Fair
T0294	Melaleuca lanceolata	Fair
T0298	Plumeria species	Good
T0299	Erythrina sylvae	Fair
T0303	Plumeria species	Fair
T0305	Callitemon Kings Park Special	Good
T0306	Argophora costata	Good
T0309	Eucalyptus camadulensis var. camadulensis	Good
T0310	Corymbia citriodora	Good
T0721	Jacaranda mimosifolia	Good
T0722	Jacaranda mimosifolia	Good
T0728	Plumeria species	Good
T0729	Melia azedarach	Good
T0030	Eucalyptus species	Good
T1388	Corymbia maculata	Good
T1389	Acacia saligna	Poor

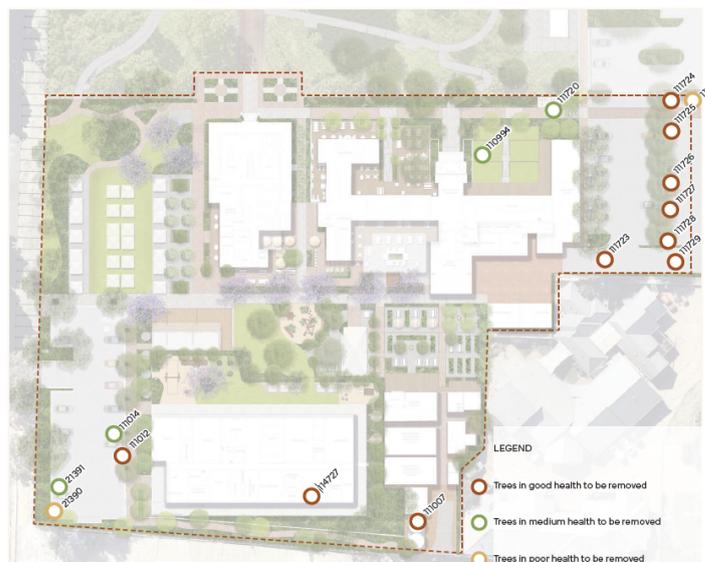
Tree removal plan

This diagram represents the existing trees proposed to be removed, noting that some trees with high and medium retention value are earmarked for removal due to their proximity to proposed infrastructure (buildings, car parks etc)

Below is a summary of the arborists report for trees to be removed:

Health value	Total trees to be removed
Trees in good health to be removed	10 total
Trees in fair health to be removed	4 total
Trees in poor health to be removed	2 total

Tree ID number	Species	Health value
T0994	Cupressus species	Fair
T0007	Corymbia calophylla	Good
T0012	Pinus radiata	Good
T0014	Acacia saligna	Fair
T0117	Callitris prelessi	Poor
T0120	Melia azedarach	Fair
T0123	Agonis flexuosa	Good
T0124	Lophostemon confertus	Good
T0125	Lophostemon confertus	Good
T0126	Lophostemon confertus	Good
T0127	Lophostemon confertus	Good
T0128	Lophostemon confertus	Good
T0129	Lophostemon confertus	Good
T0427	Corymbia citriodora	Good
T1390	Lophostemon confertus	Poor
T1391	Eucalyptus casia	Fair

It should be noted that there is a discrepancy in this plan between the list and the diagram. The list of trees for removal and the summary table states 16 trees were to be removed compared with 17 trees in the accompanying diagram.

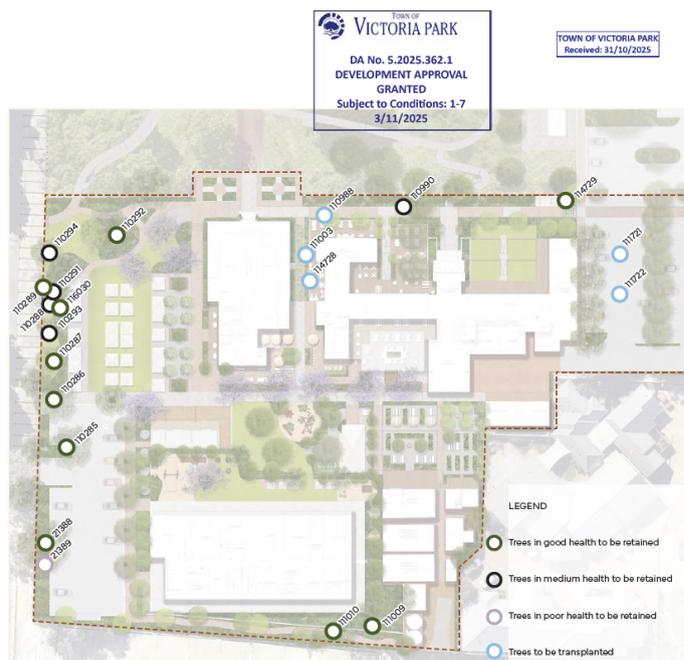
Tree retention plan

The Town of Victoria Park Tree Audit (July 2023) determined which trees were worthy of protecting and which trees were of lower retention value that can be potentially removed. Some trees with high and medium retention value are earmarked for removal due to their proximity to proposed infrastructure (buildings, car parks etc)

Below is a summary of the report for trees to be retained.

Health value	Total trees to be retained
Trees in good health to be retained	12 total
Trees in fair health to be retained	5 total
Trees in poor health to be retained	1 total
Trees to be transplanted	5 total

Tree ID number	Species	Health value
110286	<i>Platanus occidentalis</i>	Good
110287	<i>Platanus occidentalis</i>	Good
110288	<i>Melaleuca lanceolata</i>	Good
110289	<i>Melaleuca neophylla</i>	Fair
110290	<i>Melaleuca lanceolata</i>	Good
110291	<i>Callitris preissii</i>	Fair
110292	<i>Ficus religiosa</i>	Good
110293	<i>Acacia neophylla</i>	Fair
110294	<i>Melaleuca lanceolata</i>	Fair
110295	<i>Plumeria species</i>	Good
110296	<i>Erythrina speciosa</i>	Fair
110300	<i>Plumeria species</i>	Fair
110309	<i>Eucalyptus camaldulensis</i> var. <i>camaldulensis</i>	Good
110310	<i>Corymbia citriodora</i>	Good
110321	<i>Jacaranda mimosaefolia</i>	Good
110322	<i>Jacaranda mimosaefolia</i>	Good
110323	<i>Plumeria species</i>	Good
110324	<i>Melia azedarach</i>	Good
110390	<i>Eucalyptus species</i>	Good
21888	<i>Corymbia maculata</i>	Good
21889	<i>Acacia saligna</i>	Poor

*Tree ID's 110286 / 110286 as tabled above were assessed with a GOOD health value in 2023 but have subsequently died as of October 2025.

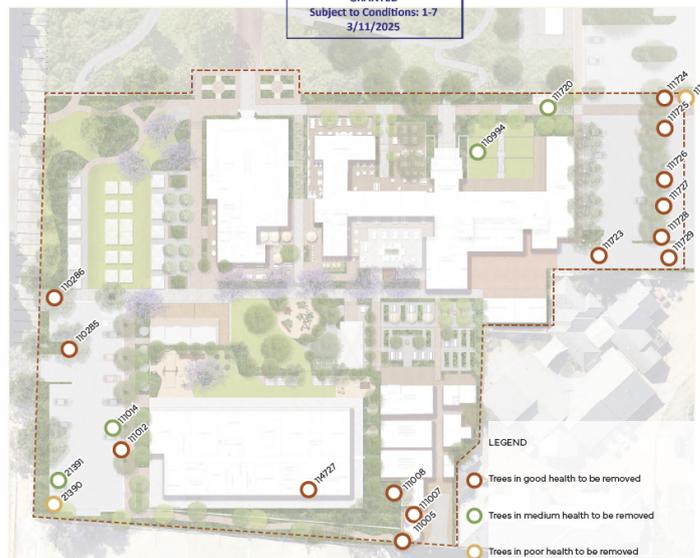
Tree removal plan

This diagram represents the existing trees proposed to be removed, noting that some trees with high and medium retention value are earmarked for removal due to their proximity to proposed infrastructure (buildings, car parks etc)

Below is a summary of the arborists report for trees to be removed:

Health value	Total trees to be removed
Trees in good health to be removed	14 total
Trees in fair health to be removed	4 total
Trees in poor health to be removed	2 total

Tree ID number	Species	Health value
110994	Cupressus species	Fair
110007	Corymbia cactophylla	Good
110012	Pinus radiata	Good
110014	Acacia saligna	Fair
110171	Callitris preissii	Poor
110220	Melia azedarach	Fair
110223	Agrostis flexuosa	Good
110224	Lepostemon confertus	Good
110225	Lepostemon confertus	Good
110226	Lepostemon confertus	Good
110227	Lepostemon confertus	Good
110228	Lepostemon confertus	Good
110229	Lepostemon confertus	Good
110227	Corymbia citriodora	Good
23390	Lepostemon confertus	Poor
23391	Eucalyptus caesia	Fair
110005	Callistemon Kings Park Special	Good
110006	Angophora costata	Good
110285	Pinus radiata	Good
110286	Pinus radiata	Good

*Tree IDs 110285 / 110286 as tabled above were assessed with a GOOD health value in 2023 but have subsequently died as of October 2025.

This approval is for the removal of only those trees identified on the Tree Removal Plan within the amended Landscape Masterplan dated received 31 October 2025, unless otherwise approved by the Town.
