Victoria Park-Canning Level Crossing Removal TREE MANAGEMENT PLAN SUMMARY September 2022

Preliminary Tree Survey

Location: Armadale Line Upgrade; Leach Highway to Miller Street

Date: 18 August 2022

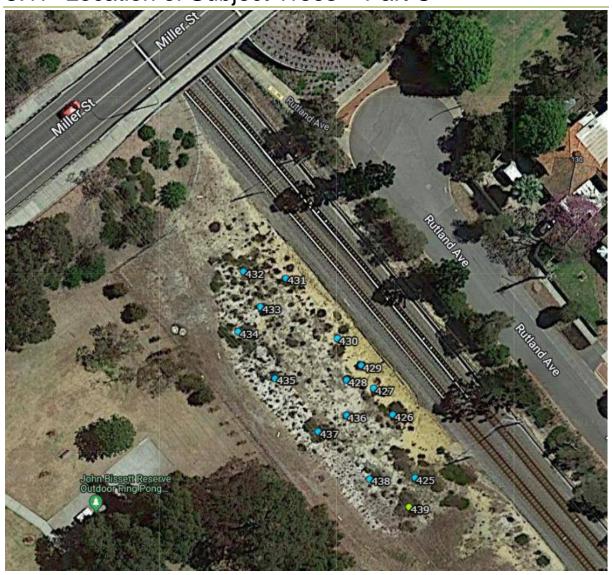
Tree Details	
Latin Name:	Corymbia ficifolia
Common Name:	Flowering Gum
Tree Age:	Semi mature
Health:	Poor
Structure:	Poor
Tree Height (Estimated) [m]:	6
Canopy Spread [m]:	6
DBH [cm]:	37
DBH Range:	30-45cm
Diameter at Root Flare (DRF) [m]:	0.462
Tree Protection Zone (TPZ) [m]:	4.44
Structural Root Zone (SRZ) [m]:	2.39
Useful Life Expectancy:	11-20 years
Origin:	Exotic
Habitat value:	Low
QTRA Risk Category:	Broadly Acceptable
Observation Comments:	This tree is in poor condition, likely due to compacted soil around it remove all grass for radius of 3 m and replace with mulch Myer prime at 1% and remove all dead wood over 25 mm in diameter.
Foraging species:	No
