SITE CONTEXT PLAN
EDWARD MILLEN HOME
DEVELOPMENT APPLICATION

SITE ELEVATIONS
EDWARD MILLEN HOME
DEVELOPMENT APPLICATION

ROTUNDA - PROPOSED FLOOR PLANS

MILDRED CREAK BUILDING - MAJOR RESTORATION

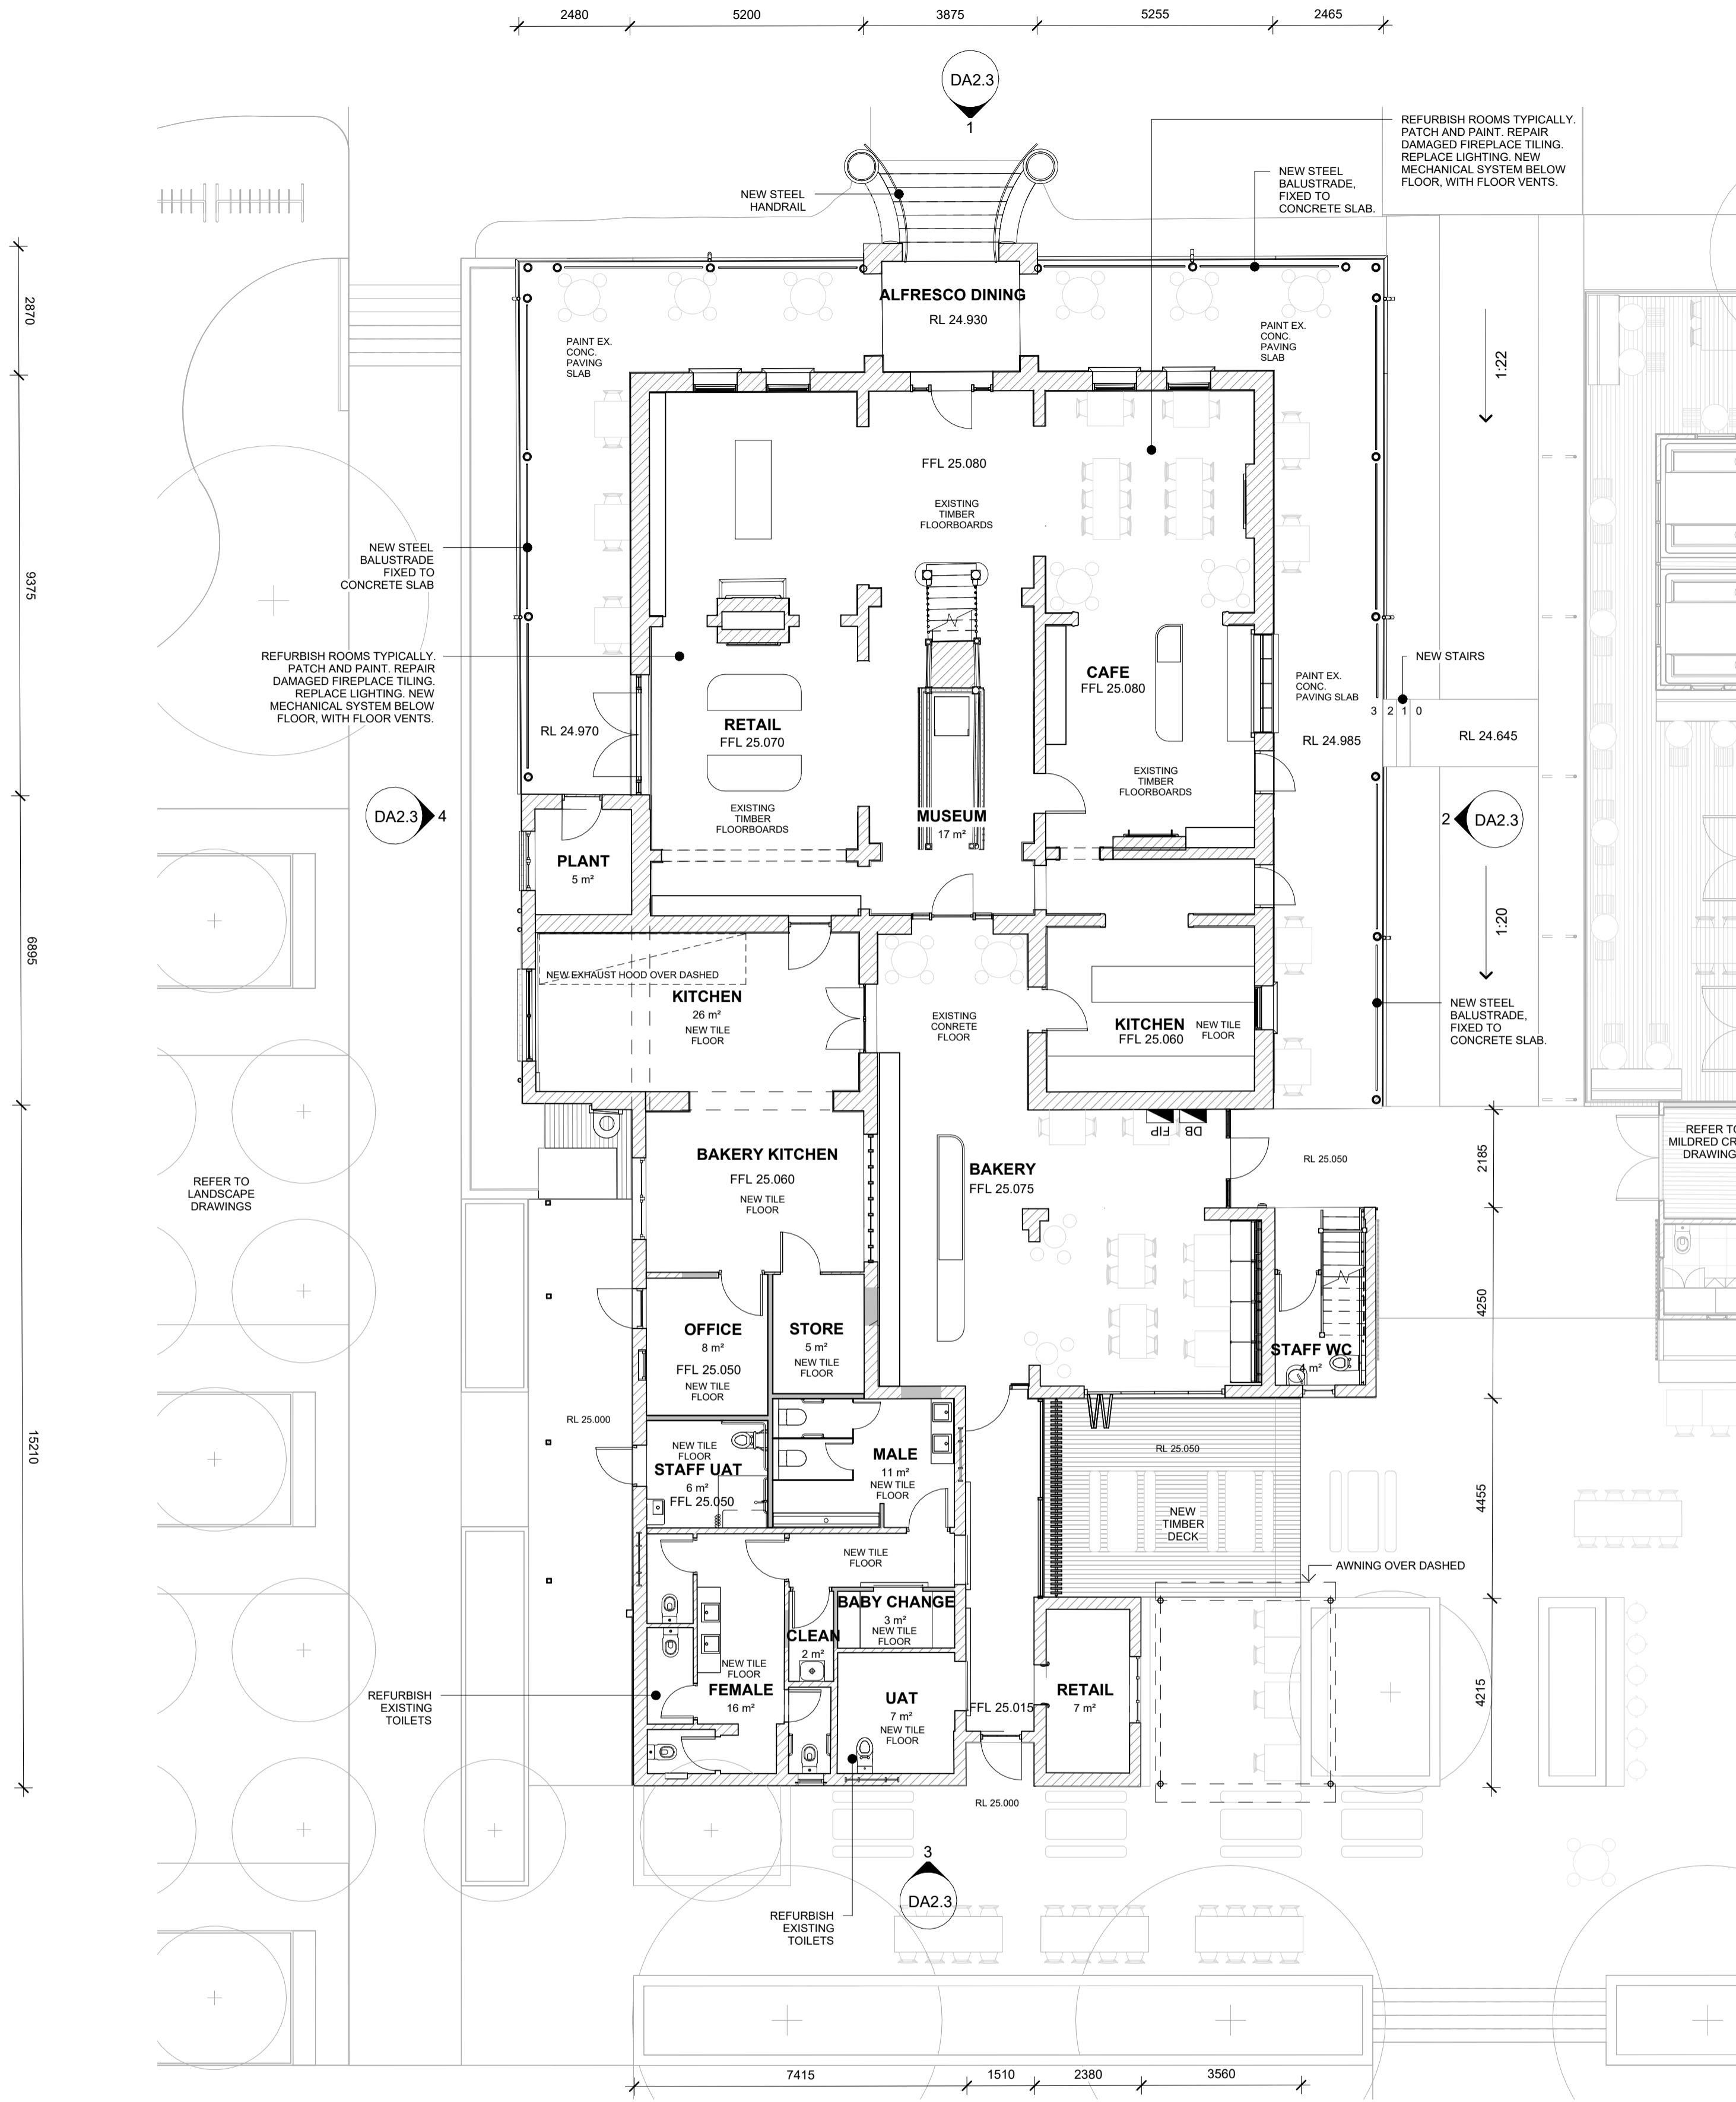
GROUND FLOOR PLAN

- EXTERIOR
- Tuck Pointed Brickwork:** Restore and make good where necessary. Generally, in good condition
 - Stucco Architraves, Imposts, and Pilasters:** Allow for minor repairs as required. Repaint existing painted surfaces, making sure to match original colors and textures. Generally, in good condition

- Front Entry Steps and Stucco-Finished Balustrade Walls:** Allow for minor repairs as required. Repaint existing painted surfaces. Generally, in good condition

- Ground Floor Verandah:** Allow for minor repairs as required. Repaint existing painted surfaces. Generally, in good condition
 - Terracotta Roof Tiles:** Conduct repairs as necessary, matching original materials to prevent water ingress. Generally, in good condition

- Balustrading, Frieze, and Brackets:** Make good where necessary and repaint existing painted surfaces. Generally, in good condition
 - Columns on Ground Level and Level 1:** Make good where necessary and allow for repaint existing painted surfaces. Assess for repairs to downpipes and brackets. Generally, in good condition

- Timber and Steel Framed Doors and Windows:** Re-furbish and repaint existing joinery. Replace damaged glazing.
 - Exterior Light Fixtures and Fittings:** Replace with heritage-appropriate fixtures.

- First Floor Verandah Soffit Pressed Metal:** Repair and paint
 - Chimneys:** Assess for repair and make good as required, repaint existing painted surfaces. Generally, in good condition

- Gutters, Fascia's, and Downpipes:** Repair as required or replace and allow for repaint of existing painted surfaces.
- Corrugated Roofing:** Assess for repairs. New sections required to prevent current water ingress.
- Exterior Services:** Reroute recent additions to conceal as to preserve heritage aesthetics. Allow for affected surfaces to be restored and refinished.
- Soffits:** Repair as required and repaint existing painted surfaces. Allow for visible birdboards to be refinished throughout.
- Subfloor Structural Timber System:** Assess for repairs using non-destructive testing methods. Carry out repairs or replacements as required. Generally, in good condition

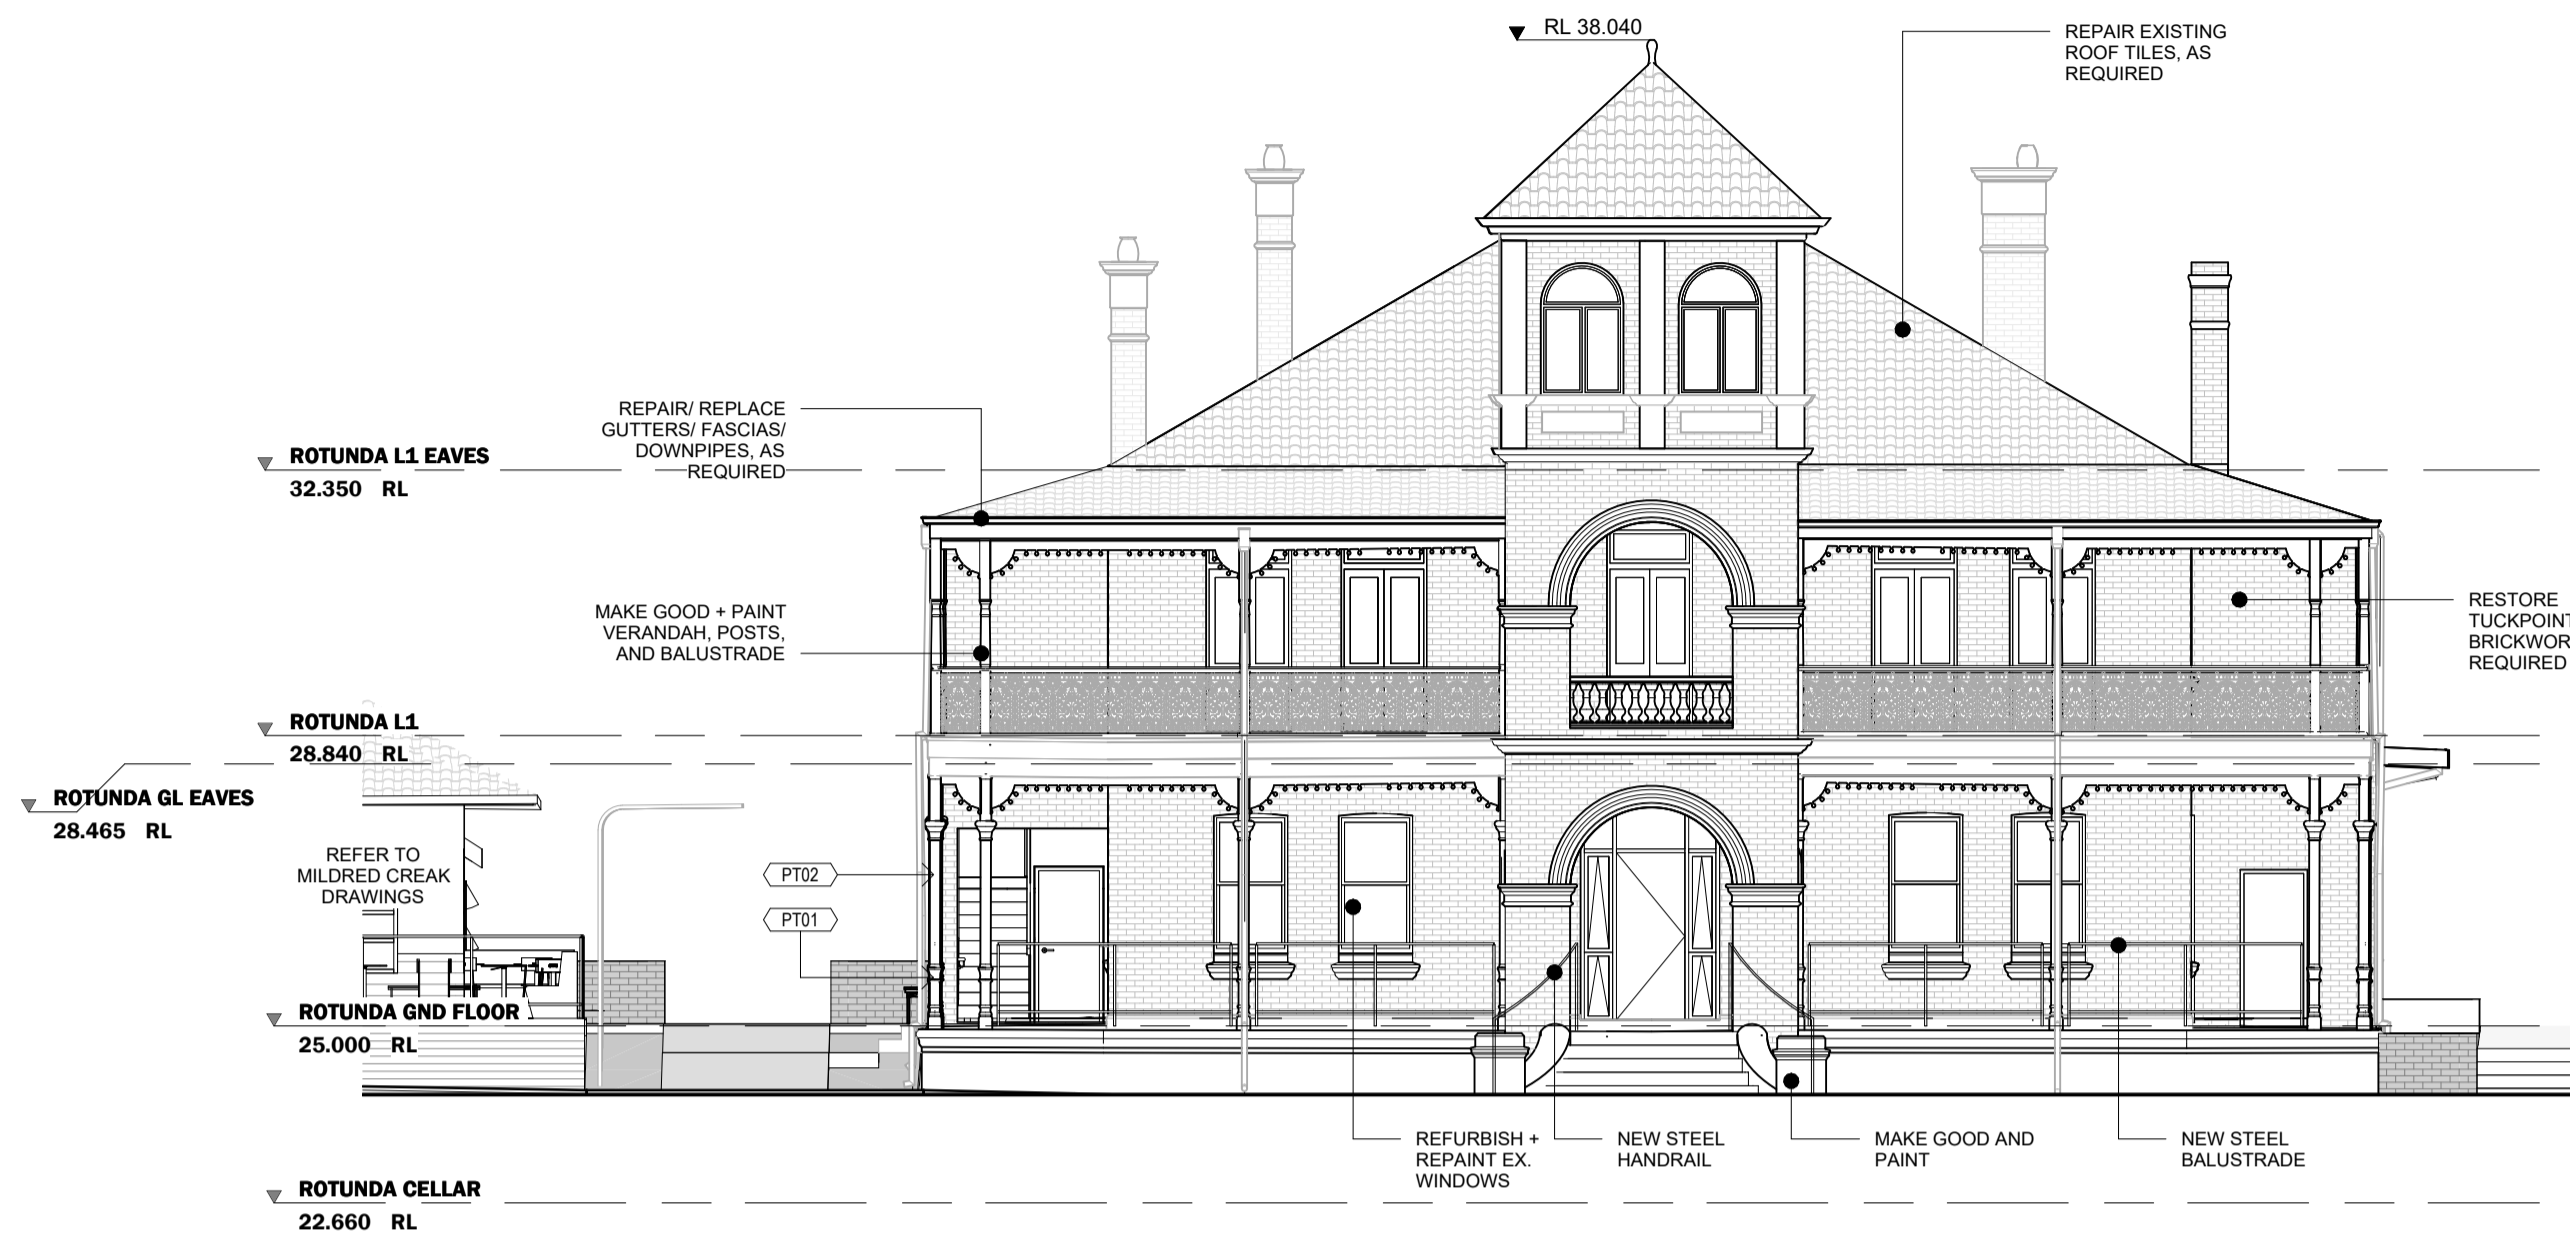
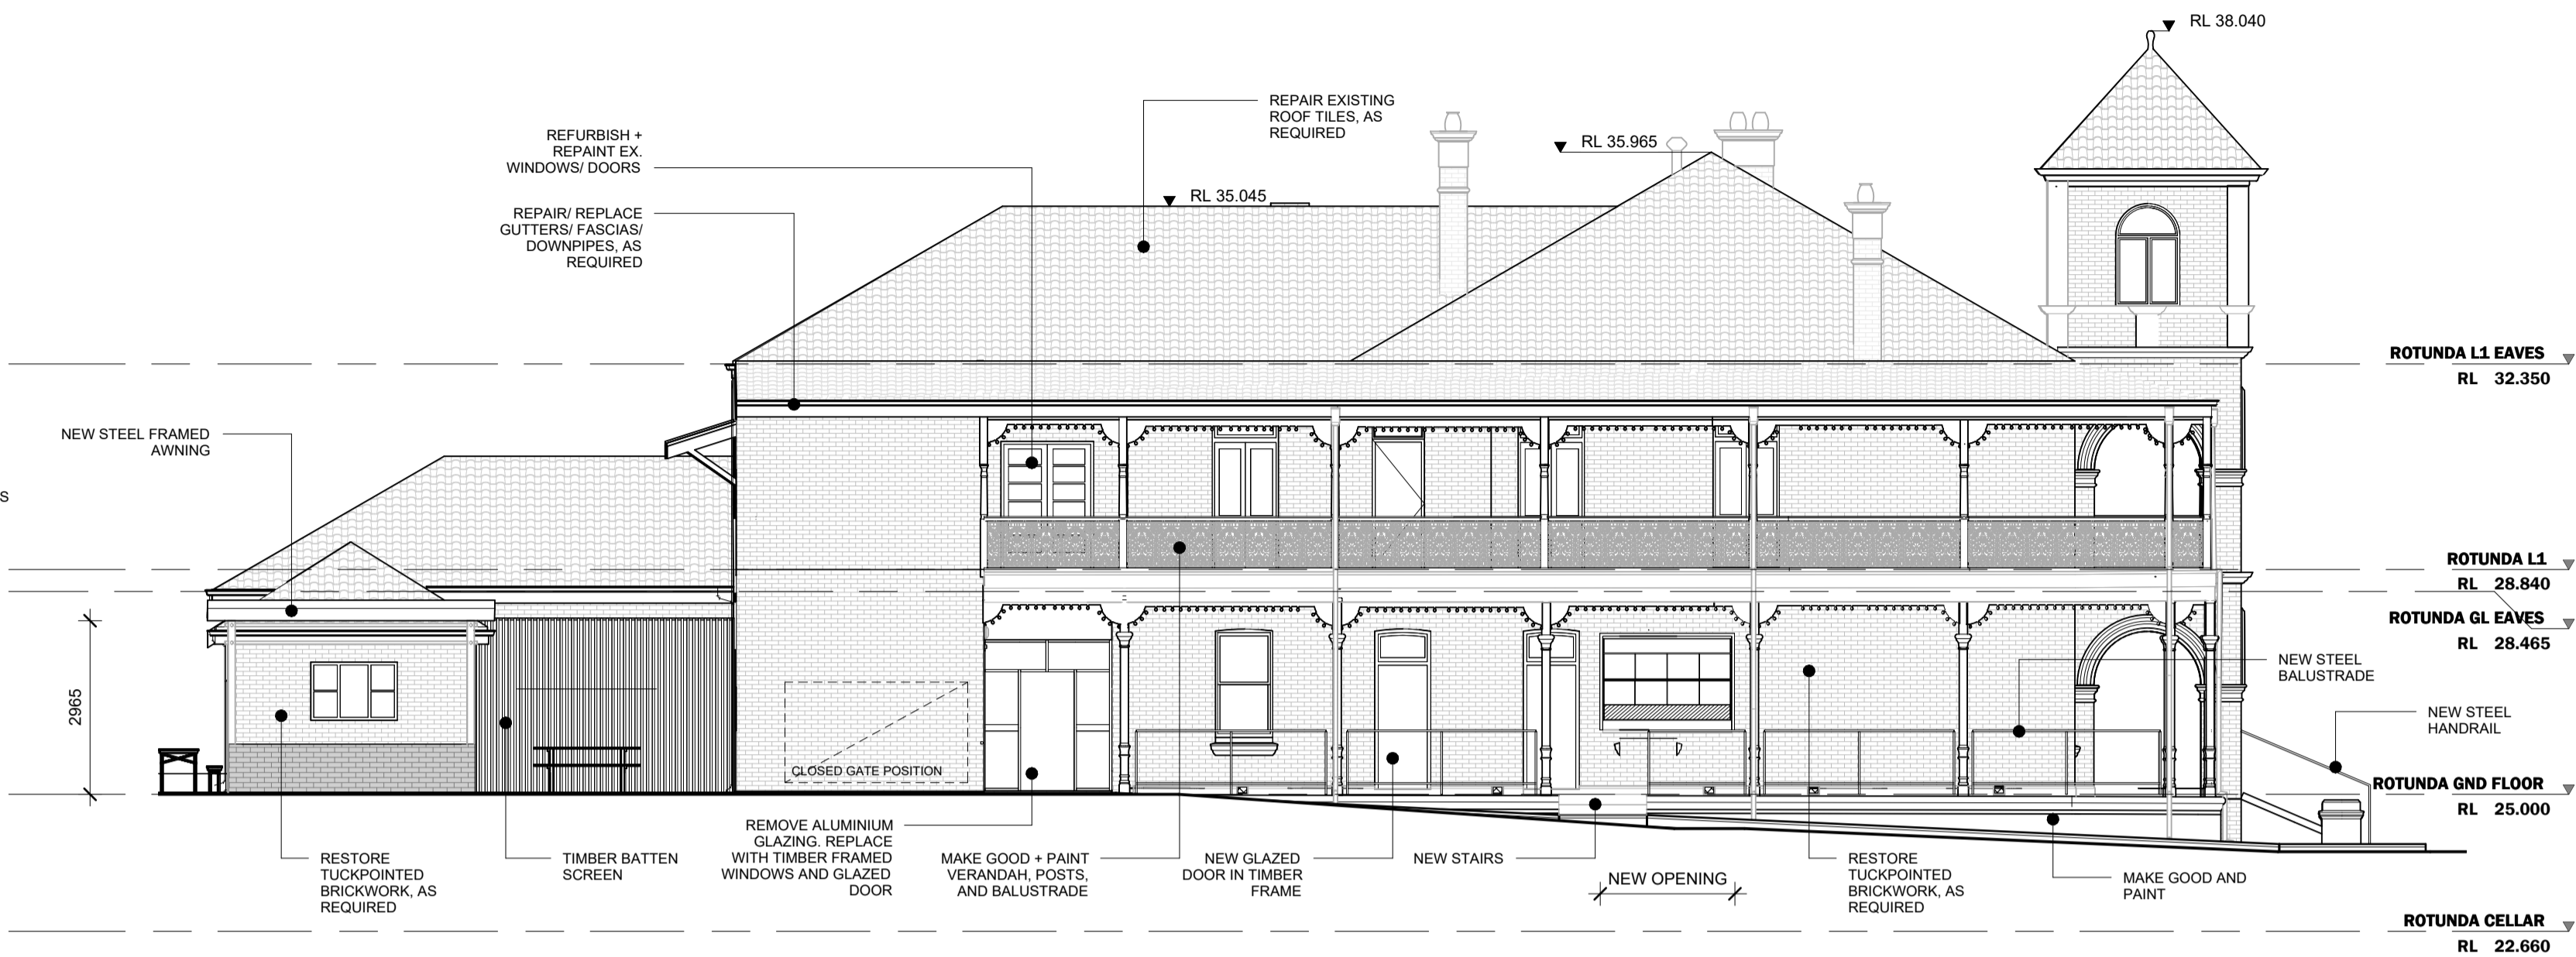
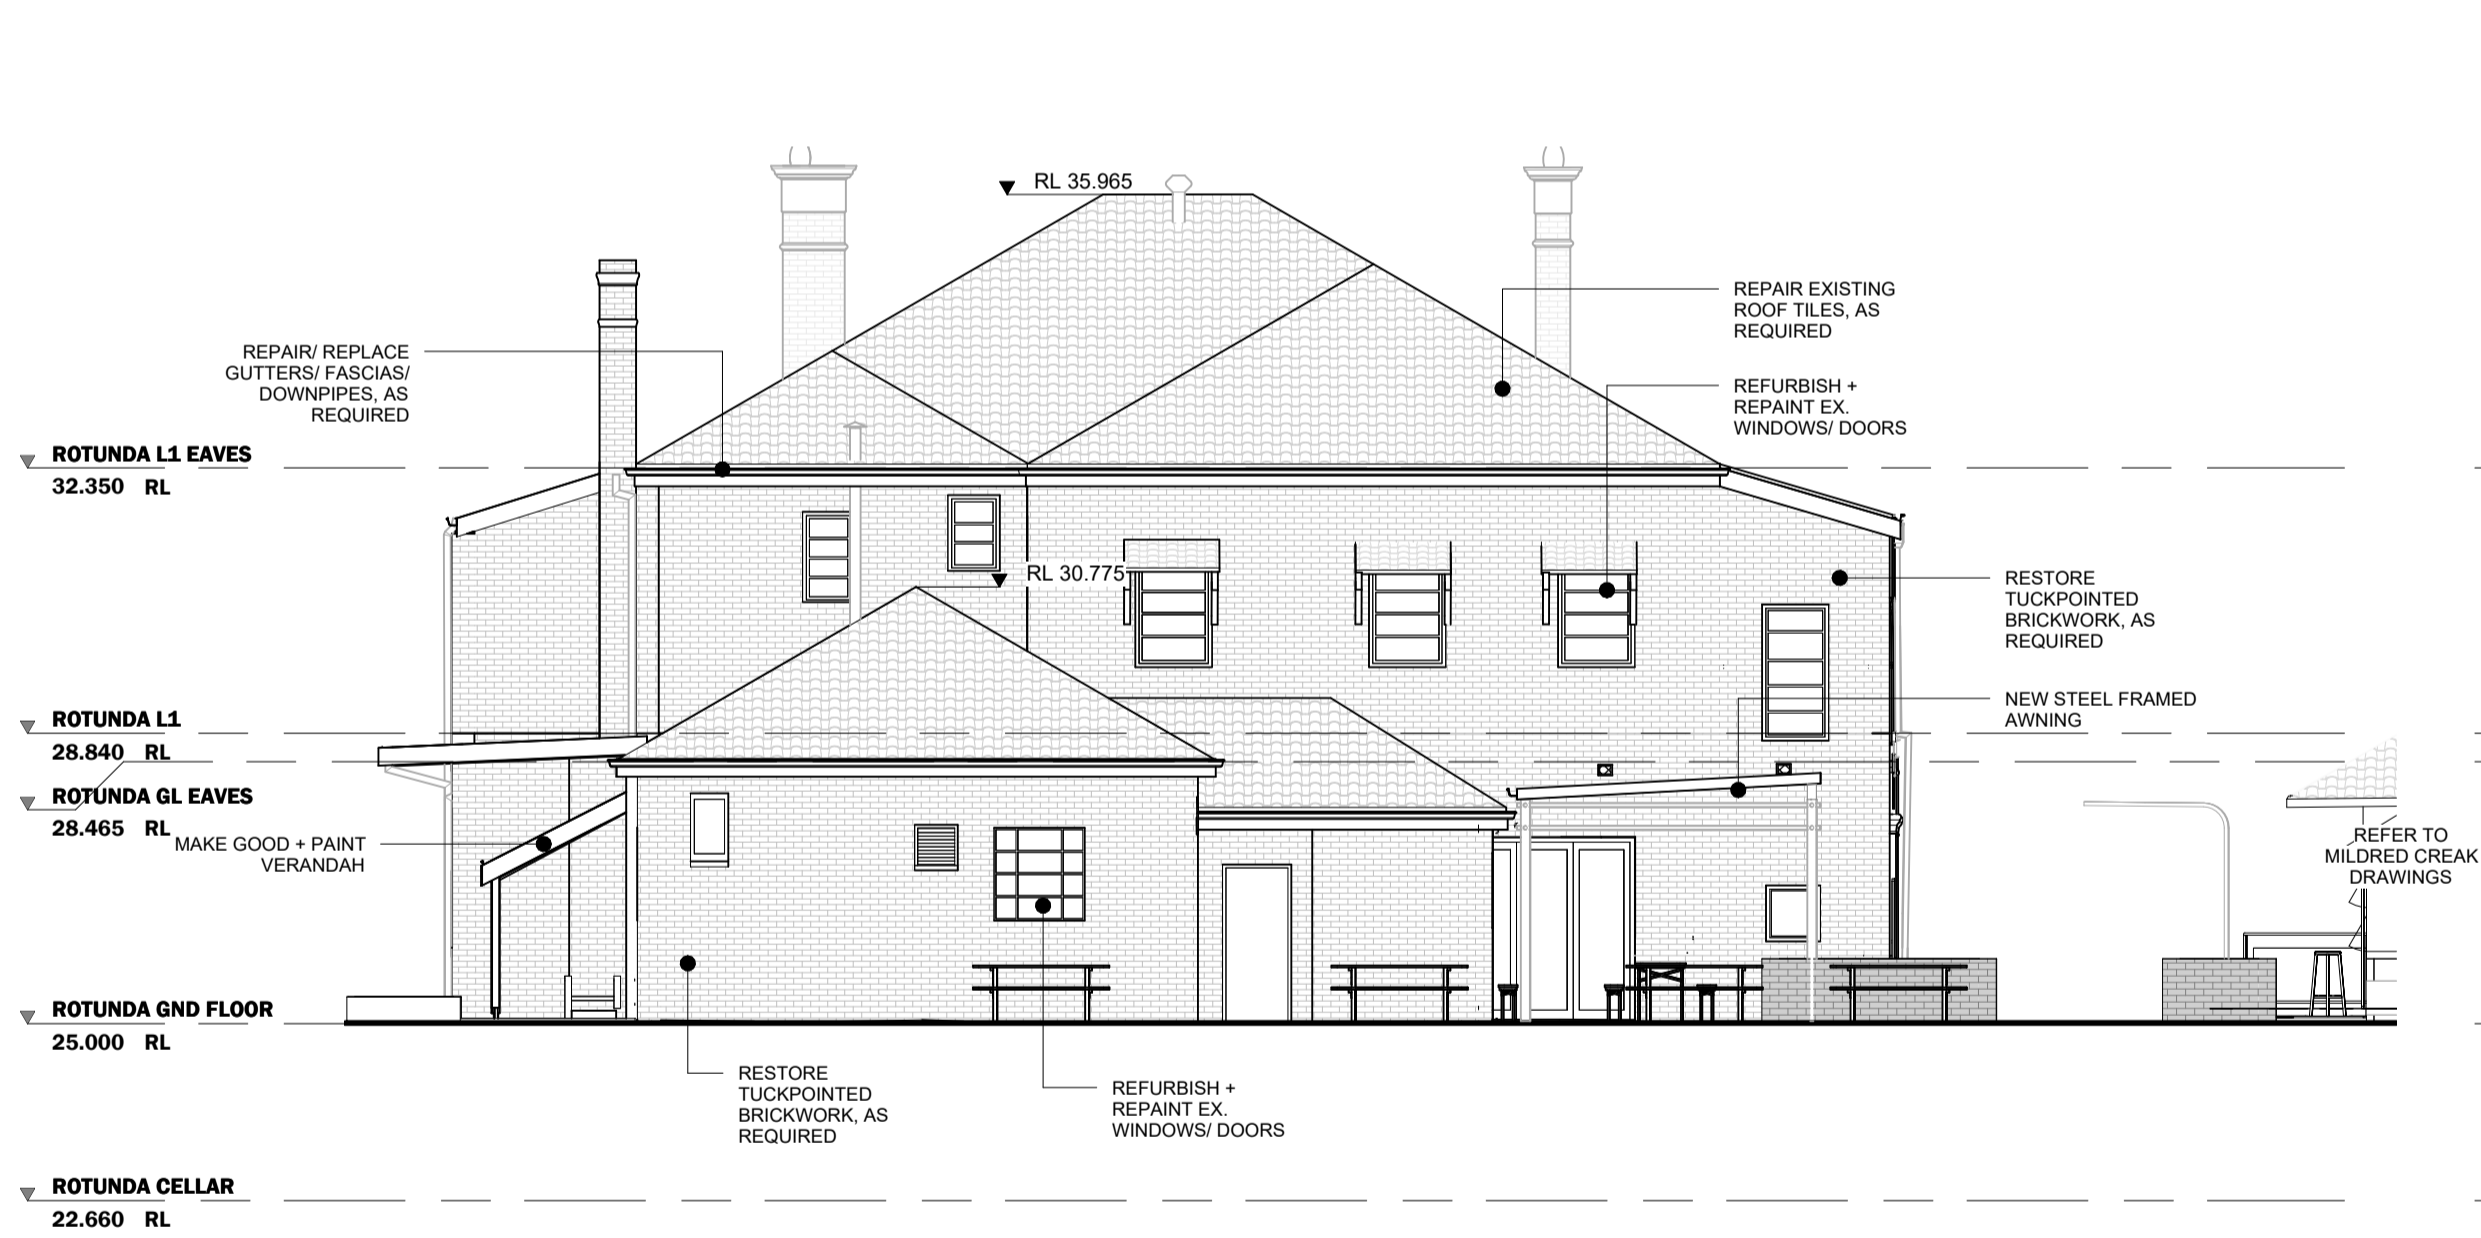
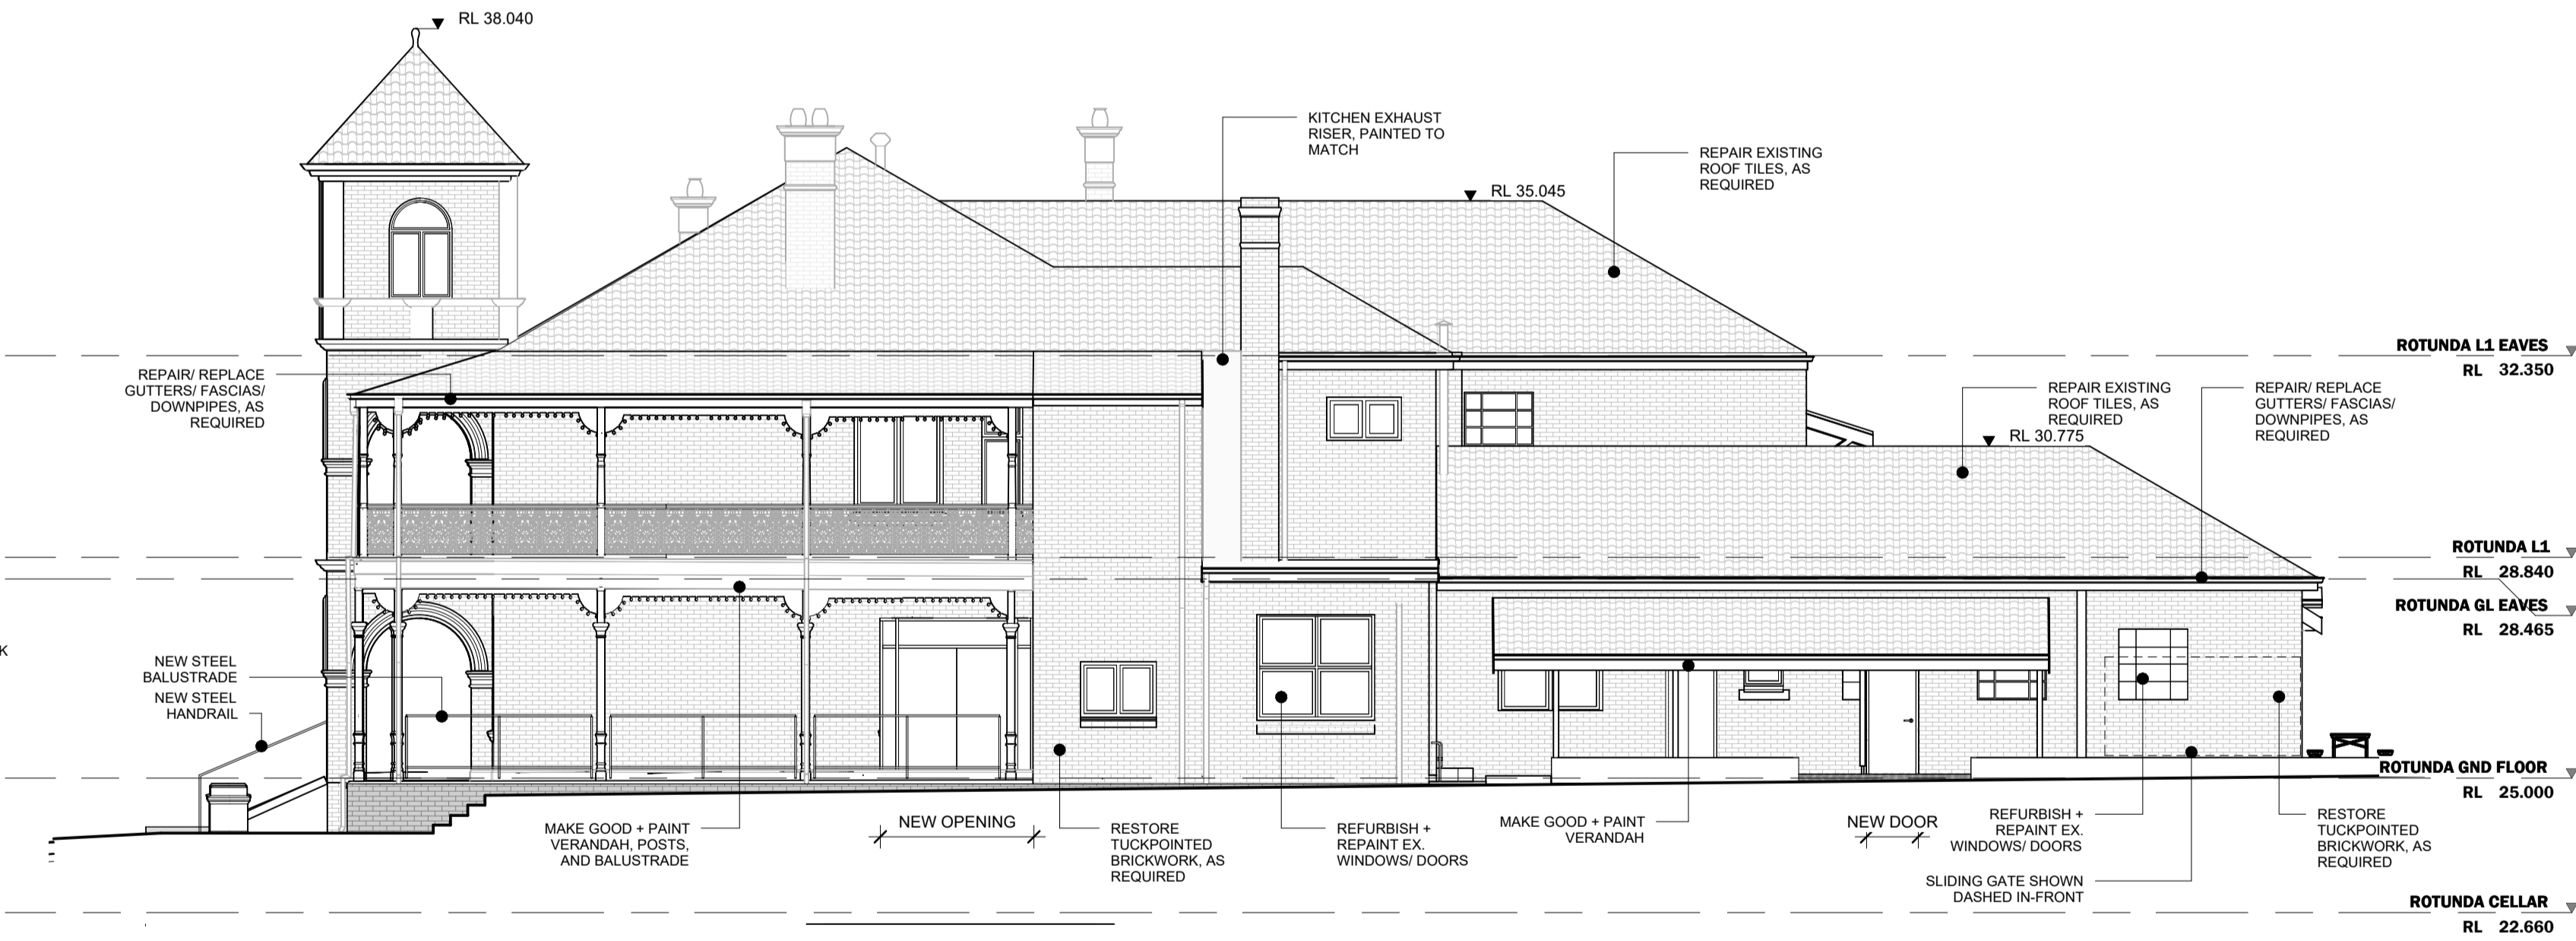
ROTUNDA NORTH ELEVATION

- EXTERIOR**
- Tuck Pointed Brickwork:** Restore and make good where necessary. Generally, in good condition
 - Stucco Architraves, Imposts, and Pilasters:** Allow for minor repairs as required. Repaint existing painted surfaces, making sure to match original colors and textures. Generally, in good condition

- Front Entry Steps and Stucco-Finished Balustrade Walls:** Allow for minor repairs as required. Repaint existing painted surfaces. Generally, in good condition

- Ground Floor Verandah:** Allow for minor repairs as required. Repaint existing painted surfaces. Generally, in good condition
 - Terracotta Roof Tiles:** Conduct repairs as necessary, matching original materials to prevent water ingress. Generally, in good condition

- Balustrading, Frieze, and Brackets:** Make good where necessary and repaint existing painted surfaces. Generally, in good condition
 - Columns on Ground Level and Level 1:** Make good where necessary and allow for repaint existing painted surfaces. Assess for repairs to downpipes and brackets. Generally, in good condition

- Timber and Steel Framed Doors and Windows:** Re-furbish and repaint existing joinery. Replace damaged glazing.
 - Exterior Light Fixtures and Fittings:** Replace with heritage-appropriate fixtures.

- First Floor Verandah Soffit Pressed Metal:** Repair and paint
 - Chimneys:** Assess for repair and make good as required, repaint existing painted surfaces. Generally, in good condition

- Gutters, Fascia's, and Downpipes:** Repair as required or replace and allow for repaint of existing painted surfaces.
- Corrugated Roofing:** Assess for repairs. New sections required to prevent current water ingress.
- Exterior Services:** Reroute recent additions to conceal as to preserve heritage aesthetics. Allow for affected surfaces to be restored and refinished.
- Soffits:** Repair as required and repaint existing painted surfaces. Allow for visible birdboards to be refinished throughout.
- Subfloor Structural Timber System:** Assess for repairs using non-destructive testing methods. Carry out repairs or replacements as required. Generally, in good condition

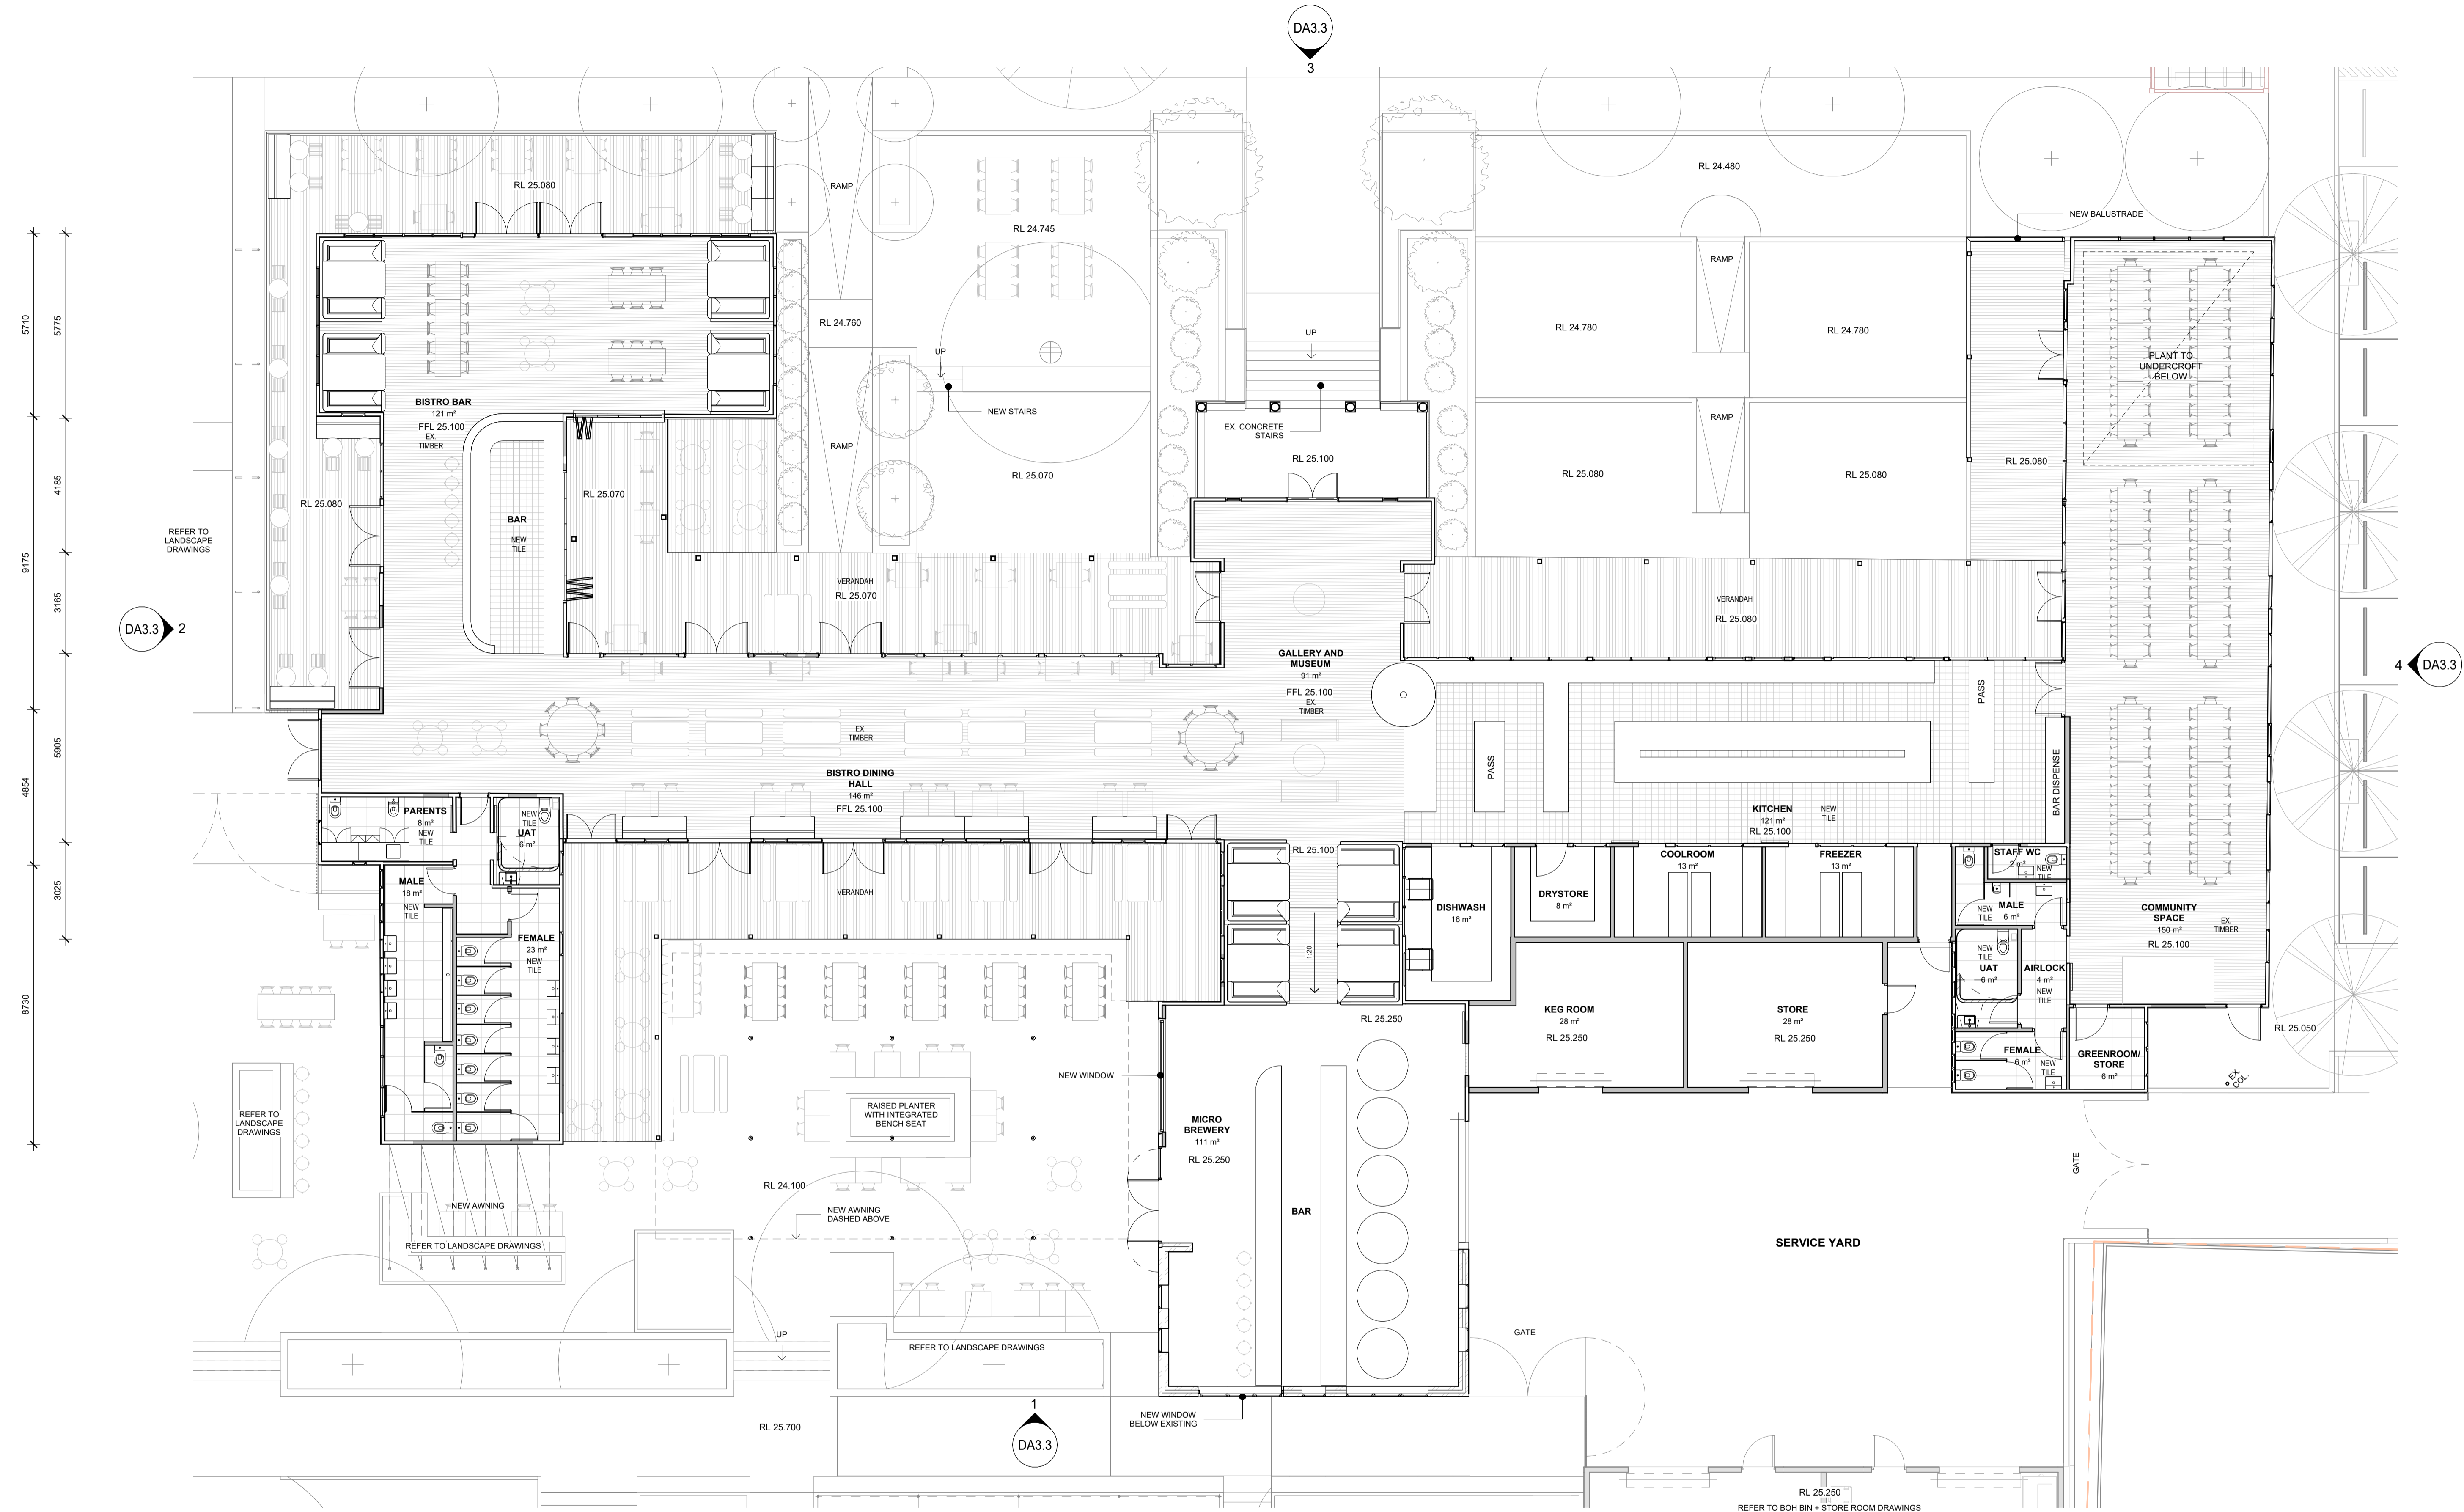
- Brickwork:** Replace and make good to damaged bricks where necessary.
 - Front Entry Steps and Brick Balustrade Walls** Assess for repair. Allow for repaint of existing painted surfaces. Allow for partial removal of rendered upturn. Existing iron balustrades to be removed and new, code-compliant replacements to be installed. Add treads to existing concrete stairs and allow for resurfacing for treads to ensure compliance.

- Entry portico:** Make good as required and allow for repaint of existing painted surfaces.
 - Verandah:** Allow for repairs as required. Existing verandah in poor condition and timber structure rotten in places. Repaint existing painted surfaces. Allow for timber verandah flooring to be repaired and refinished.
