SITE CONTEXT PLAN
EDWARD MILLEN HOME
DEVELOPMENT APPLICATION

SITE ELEVATIONS
EDWARD MILLEN HOME
DEVELOPMENT APPLICATION

ROTUNDA - PROPOSED FLOOR PLANS

MILDRED CREAK BUILDING - MAJOR RESTORATION

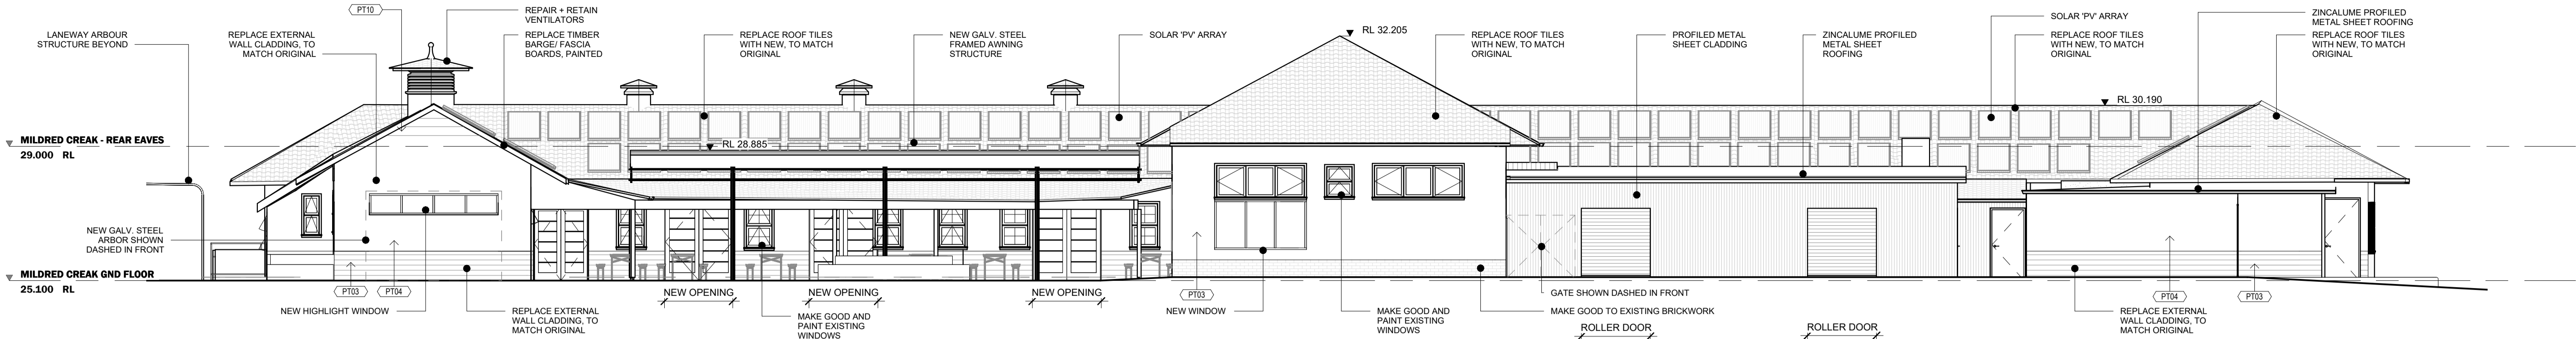
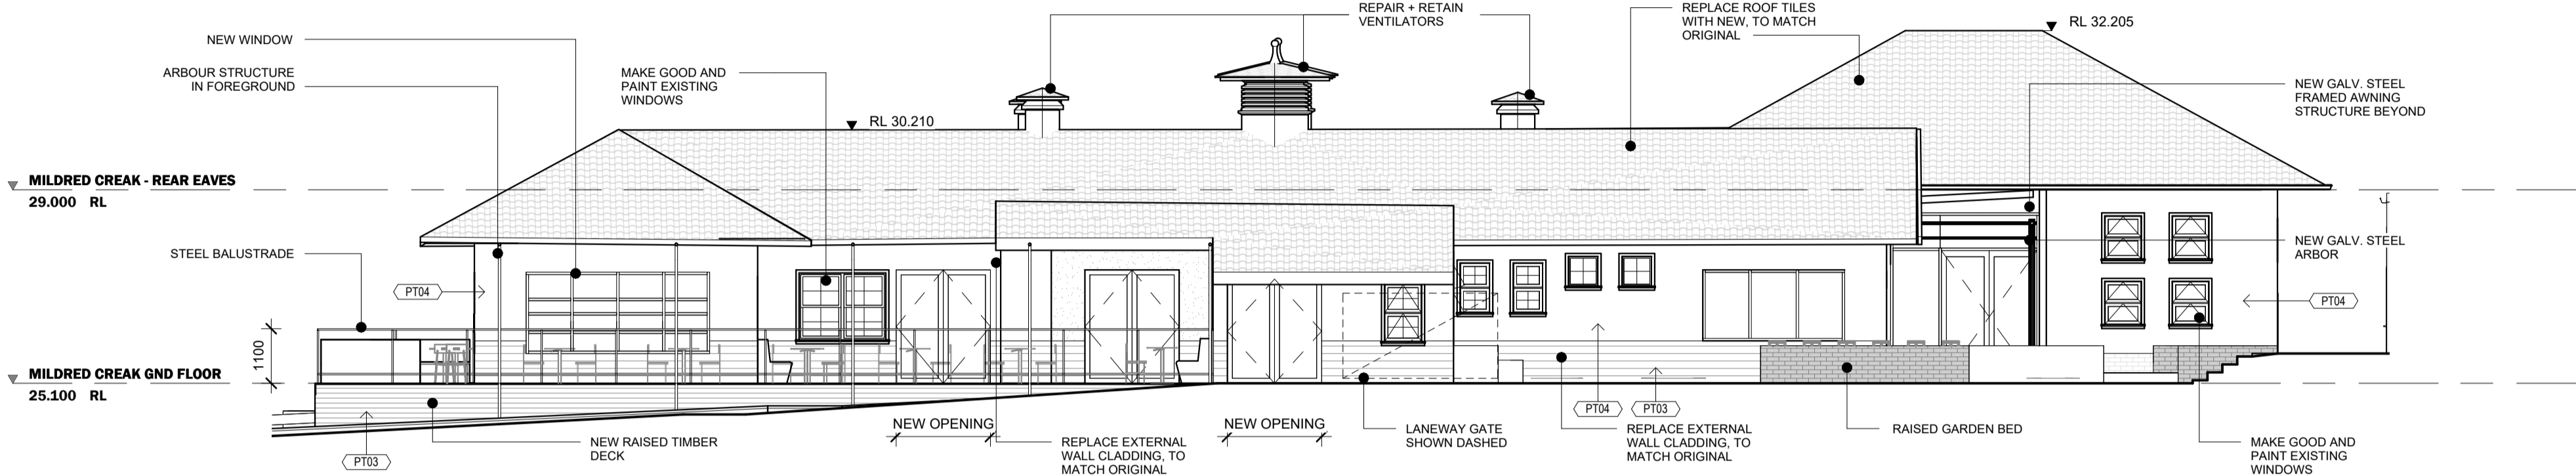
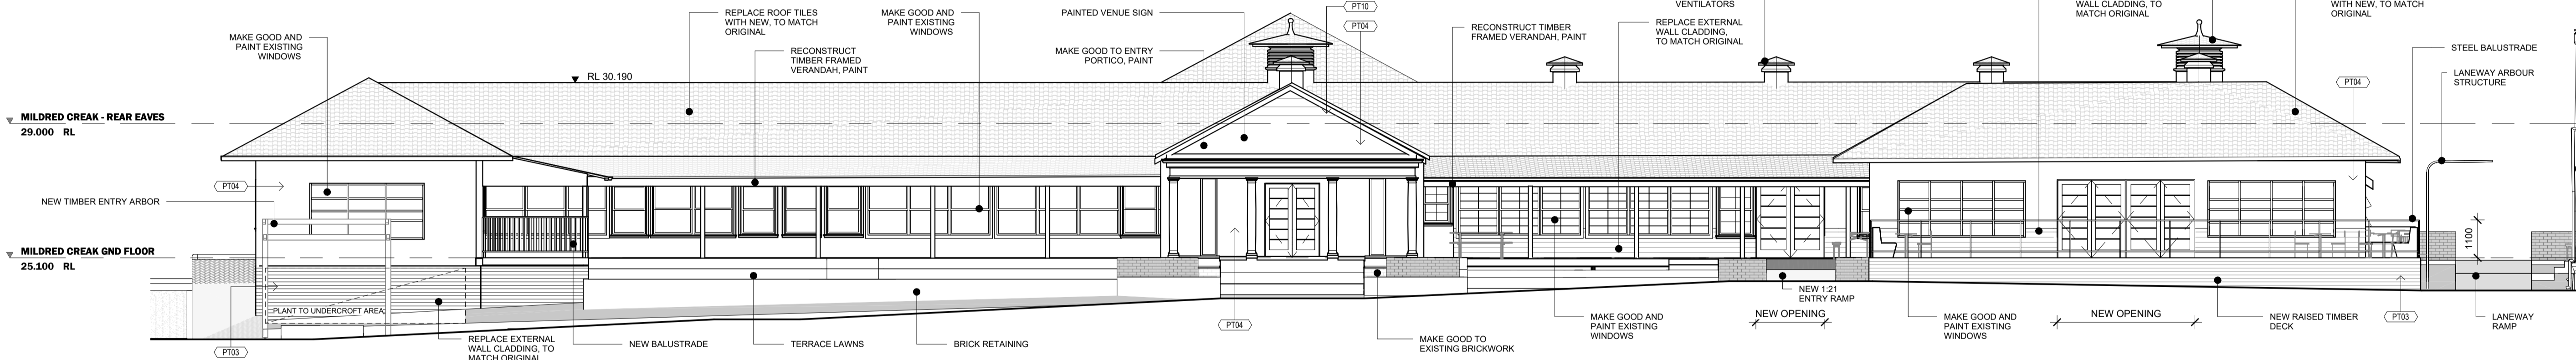
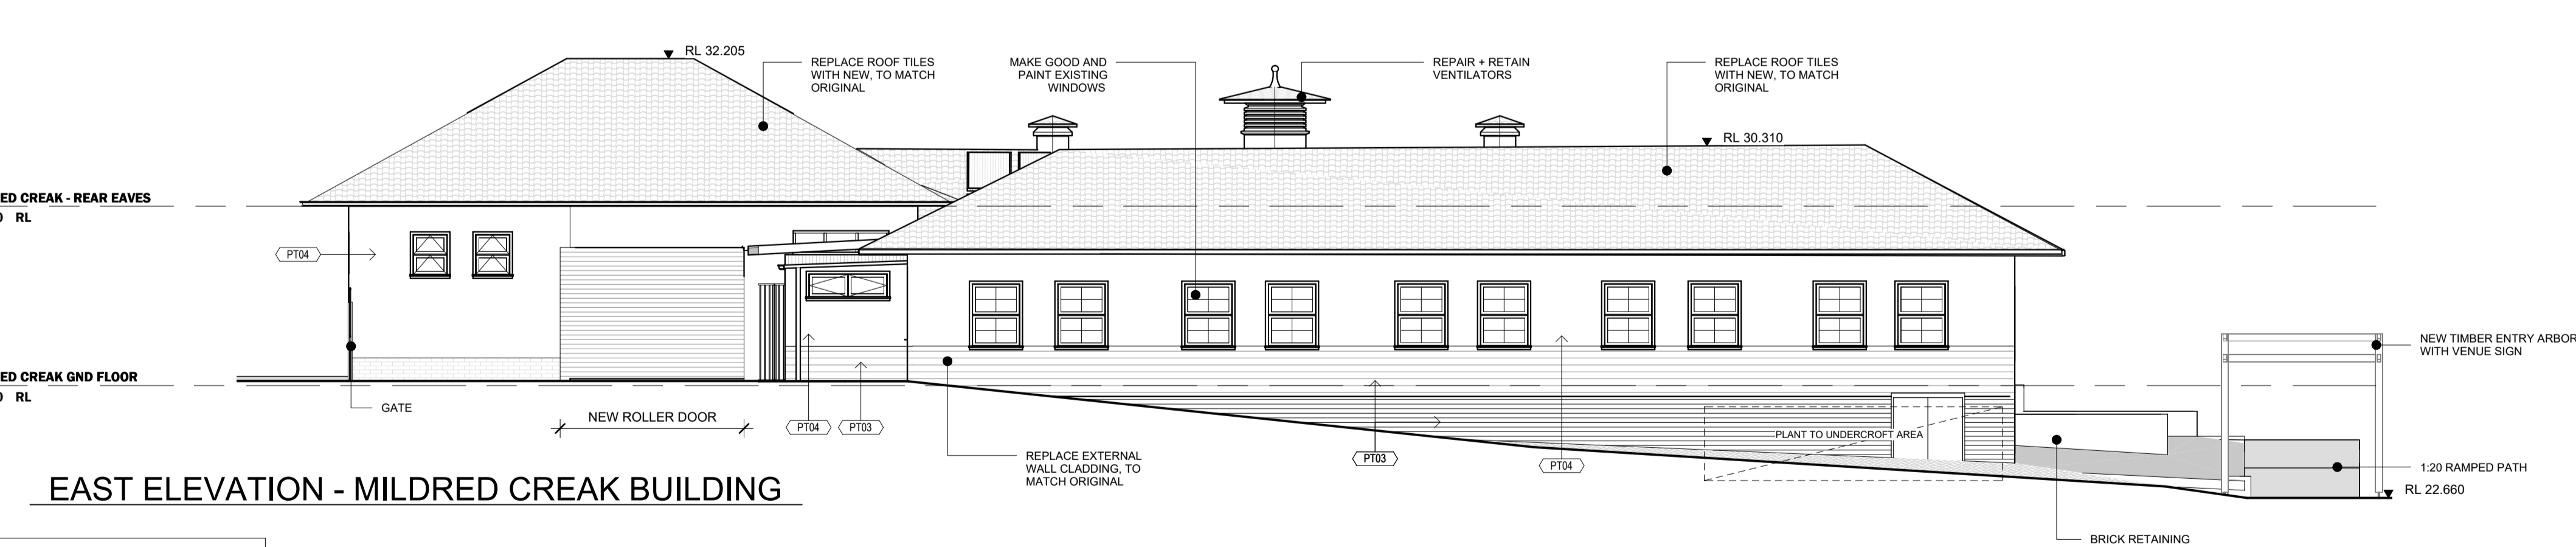
SOUTH ELEVATION - MILDRED CREAK BUILDING

FINISHES LEGEND		
CODE	DESCRIPTION	
PT03	EXTERIOR LOW SHEEN PAINT FINISH - (Green)	
PT04	EXTERIOR LOW SHEEN PAINT FINISH - (WHITE)	
PT10	AQUANAMEL - Mildred Creak

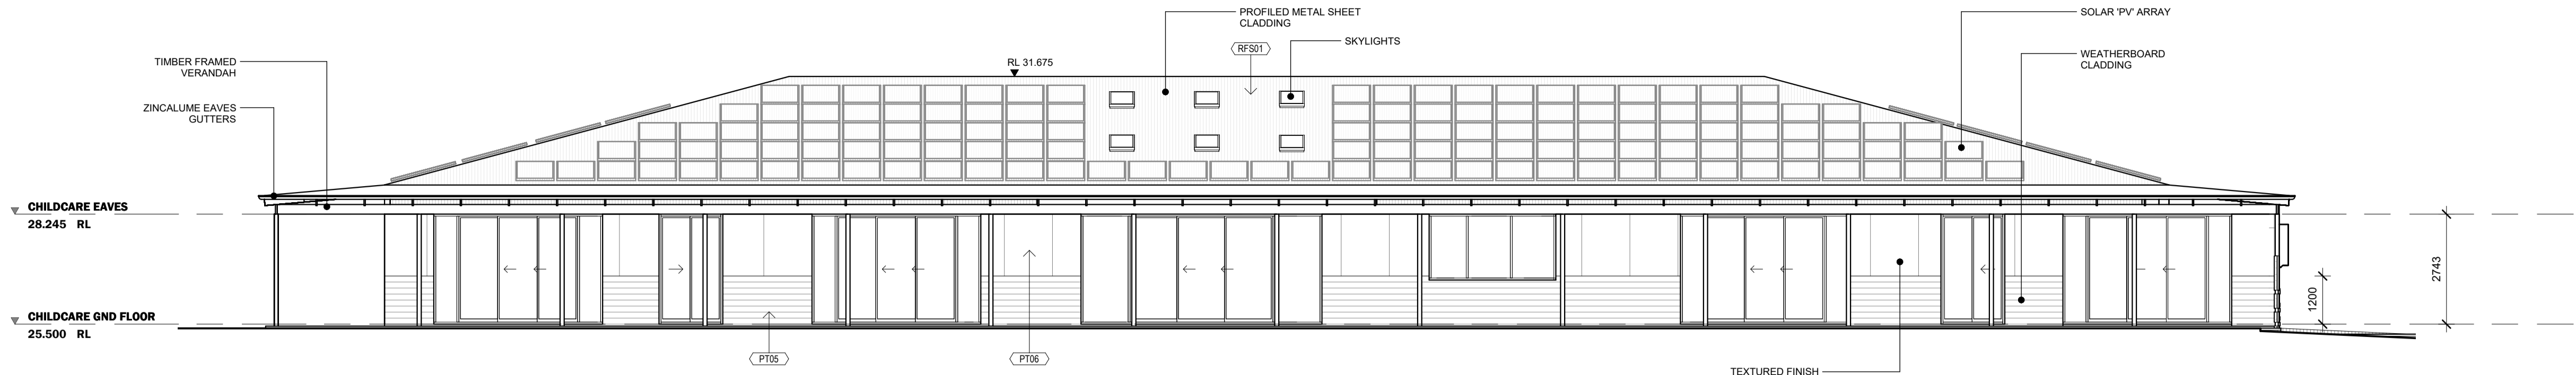
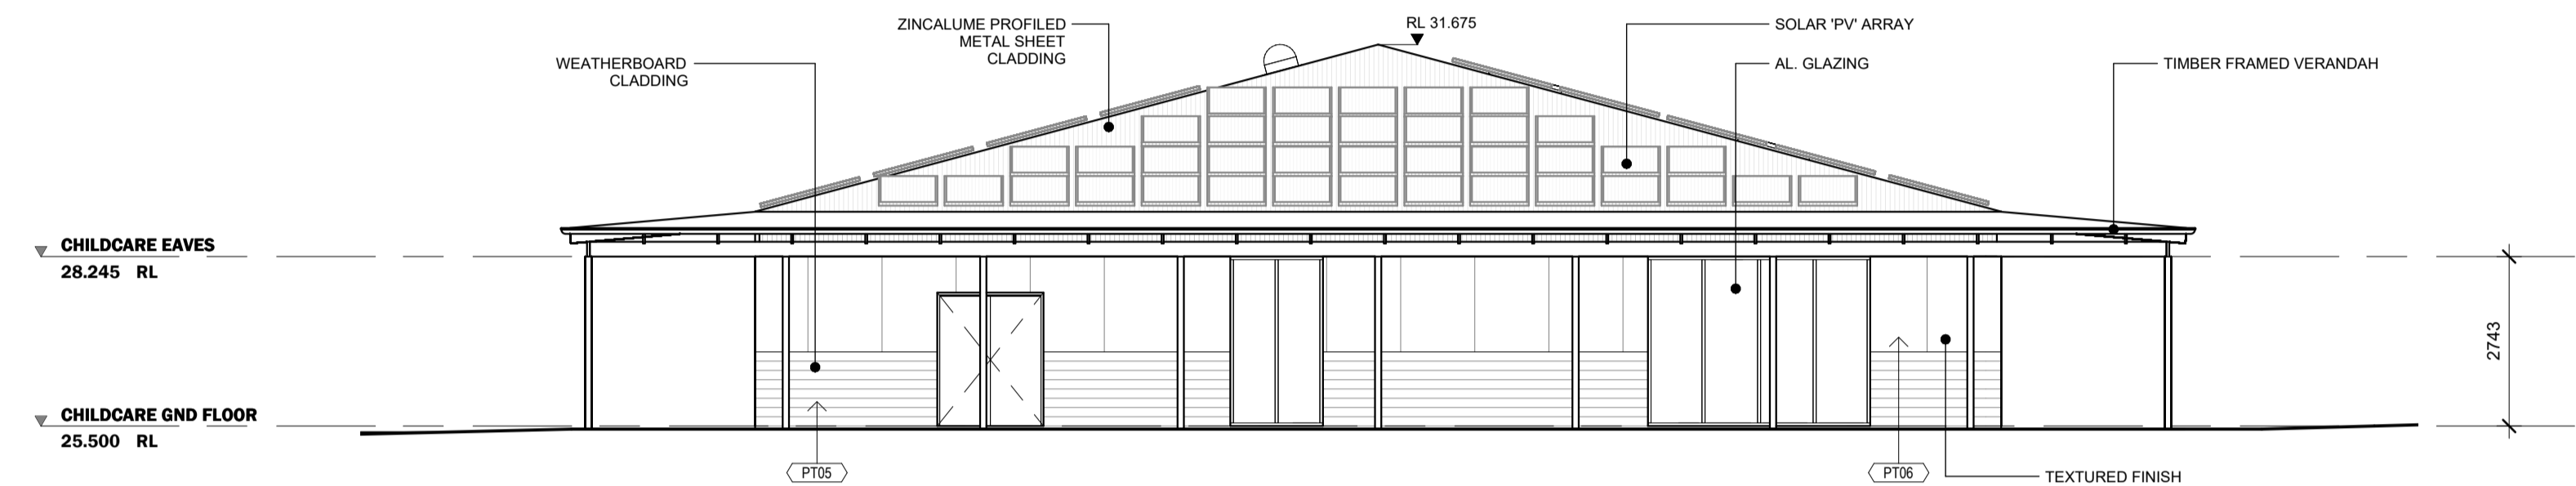
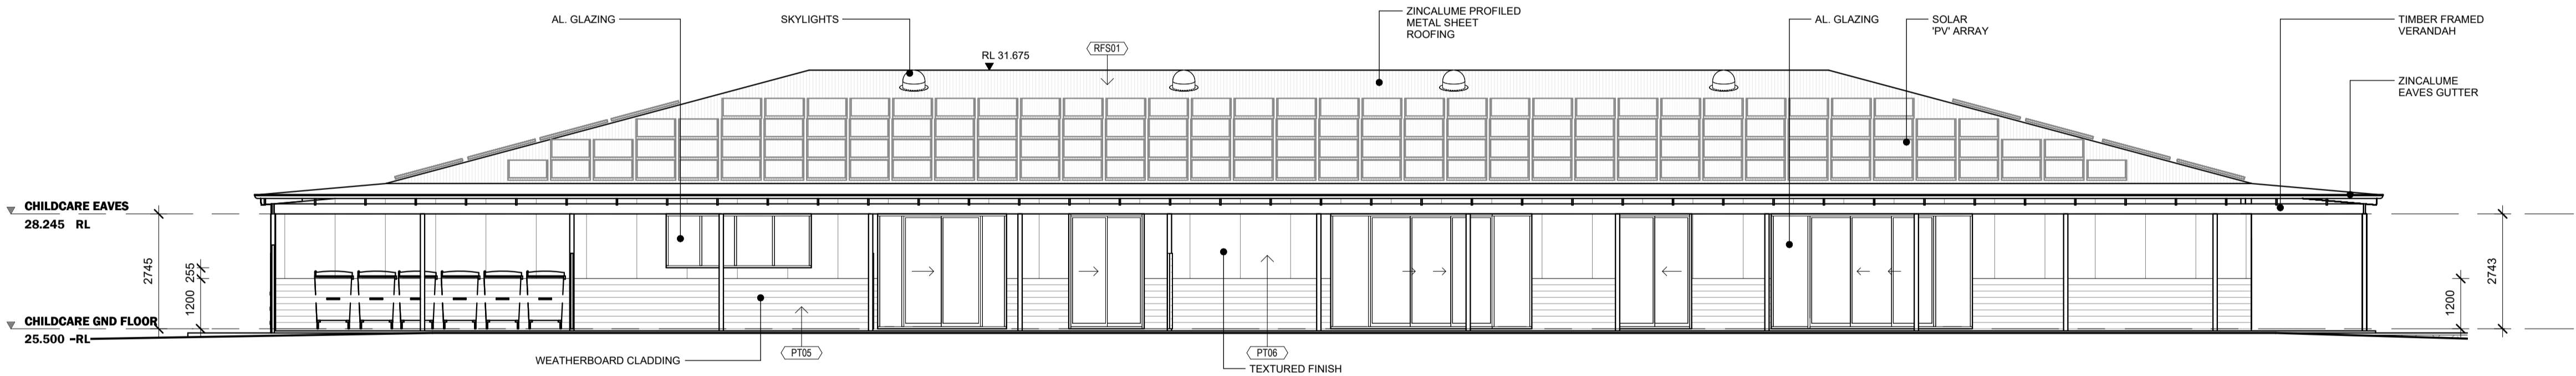
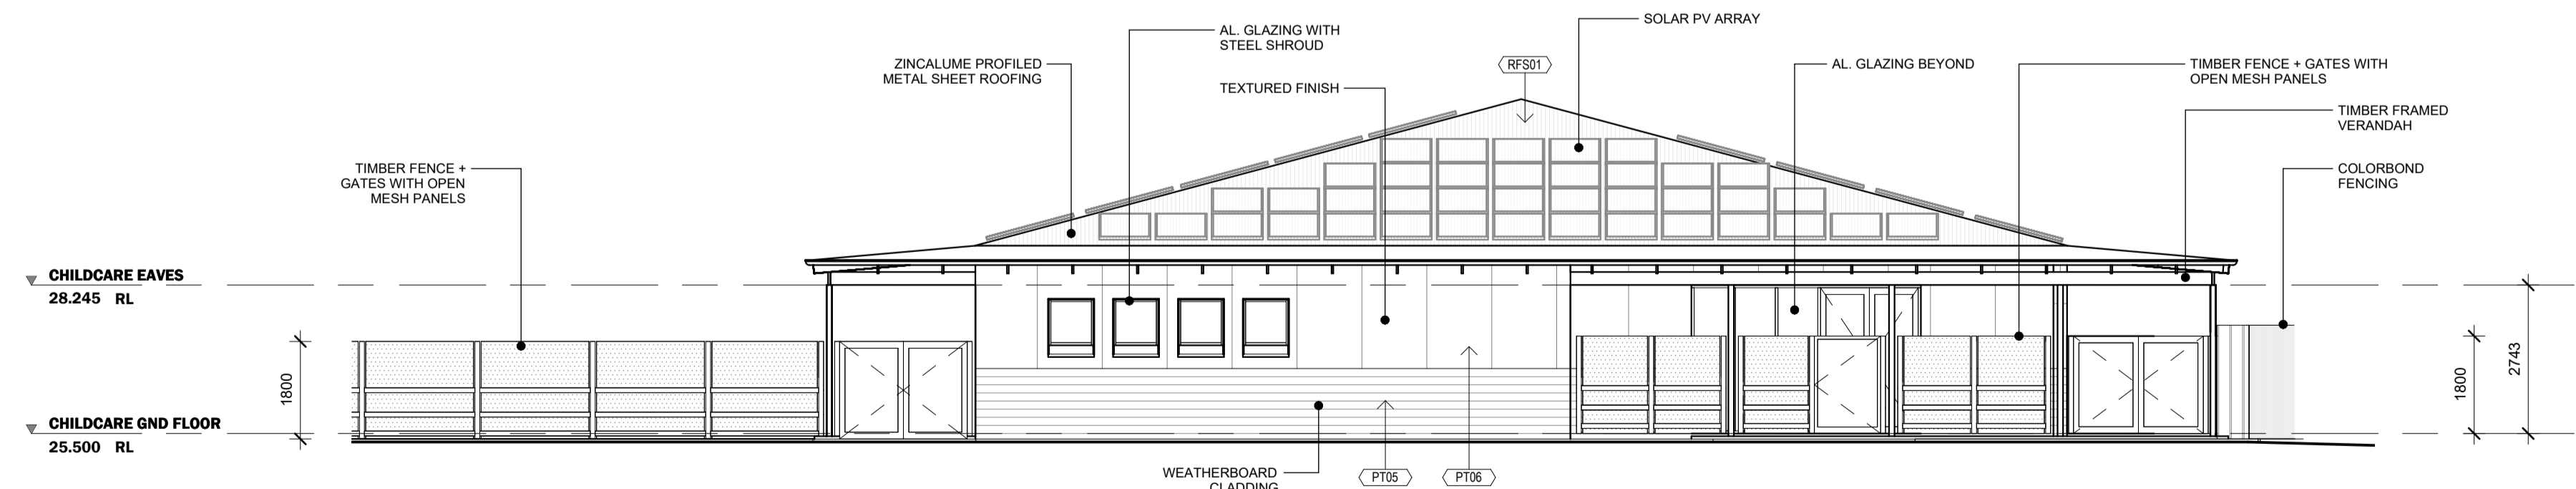
NORTH ELEVATION

FINISHES LEGEND	
CODE	DESCRIPTION
PT05	EXTERIOR LOW SHEEN PAINT FINISH - (Green)
PT06	EXTERIOR TEXTURE FINISH
RFS01	ZINCALUME ROOFING
